Chateau Comox

Our File No.: S07-262
8 November 2007

Re: Strata Plan LMS 280 - "Chateau Comox" 1272 Comox Street, Vancouver, B.C.
– Building Envelope Leak Investigation

STRATA PLAN LMS 280 – CHATEAU COMOX, 1272 COMOX STREET, VANCOUVER, BC
PHOTOGRAPHS TAKEN BY CLIFFORD SUTTON, M.ENG. ON NOVEMBER 5 - 7, 2007

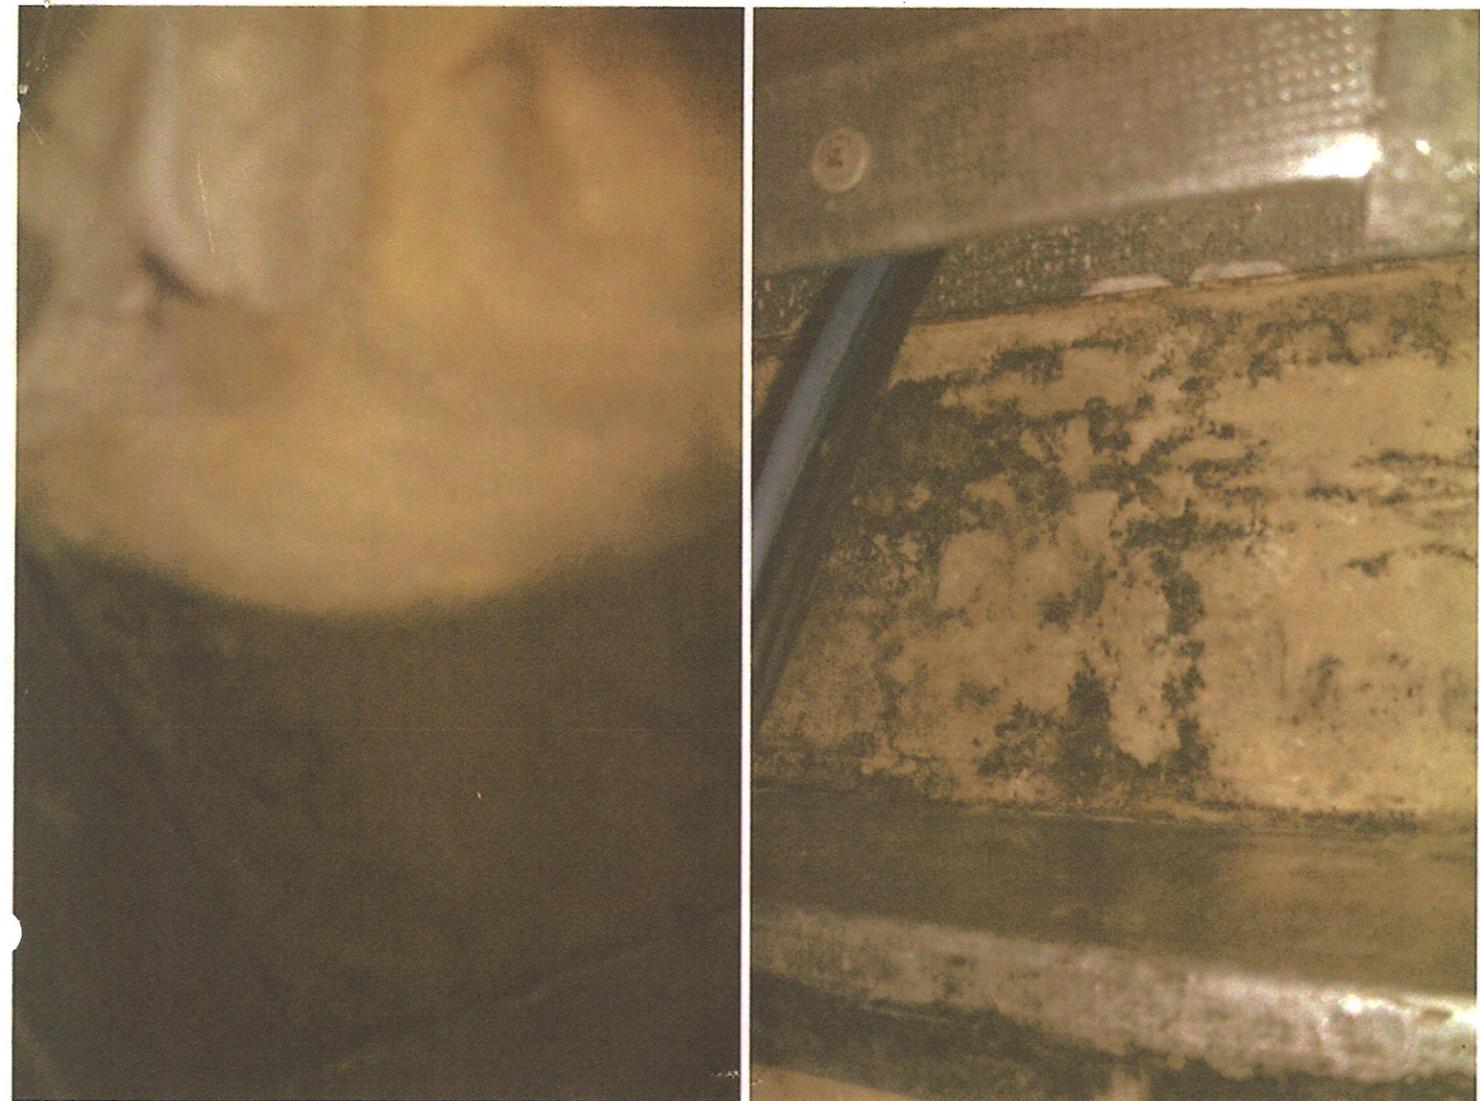
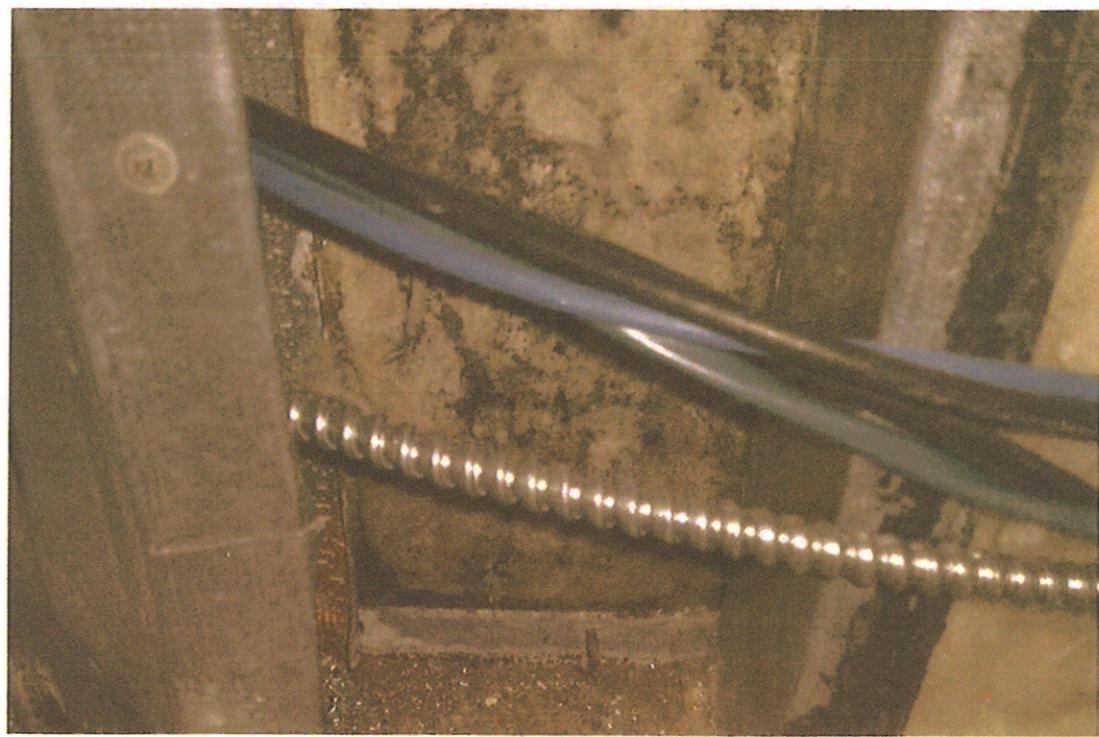
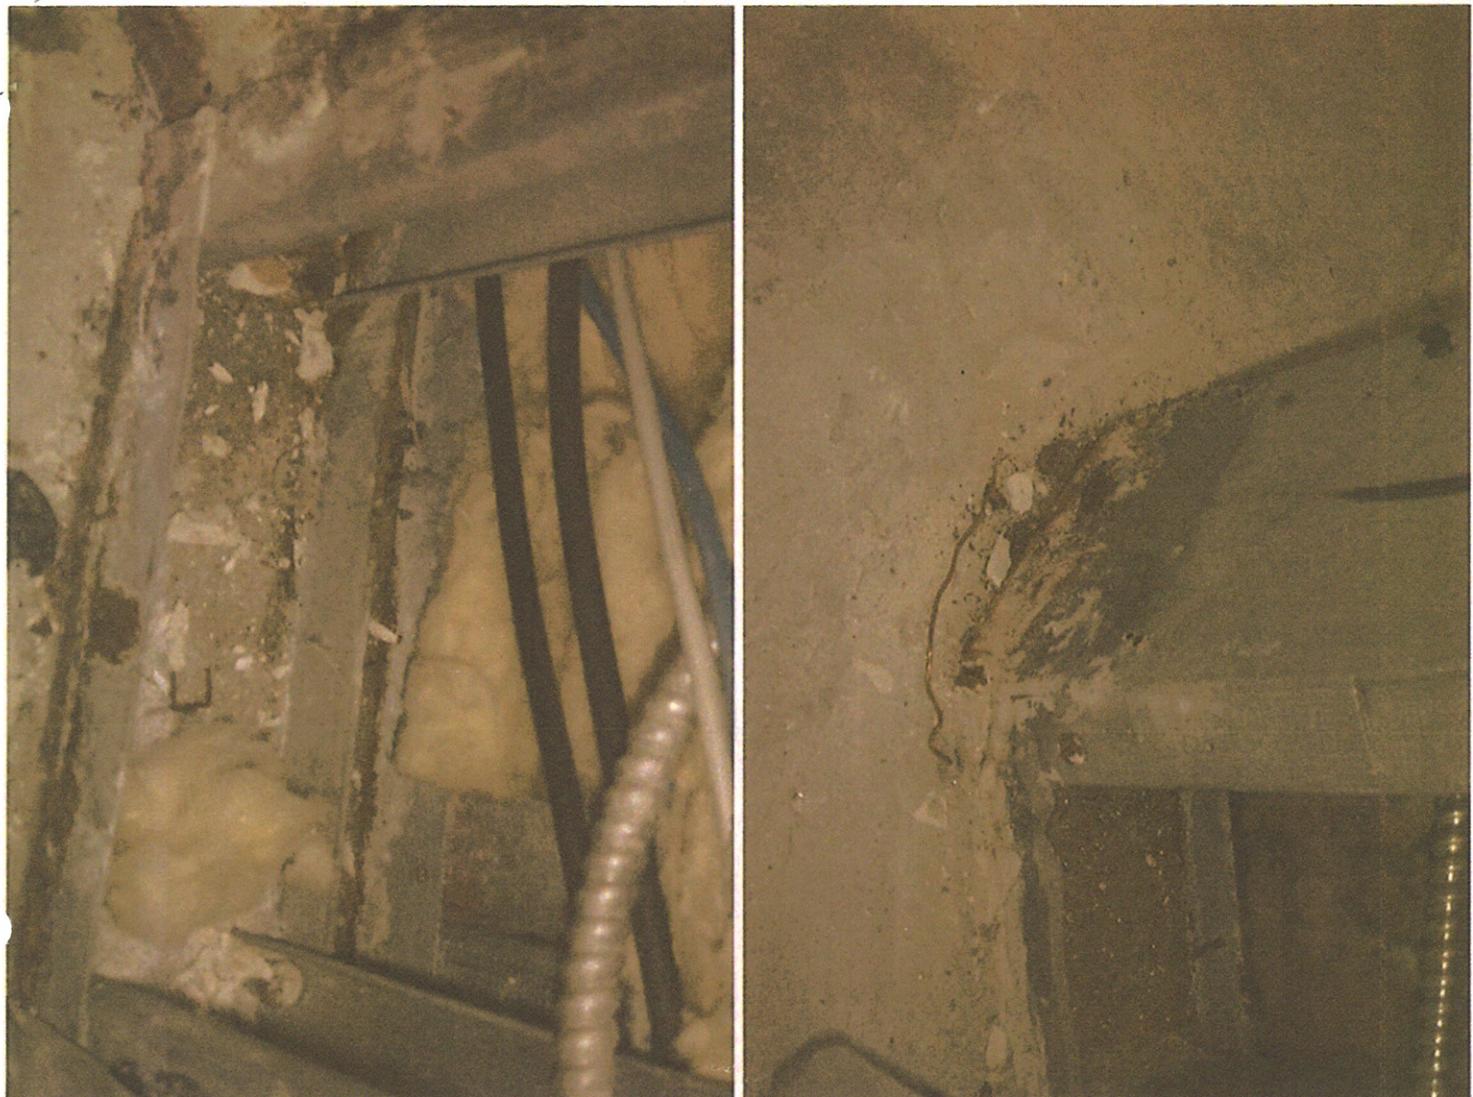
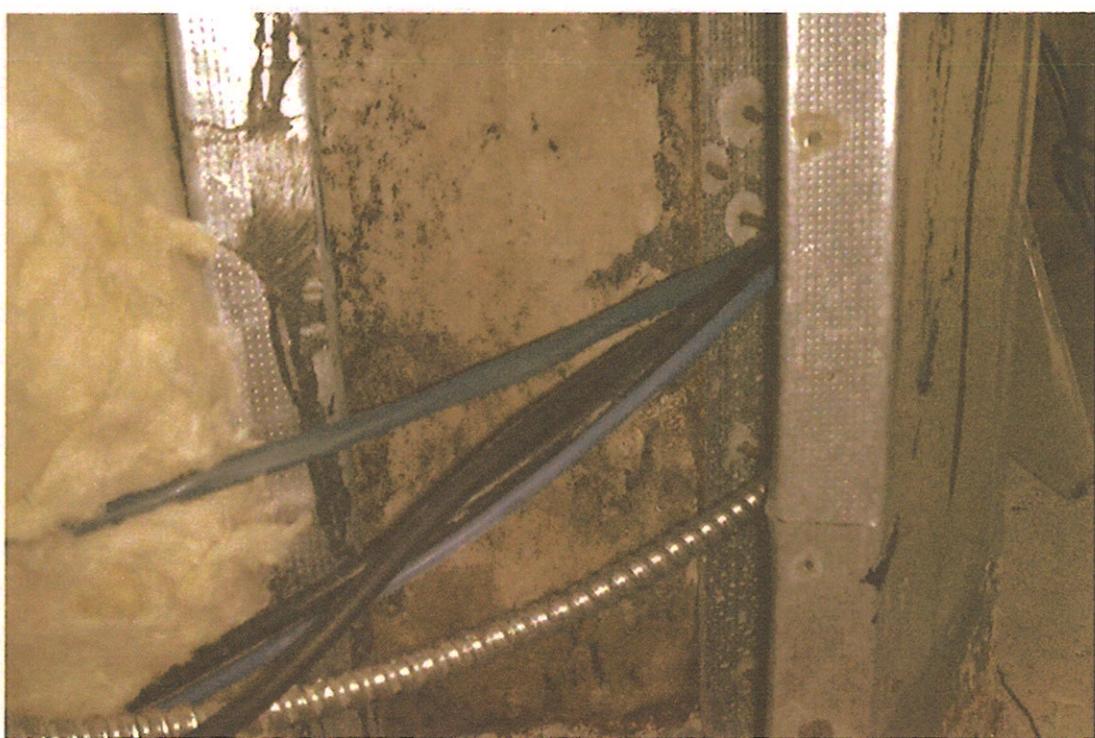
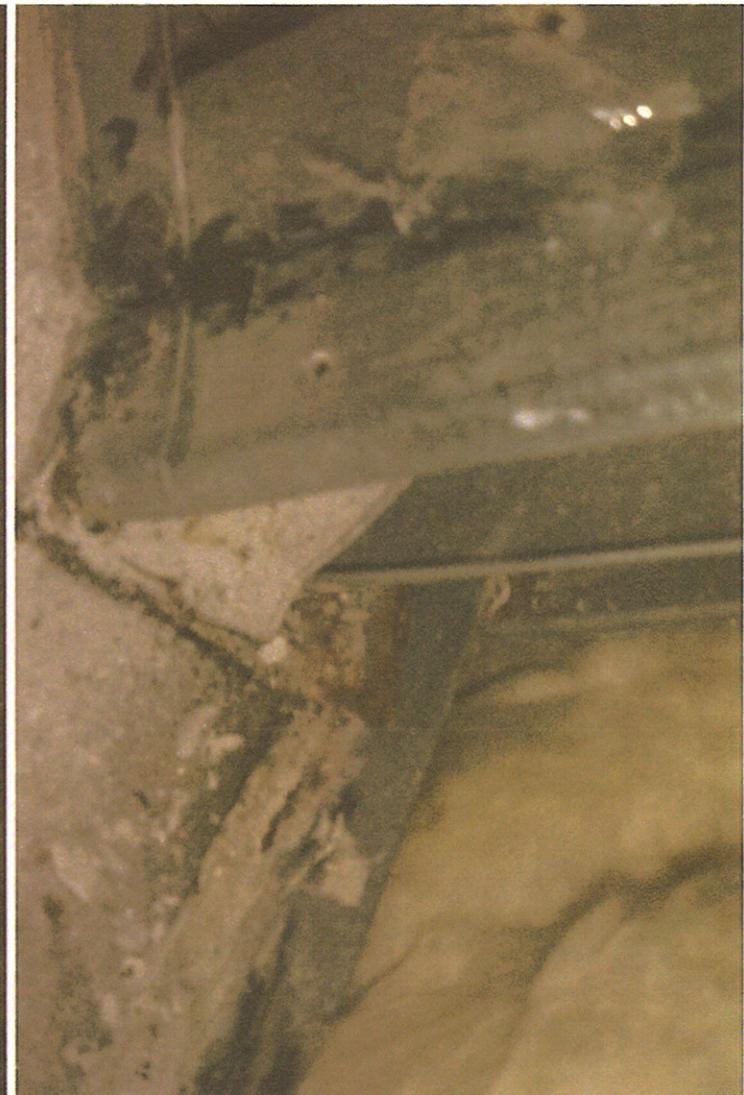
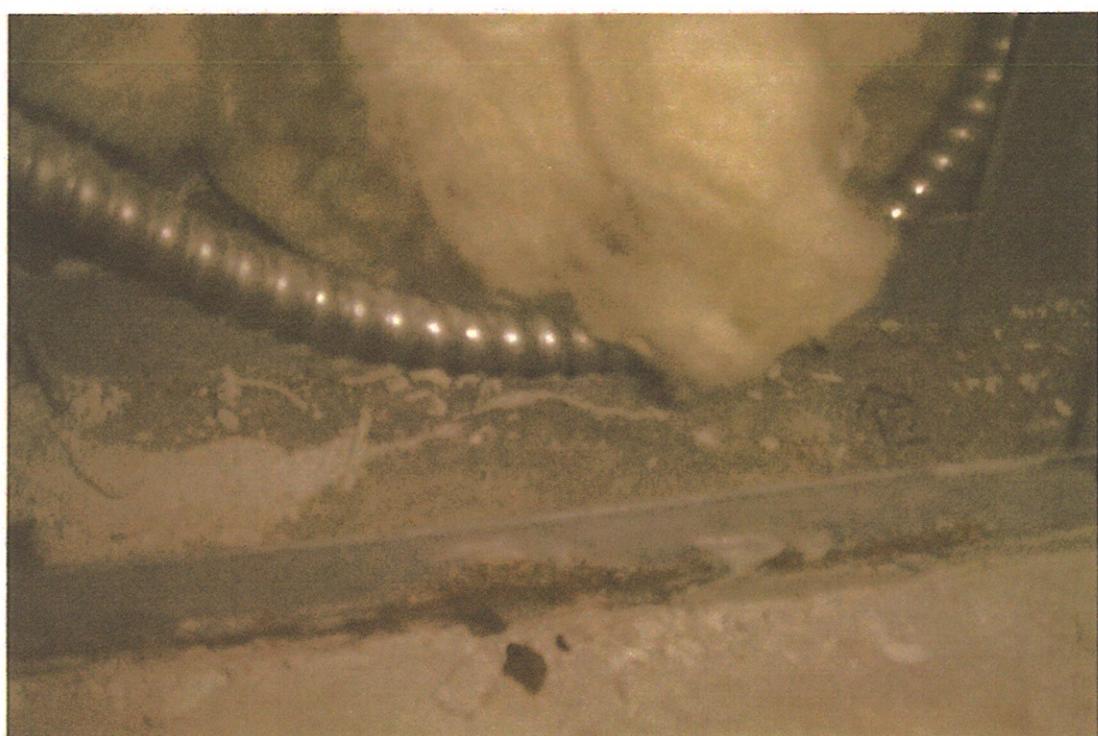
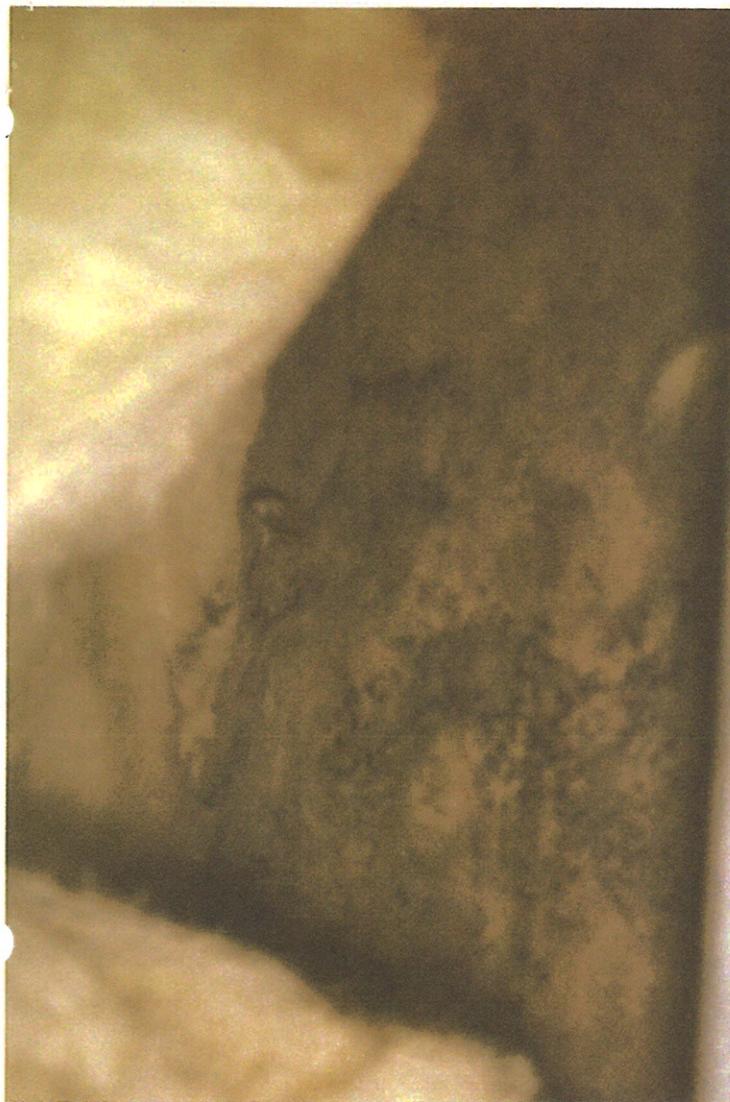
APPENDIX A

Photographs providing by the owner of Suite 701 depicting the interior wall assembly behind centre flagpole on the north elevation

Insure Wall Pics
66 Suite # 701
August 2007

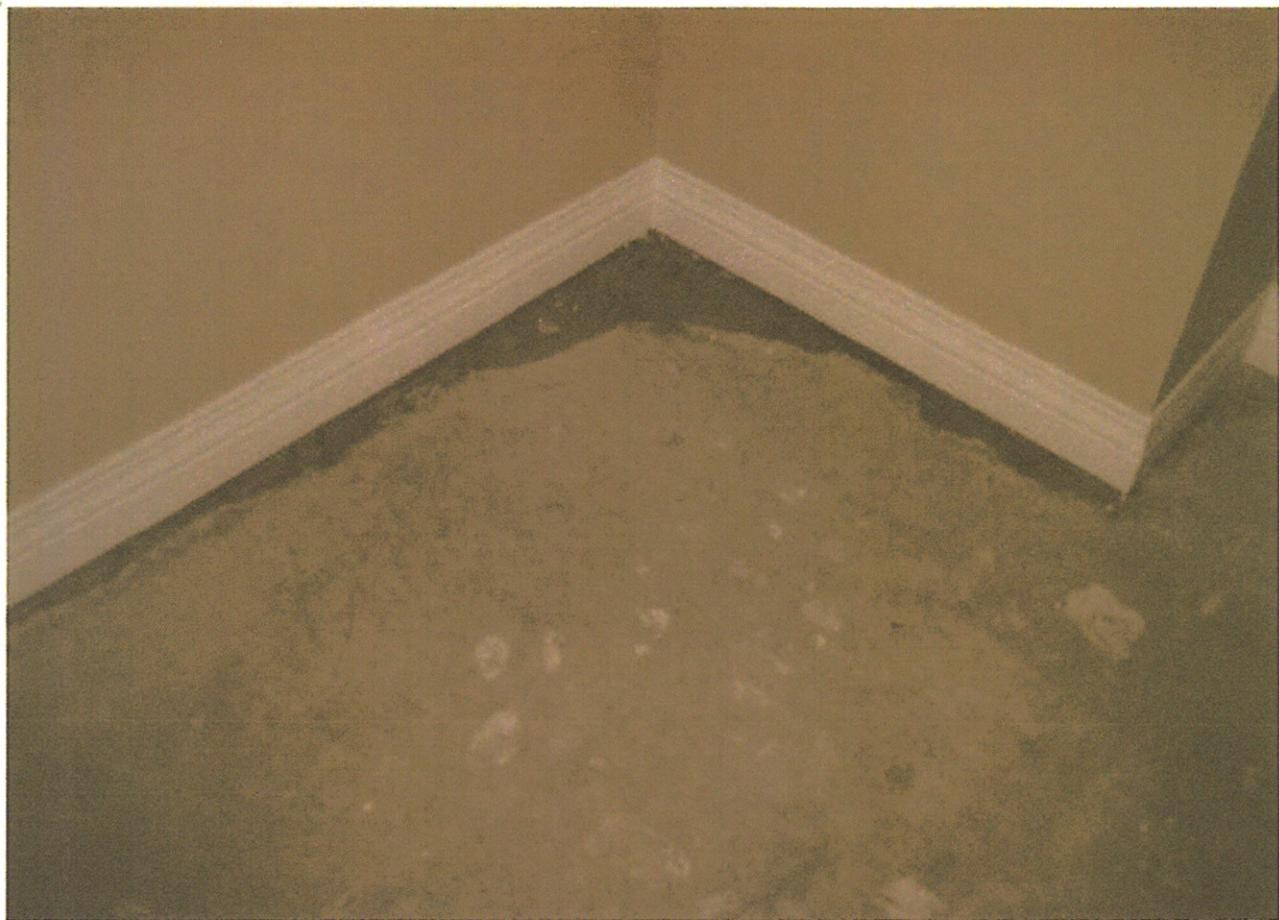
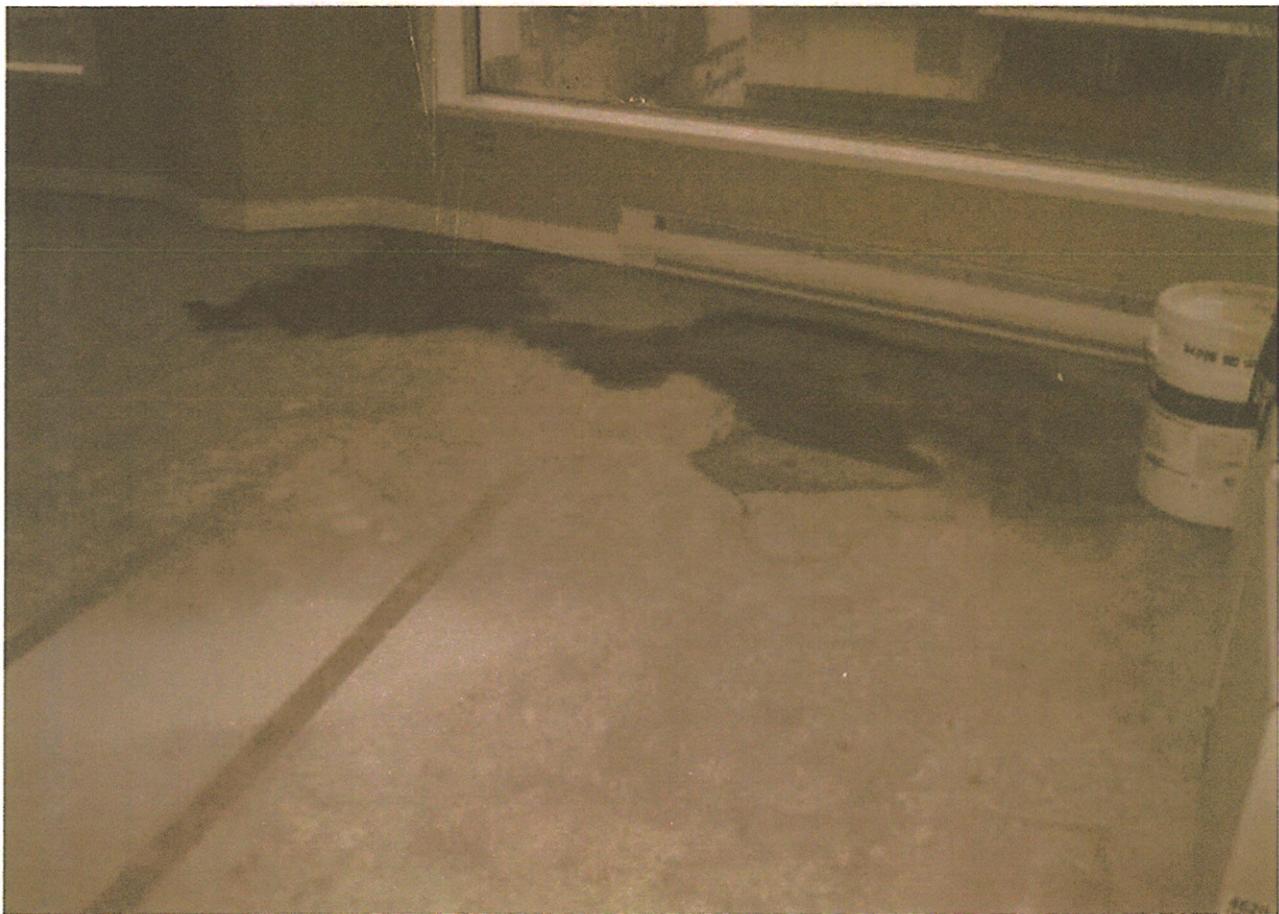
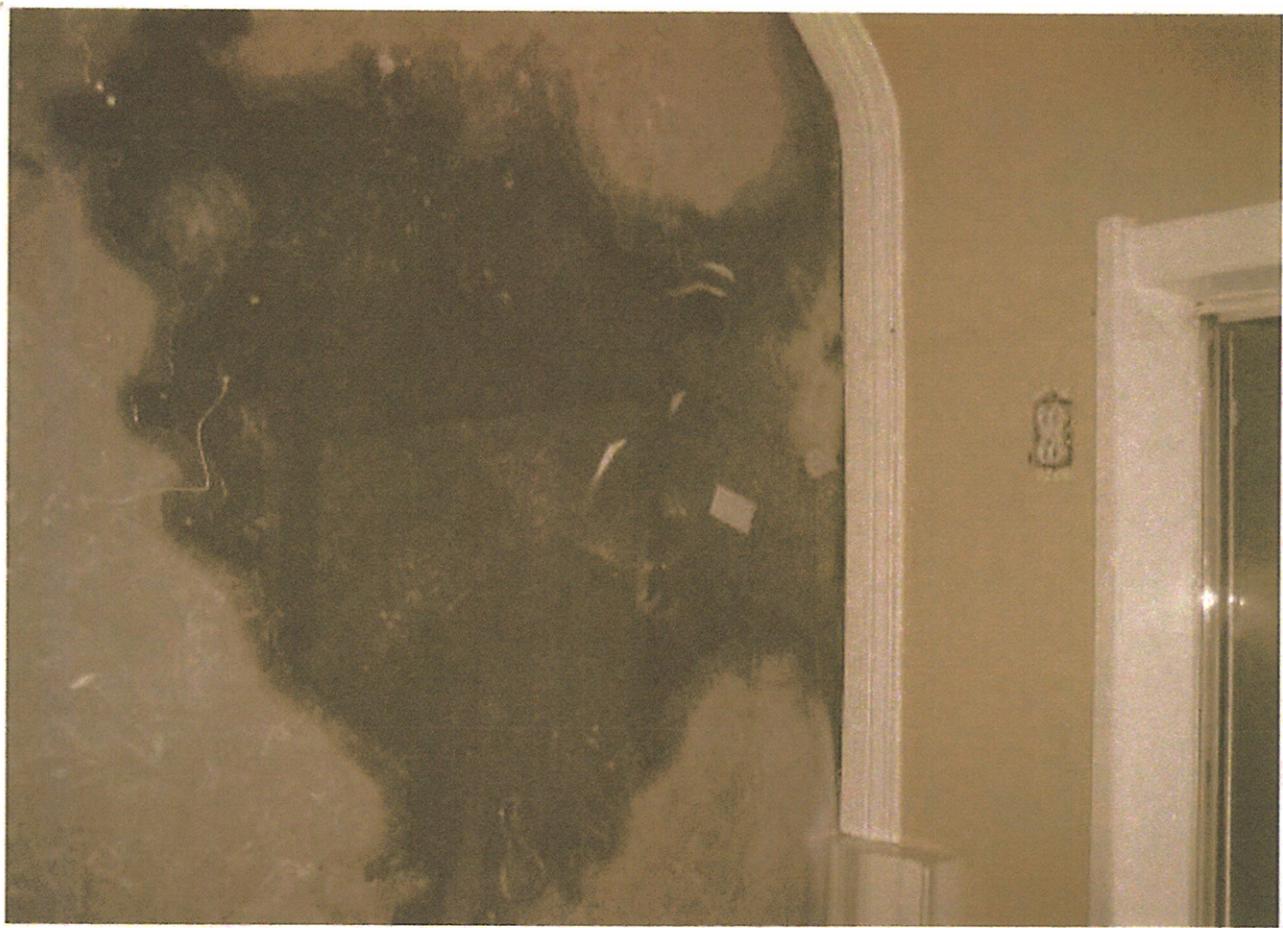
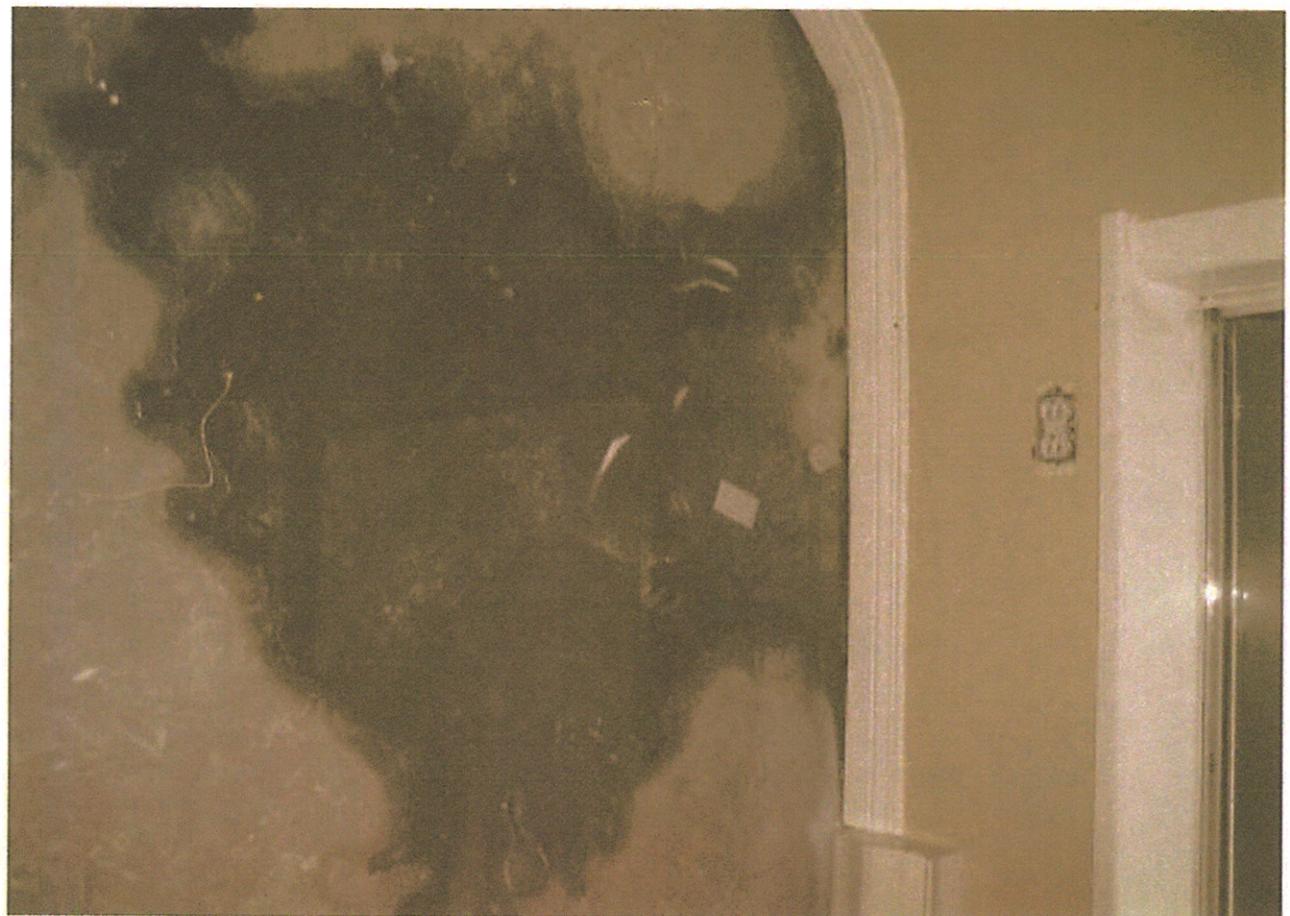
APPENDIX B

- 3.2.1 Examination of the large window assembly just east of the centre flagpole in this suite again revealed moisture in the window sill track and damage to the wooden window sill. Photographs provided by the owner depict moisture infiltration during recent renovations, and they are attached as **Appendix B**.

Photographs providing by the owner of Suite 601 water infiltration
observing during renovations

Water Ingress - Suite 601

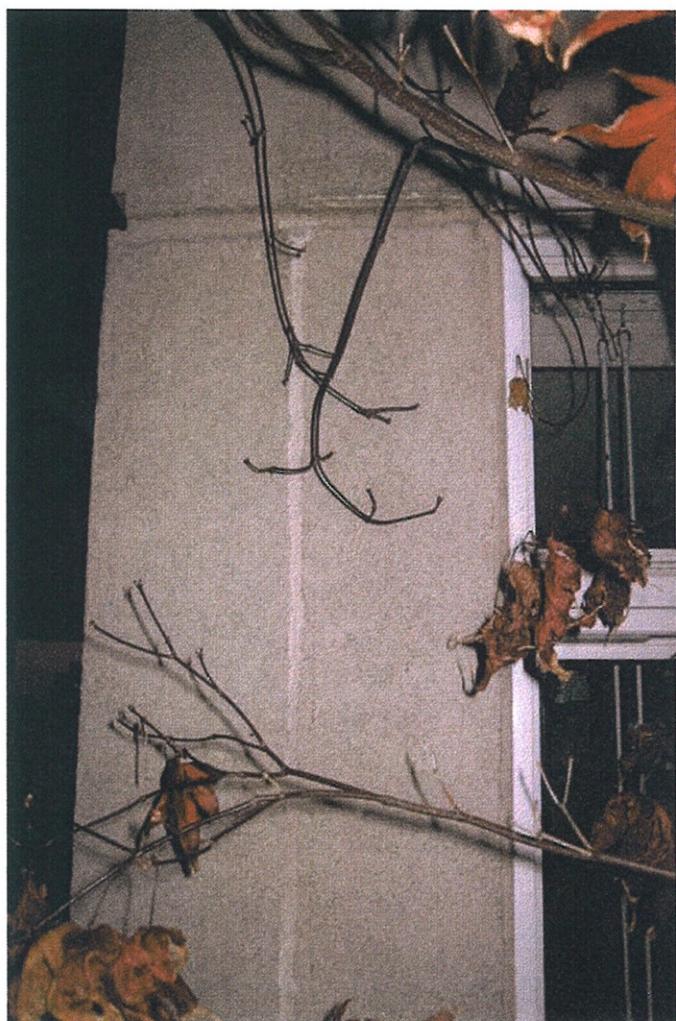
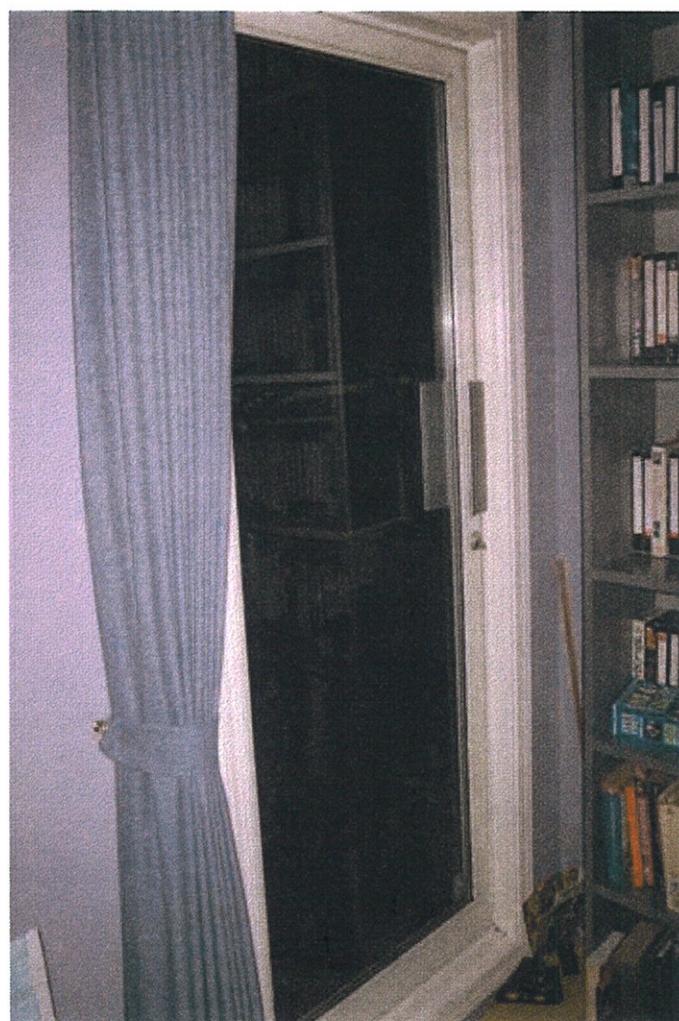
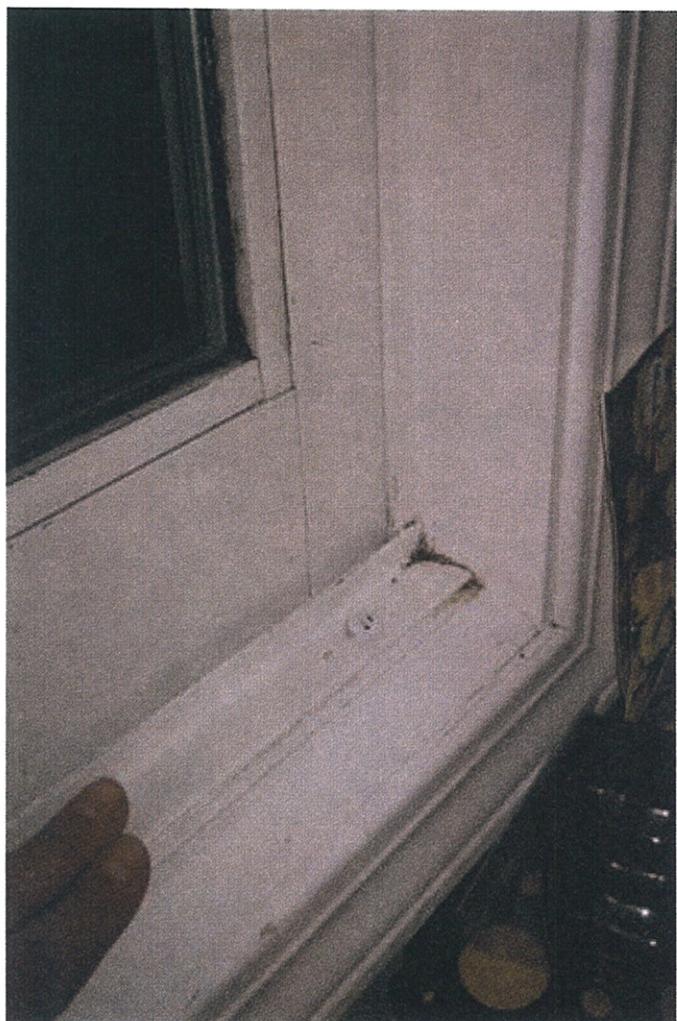
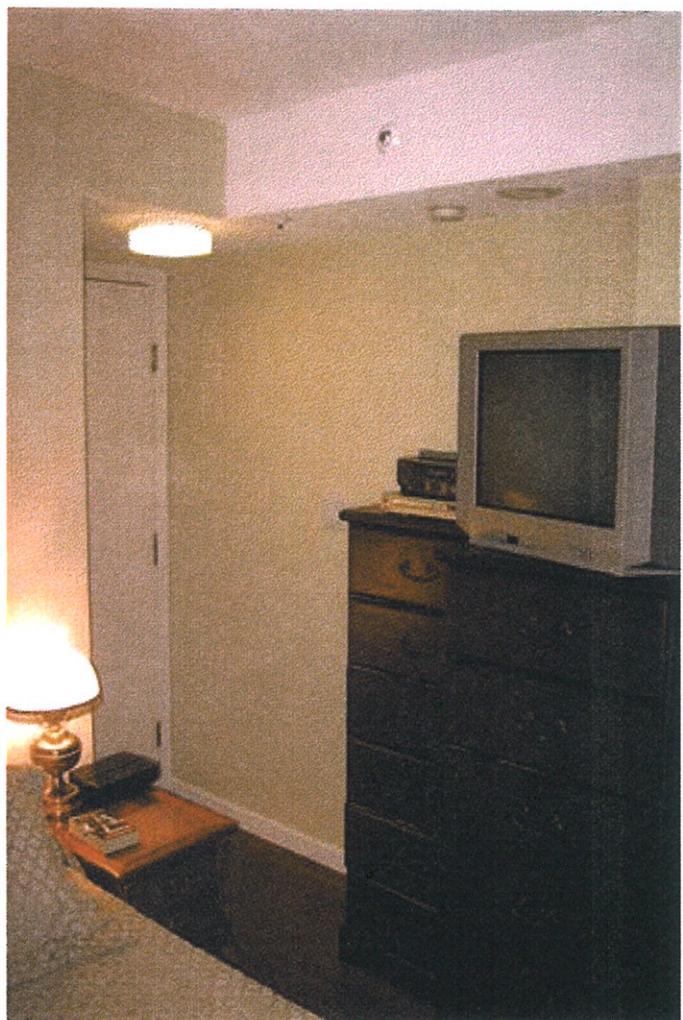
Photos No. 11 and 12

- 3.3.1 The same window as the two previous suites is similarly affected with accumulation of moisture in the window sill track.
- 3.3.2 The owner described previous moisture ingress through the swing doors in the northeast corner bedroom. Crack repair (by routing and caulking) was completed on the concrete wall adjacent to the north-facing swing door, and no further moisture ingress has been reported (**Photo No. 11**). There was no active moisture ingress at the east-facing door during this review, but the owner's description of moisture accumulation on the door sill suggests water entry through the door unit (**Photos No. 12 & 13**).

- 3.4.2 The owner also reported moisture damage to the wood floor in the bedroom on the west elevation of the suite. Buckling of the floor boards and bubbling of the coating were noted adjacent to the east wall of the room, which adjoins the elevator shaft and the washroom (**Photos No. 14 & 15**).

- 4.6 **Reported water entry at the patio swing door of Suite 801 was not observed during this review.** The first recommendation for resolving any issues with this door would be refurbishment of the weatherstripping. If moisture problems persist, SEE can perform an AAMA nozzle spray test in an attempt to isolate the location of the moisture infiltration.

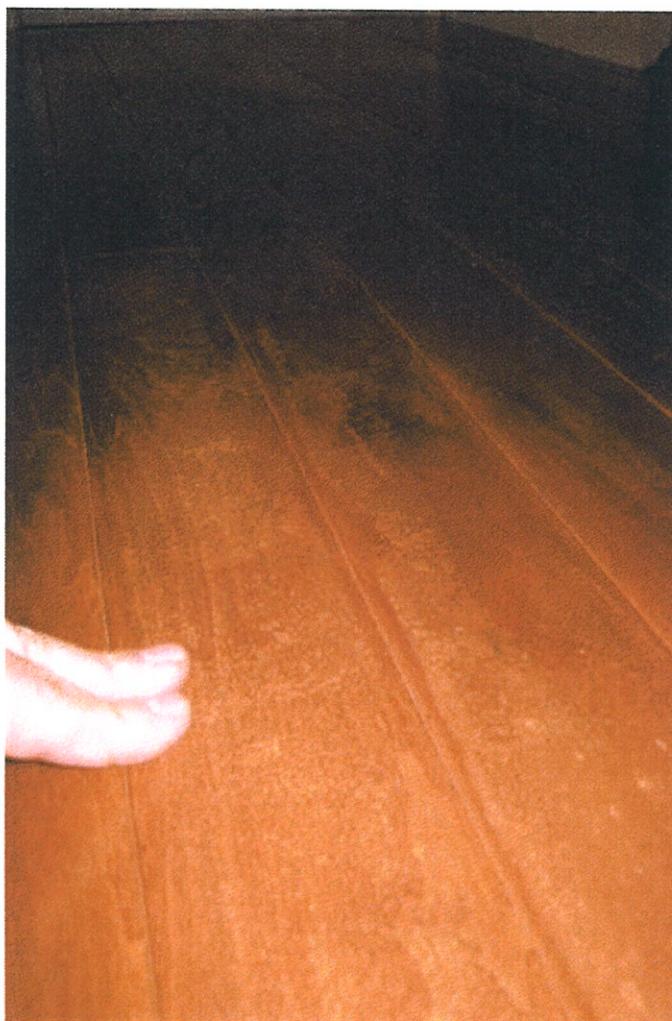
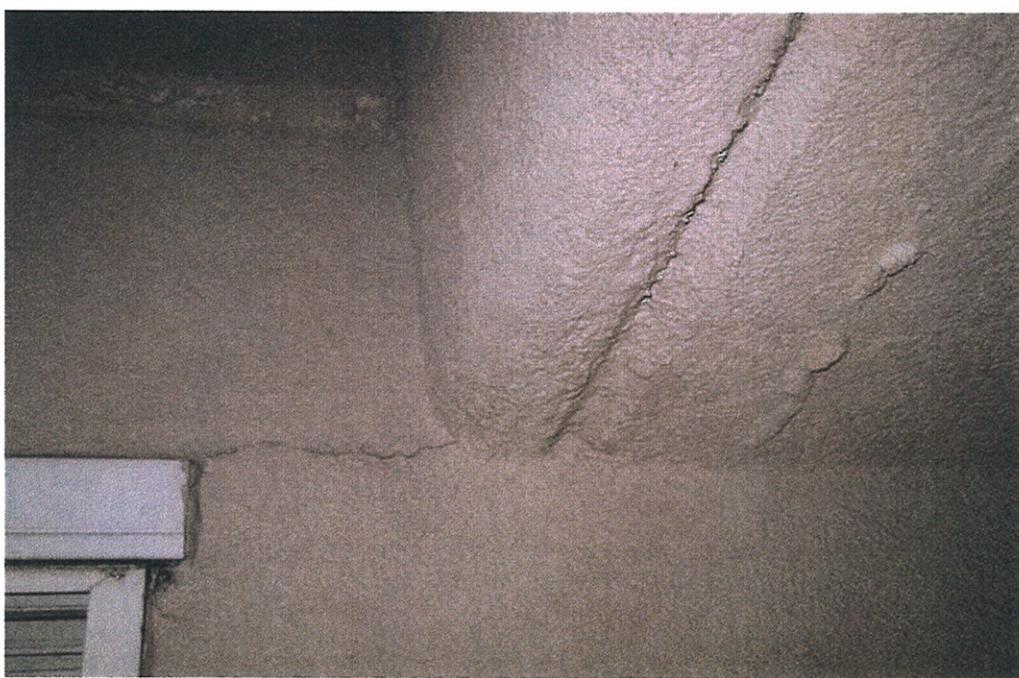
Photos No. 15 and 16

- 3.4.3 On the east and west corners of the south elevation, there is water damage on the concrete overhangs above the balconies. The west balcony overhang is marked by salt deposits accumulating on the concrete surface adjacent to the drip (**Photo No. 16**). On the east balcony the concrete damage is above the

- 4.4 **Moisture damage to the wood floor in the bedroom of Suite 802** is difficult to pinpoint; the location is removed from the exterior wall of the room which would indicate that moisture migration through the wall is unlikely. The east bedroom wall adjoins both the elevator shaft and the en suite washroom. In the absence of visible roof leaks, the moisture source must be related to this wall. SEE suspects that water from the roof level is following a drain pipe (or sanitary vent, gas line, rainwater leader, etc.) that runs through the east wall of the bedroom and accumulating at the floor level. **Further investigation is recommended by removing drywall to determine which pipes are routed through this wall and investigate for moisture accumulation within the wall assembly.**

- 4.5.2 On the west side, there is no visible crack that is leading to efflorescent deposits on the balcony side; the cement plaster applied to the concrete walls is effective at concealing underlying cracks. Repair of the crack aligned with the door head is recommended, but the efflorescence may continue. Eventually the crack permitting moisture migration into concrete will evidence itself; SEE does not recommend removing the cement plaster in attempt to locate any cracks as these efflorescent deposits pose little risk at this time.

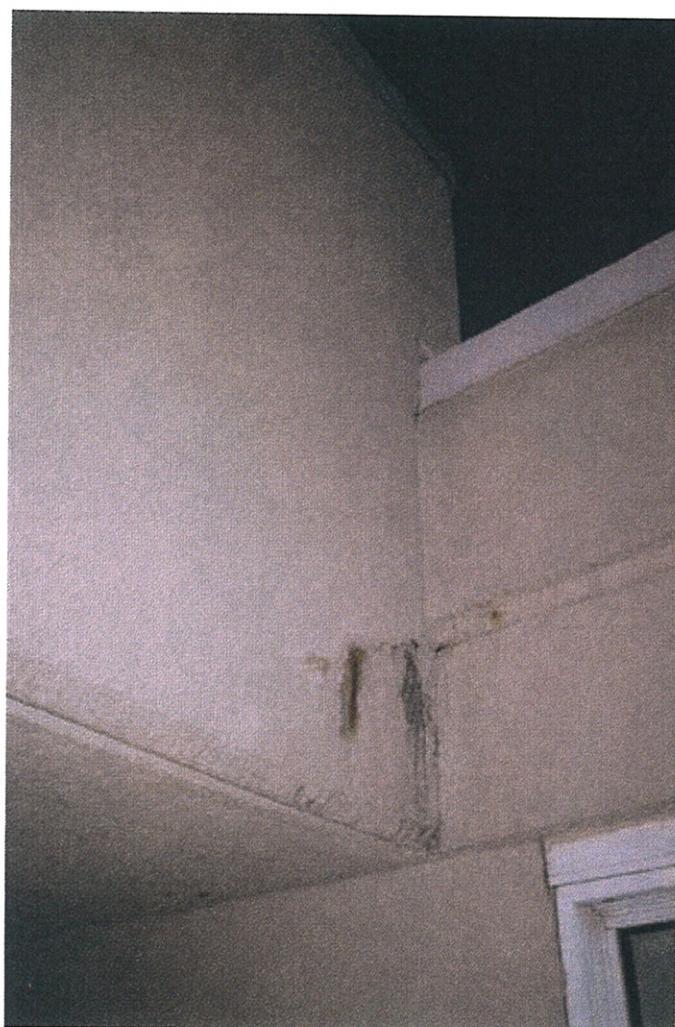
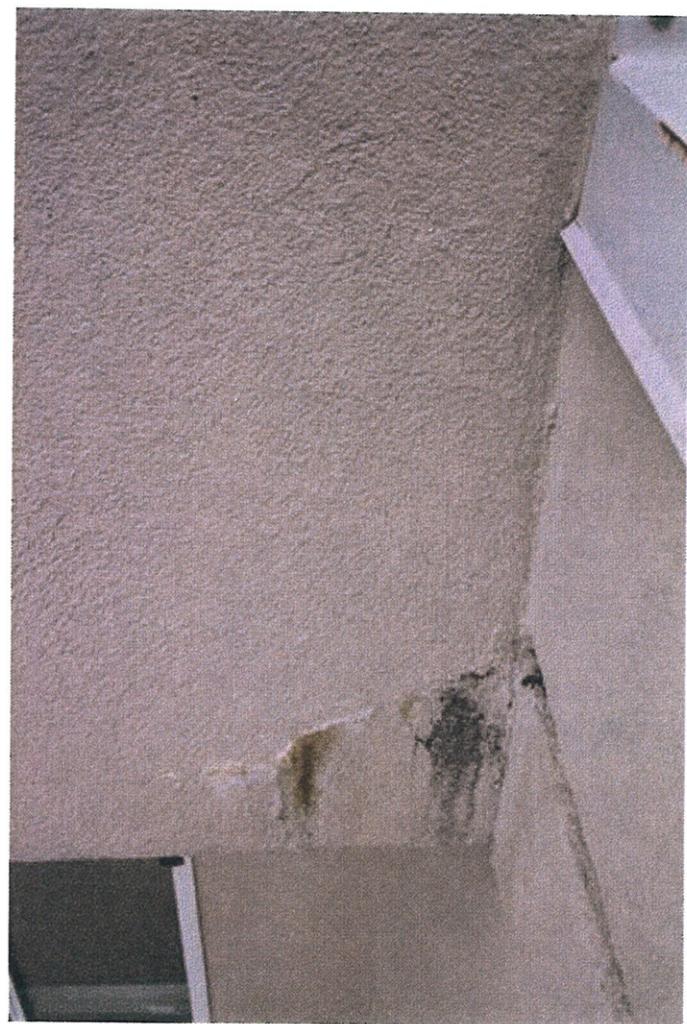
Photos No. 17 and 18

overhang and marked by salt deposits and rust stains emanating from a crack that runs horizontally from the horizontal reveal at the joint between the roof slab and the parapet wall upstand (**Photos No. 17 & 18**).

- 4.5.1 On the east side, the crack is visibly weeping rust and efflorescent stains. In addition to routing and caulking the crack, sealant application should extend up the vertical corner joint to the flashing in order to close the path of moisture entry.

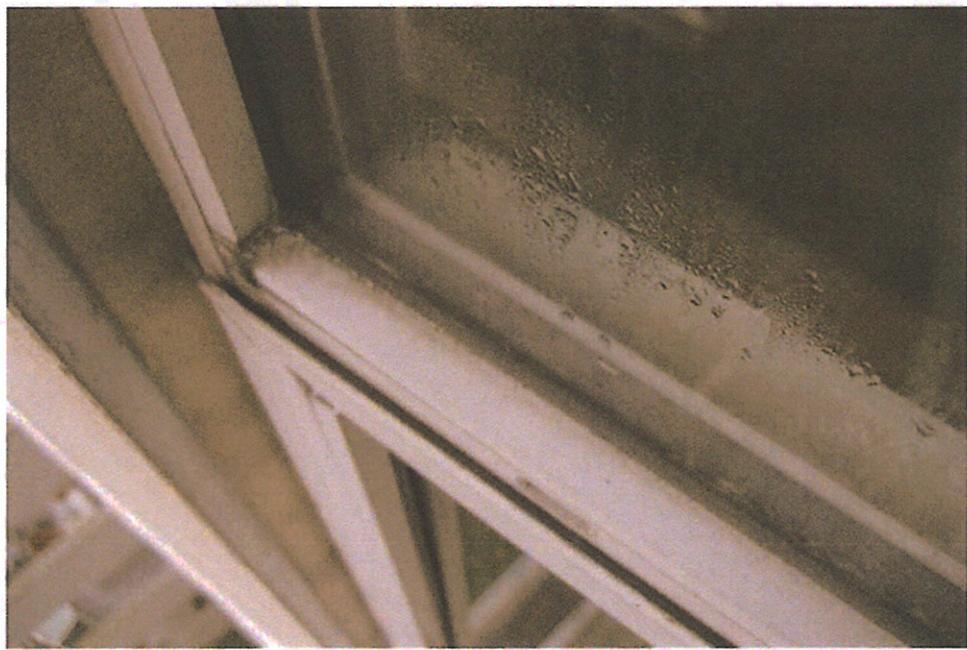
Photos No. 53 and 54

- 3.6.4 At least two failed sealed units were noted on the punch windows of this elevation (**Photos No. 53 & 54**).

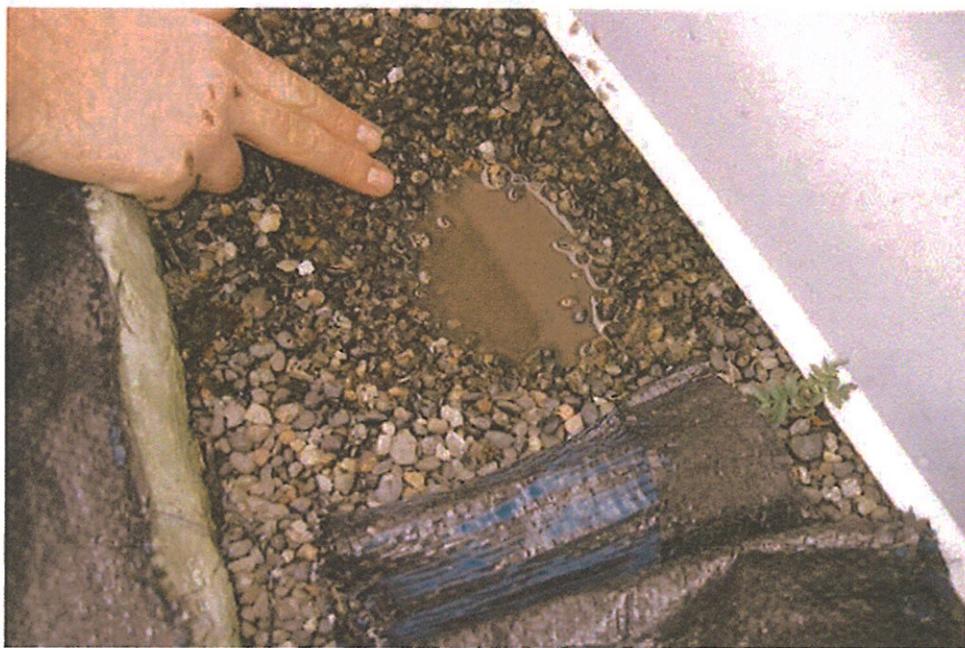
Photos No. 55 and 56

- 3.7.1 The roof assembly on this building consists of a waterproof membrane applied to the concrete slab, approximately 1.5" of XPS insulation, filter cloth, and gravel ballast. Digging through the gravel to inspect the membrane was futile in the wet conditions on the day of review (**Photo No. 55**).

4.3 The roofing membrane in the protected assembly was mostly unavailable for review. In the areas where the gravel ballast and XPS insulation were dug away, by touch the membrane was determined to be a liquid applied product. With the protected membrane assembly, an approximate lifespan of 30 years would be anticipated. While there were no serious defects noted in the roofing assembly, SEE makes the following recommendations for maintenance at the roof level:

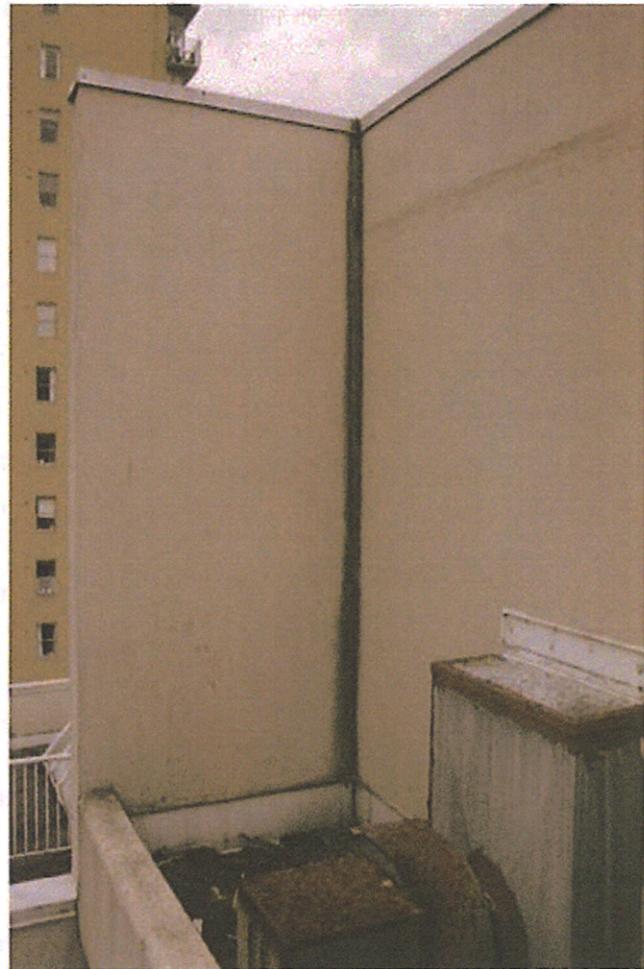
Photos No. 67 and 68

- 3.7.7 Heavy staining is noted on the parapet walls at the roof level, and also on the walls of the elevator machine room, directly below the standing seam connections for the cap flashing pieces (**Photos No. 67 & 68**).

- 4.3.3 Sealant application at the standing seam connections of the roof parapet cap flashing would alleviate the wall staining directly below. Normally the flashing directs water away from the wall surface, but at these connections moisture is bypassing the flashing and draining down the wall. Staining on the wall surface should come clean with a dilute solution of TSP and a soft bristle brush.
