Depreciation Report | Project 7671.00
Chateau Comox, 1272 Comox Street, Vancouver, BC

Site Visit April 10, 2014
Submitted January 23, 2015 by
RDH Building Engineering Ltd.
224 W 8th Avenue
Vancouver BC V5Y 1N5

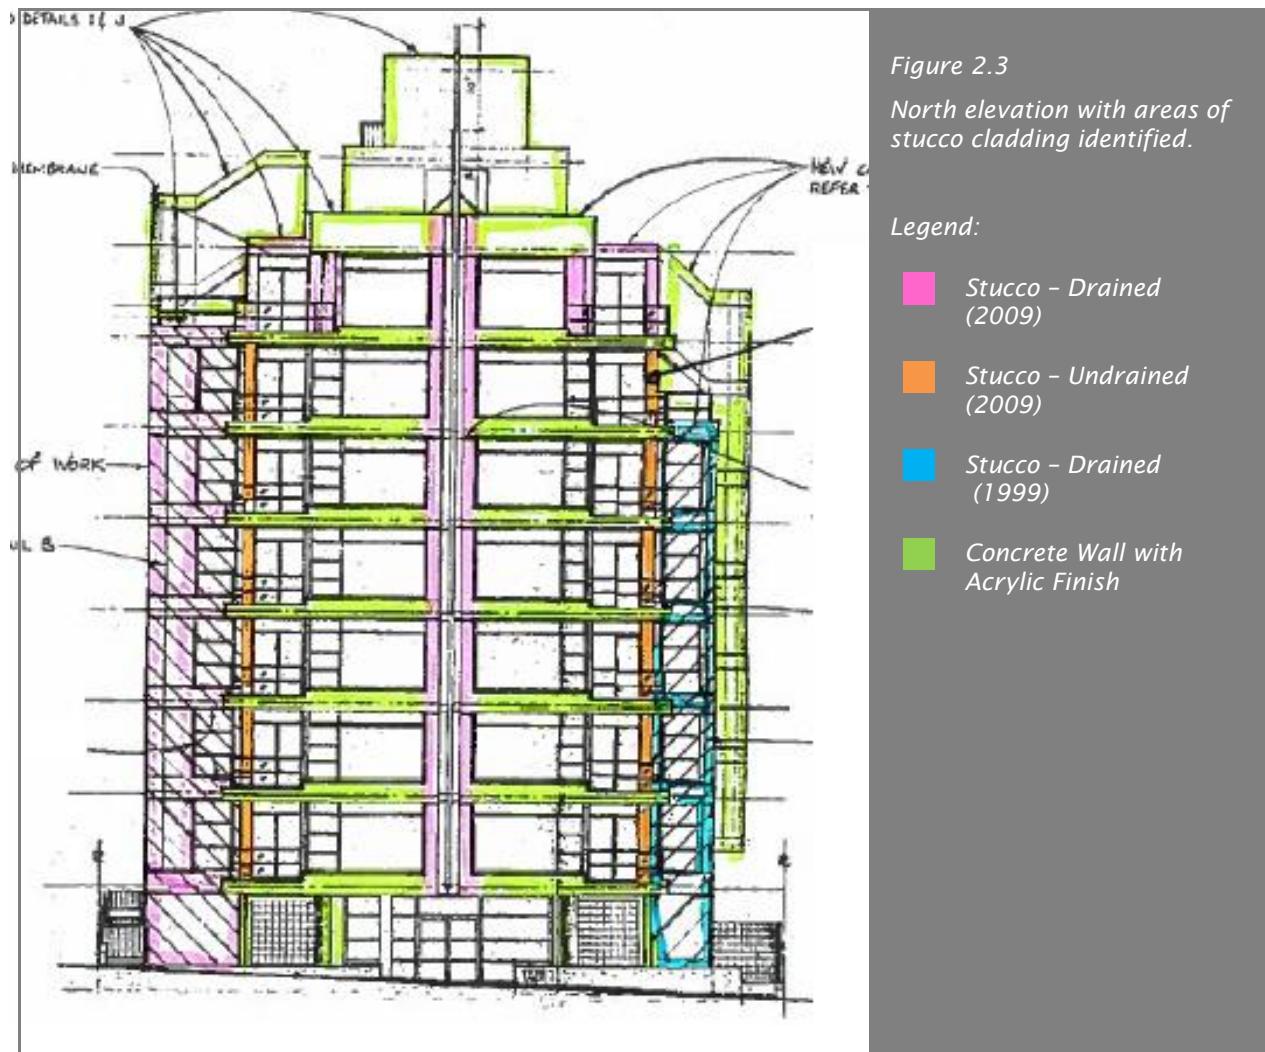
Figure 2.3

North elevation with areas of stucco cladding identified.

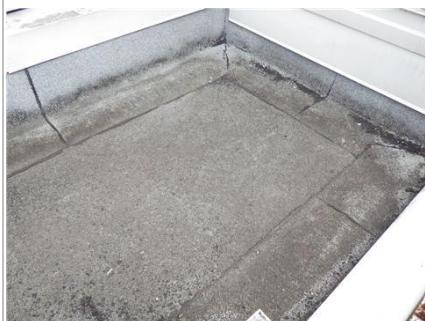
Encl 01 - Exposed SBS Membrane Roof

Location	Description		
Main rooftop level over elevator room and stairwells.	SBS modified bitumen membrane at low-slope roof.		
Information	Service Life:	25	Install Year:
Chronological Age:	7		2008
Effective Age:	7		Next Event Year: 2033

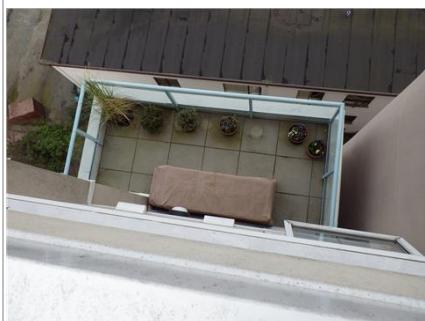
Encl 02 - Protected SBS Membrane Deck (IRMA Assembly) with Traffic-Bearing Surface

Location	Description		
7th floor decks (west side).	SBS membrane overlaid with insulation, protection board, and concrete pavers as traffic-bearing surface.		
Information	Service Life:	30	Install Year:
Chronological Age:	16		1999
Effective Age:	16		Next Event Year: 2029

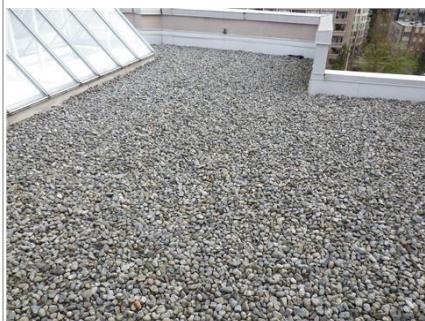
Encl 03 - Protected SBS Membrane Roof with Ballast (IRMA)

Location	Description		
Sections of main rooftop.	SBS membrane overlaid with insulation, filter fabric, and stone ballast.		
Information	Service Life:	30	Install Year:
Chronological Age:	7		2008
Effective Age:	7		Next Event Year: 2038

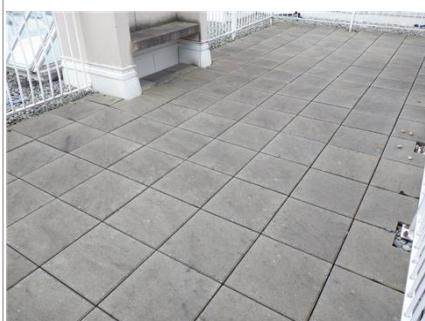
Encl 04 - Protected SBS Membrane Roof & Deck (IRMA) with Traffic-Bearing Surface

Location	Description		
Sections of main rooftop and east side decks on 8th floor.	SBS membrane overlaid with insulation, protection board, and concrete pavers as traffic-bearing surface.		
Information	Service Life:	30	Install Year:
Chronological Age:	7		2008
Effective Age:	7		Next Event Year: 2038

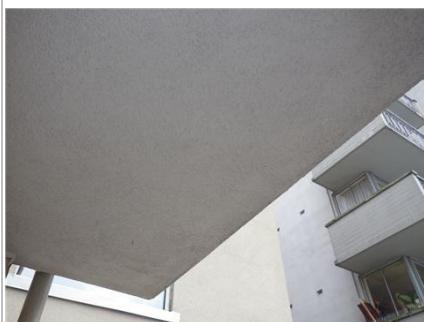
Encl 05 - Stucco Clad Soffit

Location	Description		
Underside of balconies and at entry lobby plaza.	Stucco cladding over supporting structure.		
Information			
Service Life:	40	Install Year:	1992
Chronological Age:	23	Next Event Year:	2032
Effective Age:	23

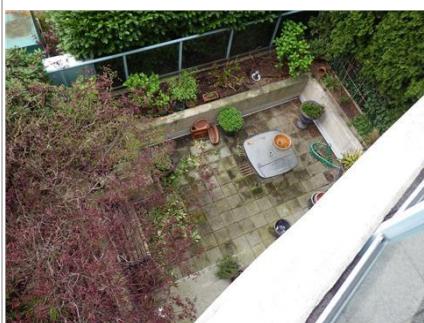
Encl 06 - Protected Podium Membrane

Location	Description		
(Concealed Asset). Waterproofing membrane on top surface of parkade ceiling podium with concrete paver and soft slab.	Waterproofing membrane at parkade podium with concrete paver and soft landscaping overburden.		
Information			
Service Life:	30	Install Year:	1992
Chronological Age:	23	Next Event Year:	2024
Effective Age:	21

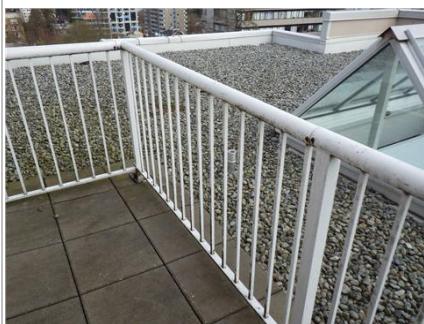
Encl 07 - Guardrail Aluminum

Location	Description		
Perimeters of decks at main roof level and northeast parkade exit stairwell.	Prefinished aluminum posts and pickets to limit access to the adjacent roofs.		
Information			
Service Life:	30	Install Year:	1992
Chronological Age:	23	Next Event Year:	2024
Effective Age:	21

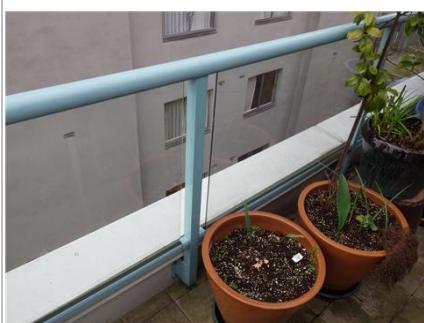
Encl 08 - Guardrail Glazed Aluminum

Location	Description		
Perimeter of decks and balconies.	Side-mounted prefabricated aluminum posts and glass infill panels functioning as a protective barrier to prevent accidental falls from one level to another.		
Information			
Service Life:	30	Install Year:	1992
Chronological Age:	23	Next Event Year:	2024
Effective Age:	21

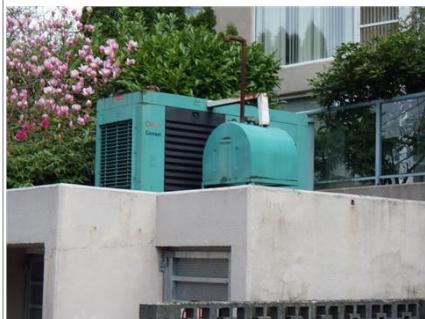
Elec 01 - Emergency Generator

Location	Description		
Above the parkade at southeast corner of the site.	Onan Genset generator to provide emergency power.		
Information	Service Life:	35	Install Year:
	Chronological Age:	23	Next Event Year:
	Effective Age:	23	2027

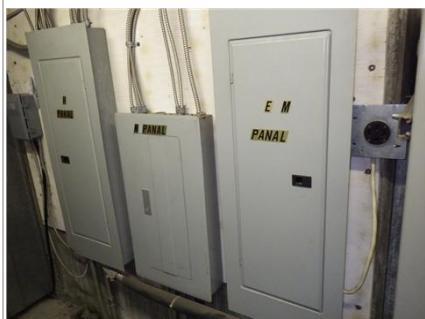
Elec 02 - Electrical Distribution

Location	Description		
Equipment in parkade P1 electrical room with wiring to suites and common areas throughout the building.	Siemens distribution switchgear, panelboards, breakers and wiring to several local sub-panels and mechanical loads.		
Information	Service Life:	40	Install Year:
	Chronological Age:	23	Next Event Year:
	Effective Age:	23	2032

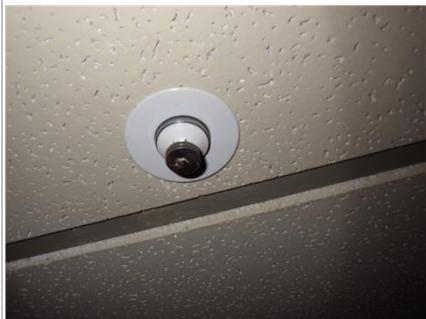
Fire 07 - Sprinkler System - Wet

Location
Throughout interior heated spaces.

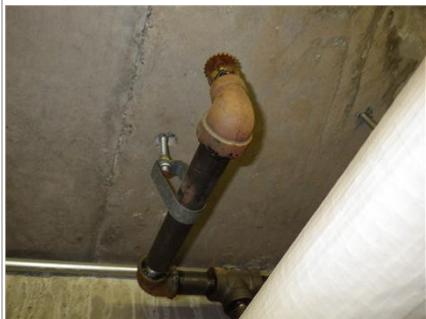
Fire 08 - Sprinkler System - Dry

Location
Service rooms and throughout the parkade. Exposed dry sprinklers, upright and sidewall sprinkler heads, steel piping.
