VISUAL BUILDING ENVELOPE CONDITION ASSESSMENT

STRATA PLAN LMS 280 – CHATEAU COMOX
1272 COMOX STREET, VANCOUVER, B.C.

Our File No.: S18-551

September 30, 2018

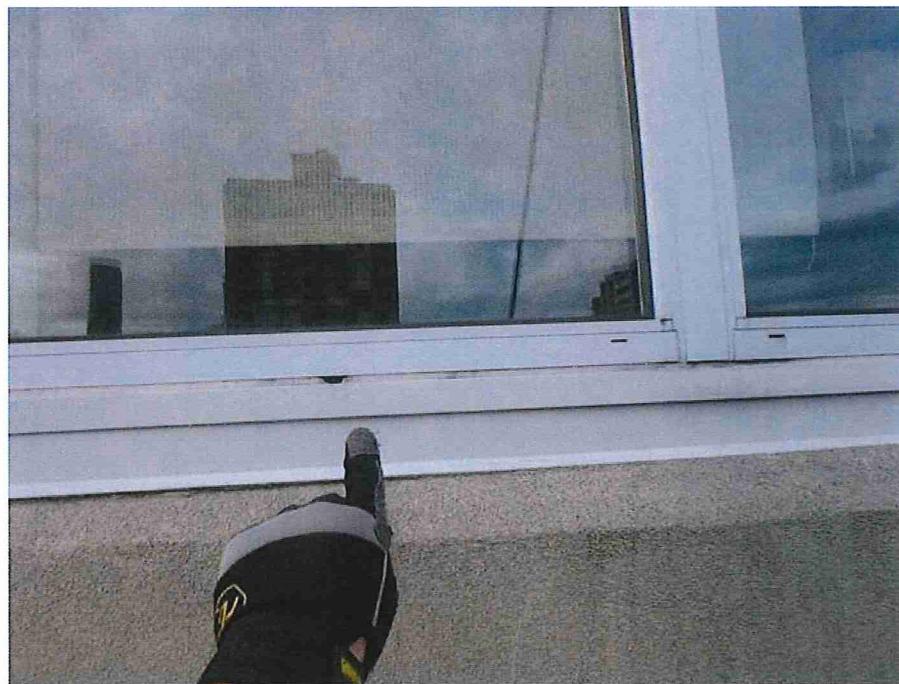
Photos No. 9 and 10

3.1.4 Guardrails are side mounted and cap flashings slope to the interior as required.	9	O
3.1.5 Level 8: Some minor caulking failures were observed in the bottom window caulking bead. SEE recommends caulking maintenance	10 to 12	M

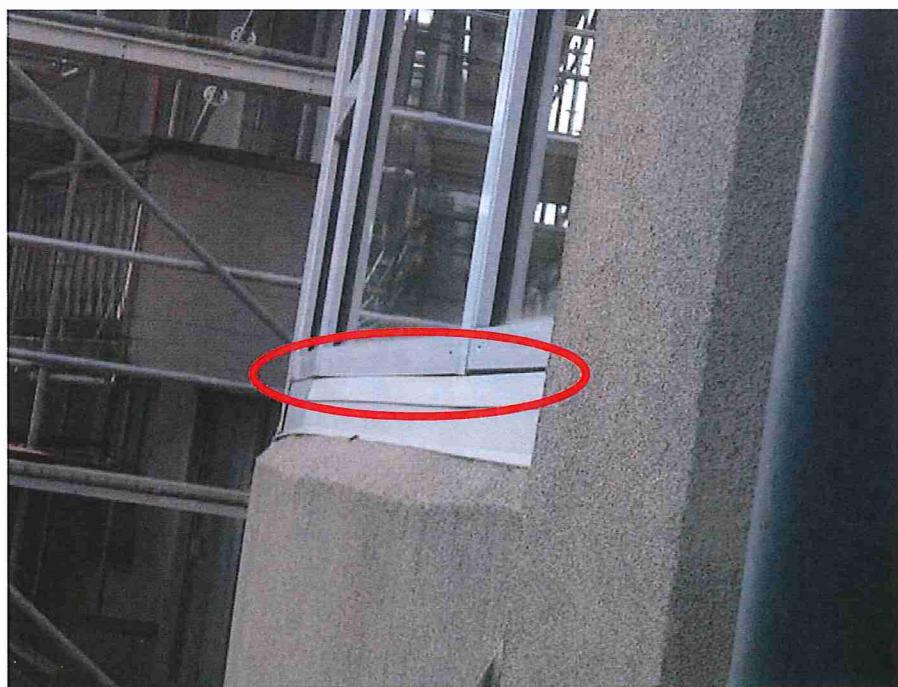
Photos No. 15 and 16

3.1.7 Level 7: The horizontal caulking joint at the sill requires re-application	15 and 16	M
3.1.8 The flagpole attachment has been done with stainless steel hardware which appears to be in excellent condition. The double flashing arrangement is providing good protection of the connection point.	17 and 18	O

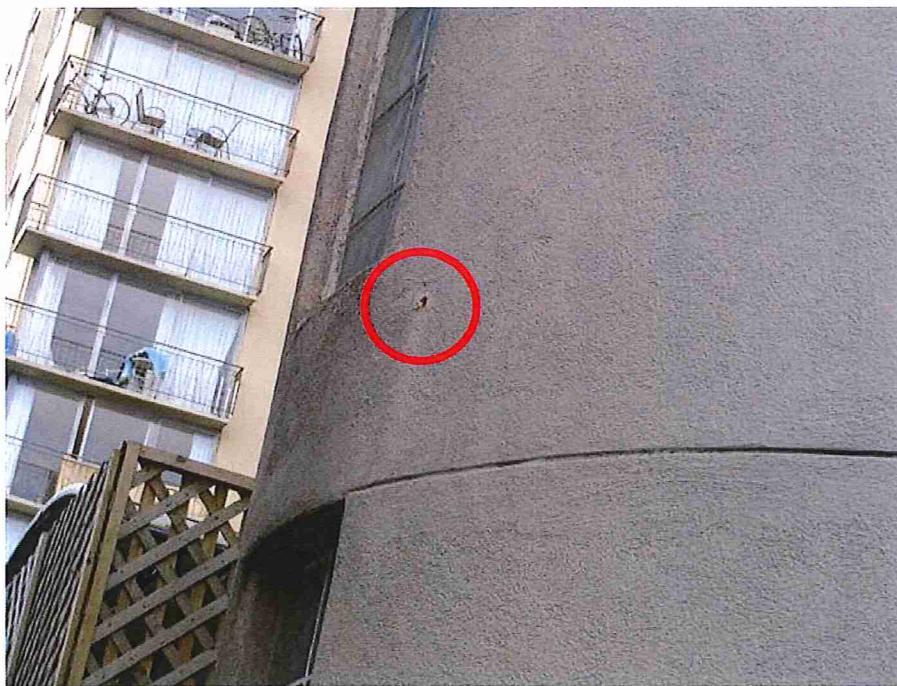
Photos No. 31 and 32

3.2.5 Exposed steel rebar ends at the emergency stairwell's mass concrete walls are causing rust staining. The rebar ends should be brushed clean, coated with zinc-rich primer and covered with troweled-on polyurethane sealant.	32	M

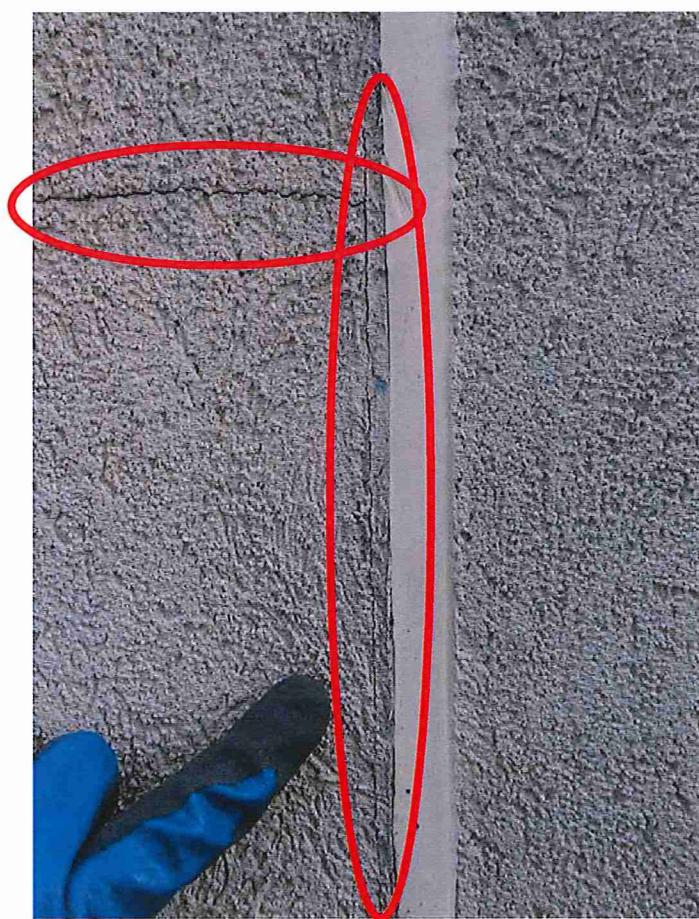
Photos No. 33 and 34

3.2.6 The vertical sealant joint to the south of the descent is in good condition. There are hairline cracks directly beside the sealant joint which should be addressed at the time of wall re-coating.	33 and 34	M

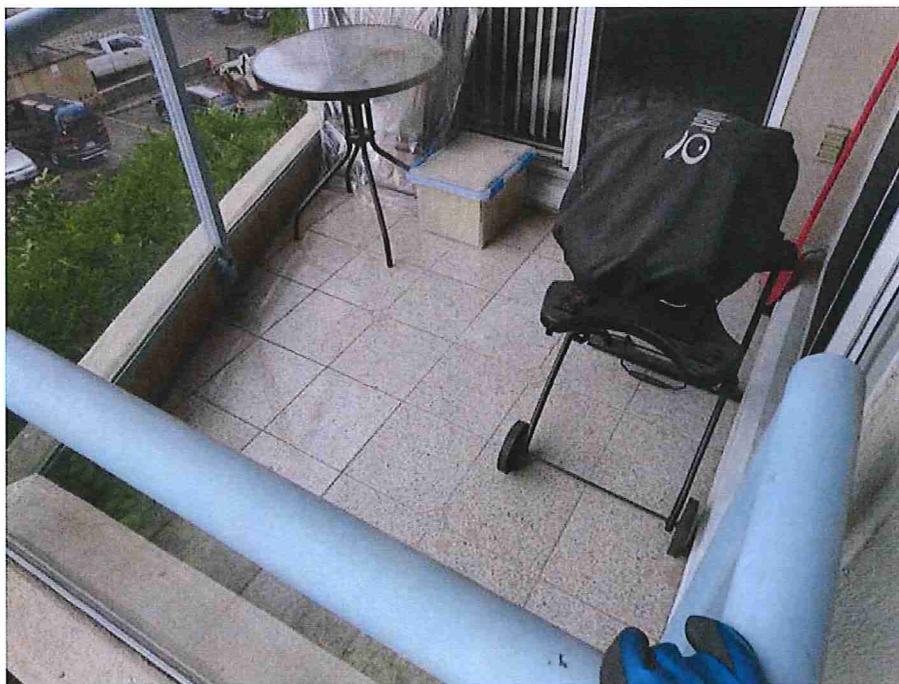
Photos No. 41 and 42

3.3.3	The bank of balconies at the very southeast corner of the building include a cold liquid-applied polyurethane waterproofing membrane over the cantilevered concrete structure. Most balconies are covered with either tiles installed over thinset mortars or removable deck tiles. Where uncovered, the membrane appears to be in fair condition.	41 and 42	O

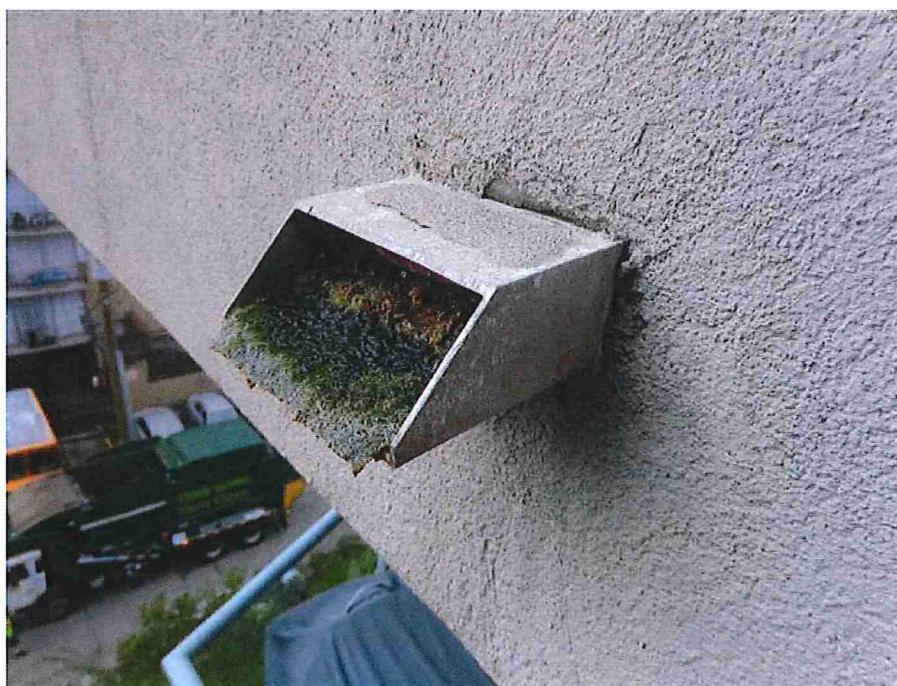
Photos No. 43 and 44

3.3.4	The rainwater leader located at the end of the balconies has peeled paint and rusted fasteners. The fasteners should be replaced with stainless steel and painted surfaces should be repainted.	43	M

3.3.5	The drainage screens in the balcony scupper drains have moss and dirt buildup which should be cleaned or the screens replaced.	44 and 45	M
3.3.6	At least one outdoor electrical outlet is unprotected from the elements. A weatherproof box should be installed where missing. GFI circuit breakers or outlets are required.	46 and 47	M/S.H.

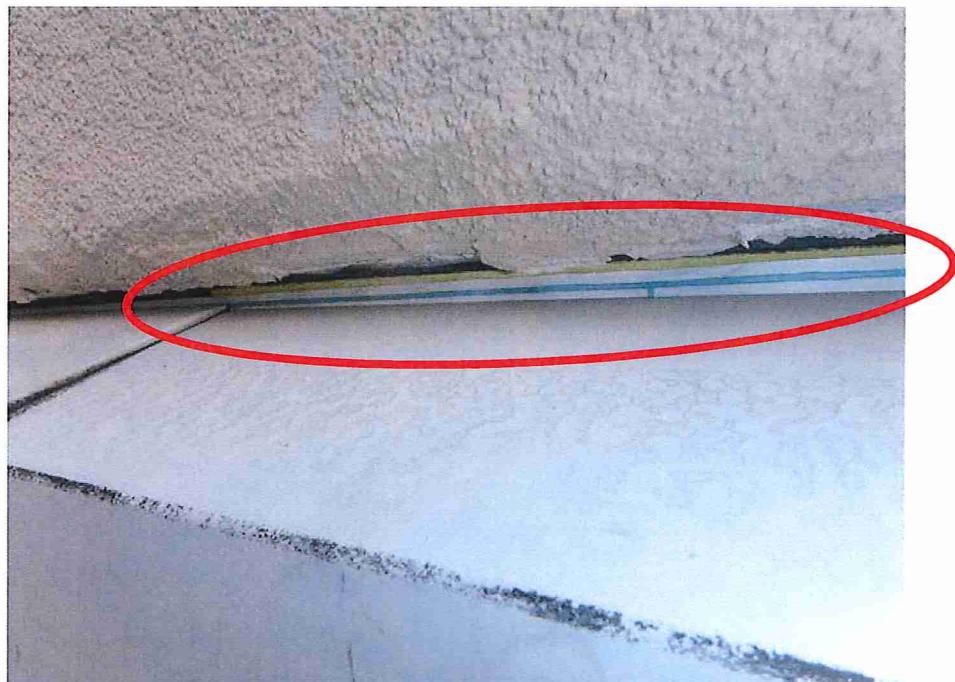
Photos No. 55 and 56

Description	Photo	Type
3.4.1 Drop No. 4 is located on the south elevation near the centre.	52 and 53	O
3.4.2 Level 8: At the top of the new rainscreen wall section no detail has been provided to terminate against the cast-in-place concrete parapet wall at the roof. Construction materials are openly visible including peel-and-stick membrane, Tyvek, and DensGlass sheathing. SEE recommends cleaning the substrate and installing a rod-and-caulk joint to prevent wind-driven rain from entering into the rainscreen wall assembly.	54 and 55	M

3.4.3 Level 8: At the base of the new rainscreen stucco the rainscreen cavity is protected with a perforated metal vent strip which is in good condition.	56	O

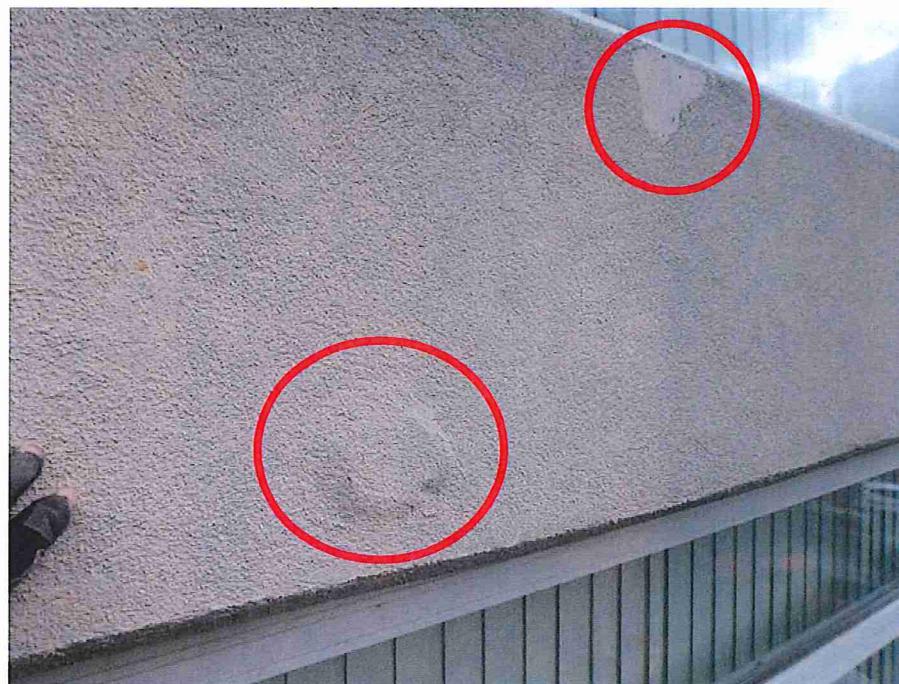
Photos No. 59 and 60

3.4.7 Level 5: There is a blister in the acrylic stucco finish and nearby an area where the finish has been removed. SEE recommends scraping the failed acrylic finish, cleaning the substrate, then applying new acrylic finish with matching texture to the surrounding areas prior to repainting.	59	M

3.4.8 Level 4: There is a caulking failure between the face-sealed stucco wall and window frame.	60 to 62	M
3.4.9 Level 3: There is a caulking failure between the corner coupler sheet metal and window frame which overlooks the balcony.	63	M

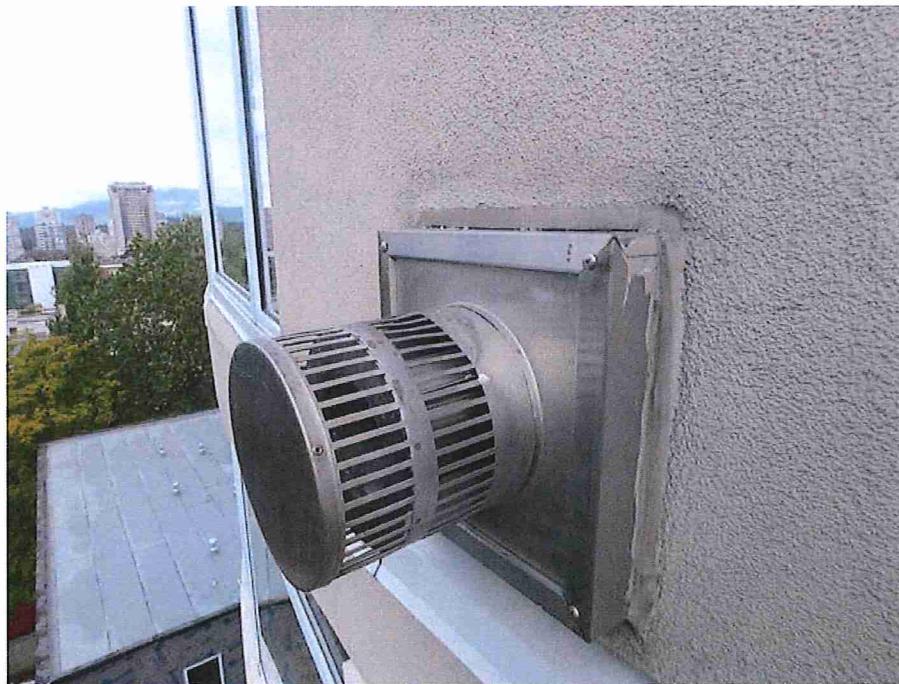
Photos No. 81 and 82

3.5.5 Level 8: The window sill was detailed with a reinforced liquid-applied membrane. Insufficient membrane basecoat was applied with the reinforcement fabric resulting in the lack of bond and unsaturated surface. Given the existing condition, SEE recommends re-adhering the bottom edge of this reinforcement with new polyurethane caulking.	81	M

3.5.6 Level 8: There is a caulking failure at the head of the fireplace vent termination. The fireplace vent is stainless steel and appears to be in good condition.	82 and 83	M

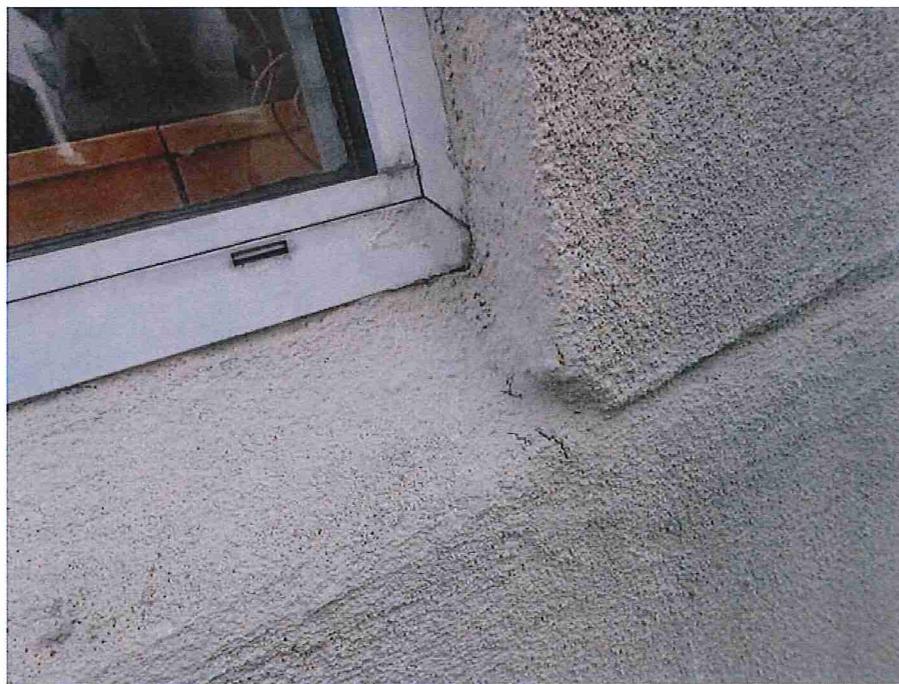
Photos No. 89 and 90

3.5.9 Level 7: Below the fireplace vent there is cracking on the surface and rust staining indicating moisture migration through the stucco – possible water ingress. Rust staining is likely due to rusting of the stucco J-bead.	89	M

3.5.10 Fireplaces at Levels 7 and 6 are waterproofed at the perimeter with a wide troweled application of caulk. Fastener heads are showing through the surface of the caulk. Caulking replacement is recommended. Fireplace terminations are rusted and require grinding and recoating with zinc-rich primer and paint.	90 to 91	M

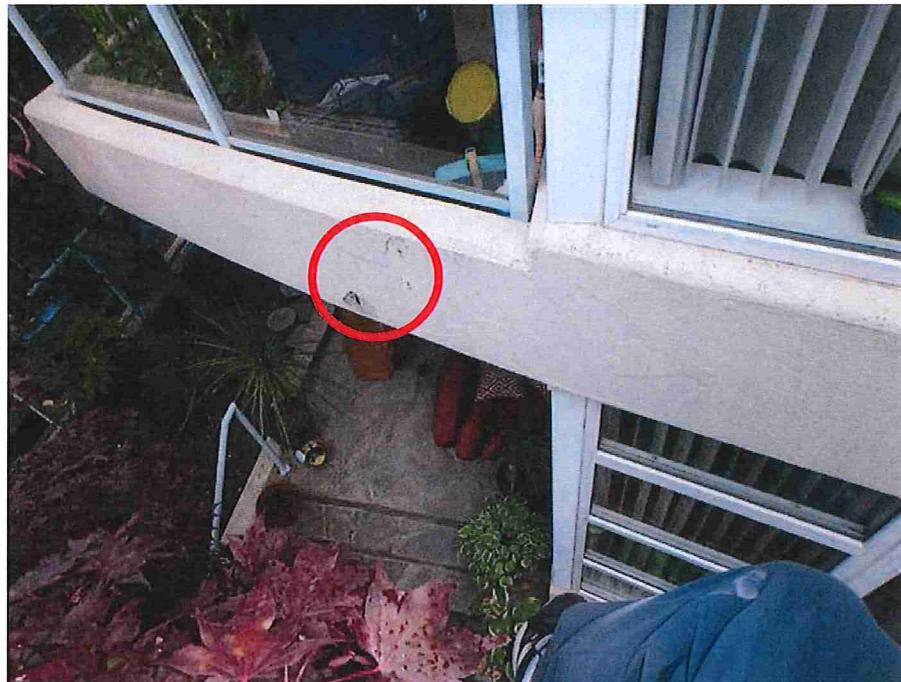
Photos No. 99 and 100

3.5.16 At several locations on this drop the original acrylic stucco finish which had been applied to the cast-in-place concrete failed and was scraped off. SEE recommends at the time of painting that new acrylic stucco with a matching texture be applied to the concrete prior to new paint coating being done.	98 and 99	M

Description	Photo	Type
3.5.17 Level 2: On the lower floor patio there are reviewable areas of the 1999 reclad work. The rainscreen cavity gap has been closed with a wide caulking joint. The caulking is aged with heavy alligatoring on the surface. Replacement is recommended.	100 to 102	M

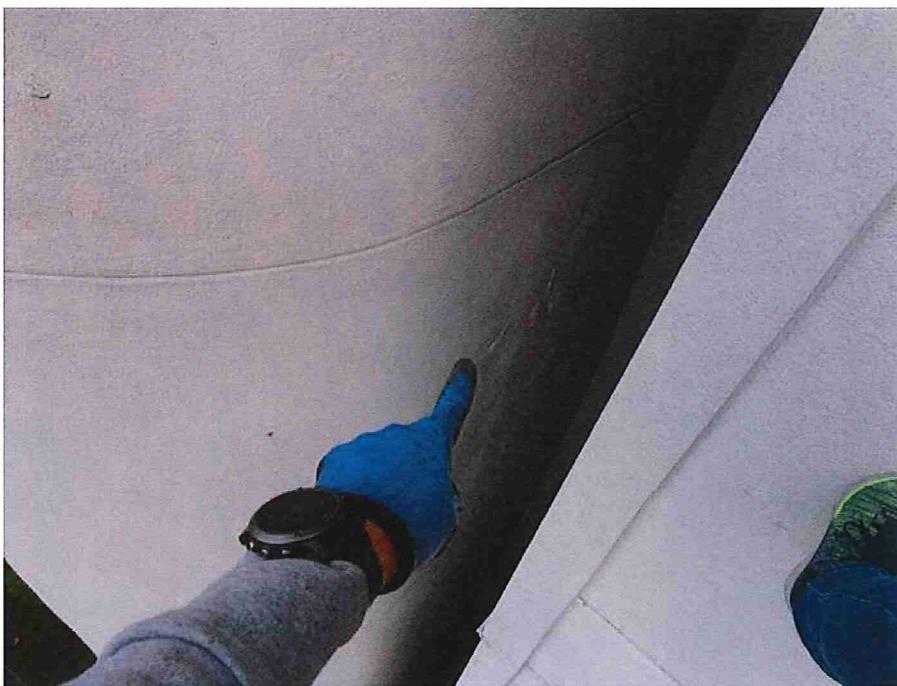
Photos No. 113 and 114

3.6.5 To the north of the drop is the west emergency stairwell which consists of mass concrete walls coated with acrylic stucco and glass block window openings. The exterior surfaces appear to be in good condition with the exception of one exposed concrete crack on Level 5 with signs of water intrusion. The crack can be remedied by routing and caulking with a polyurethane sealant.	112 to 115	M

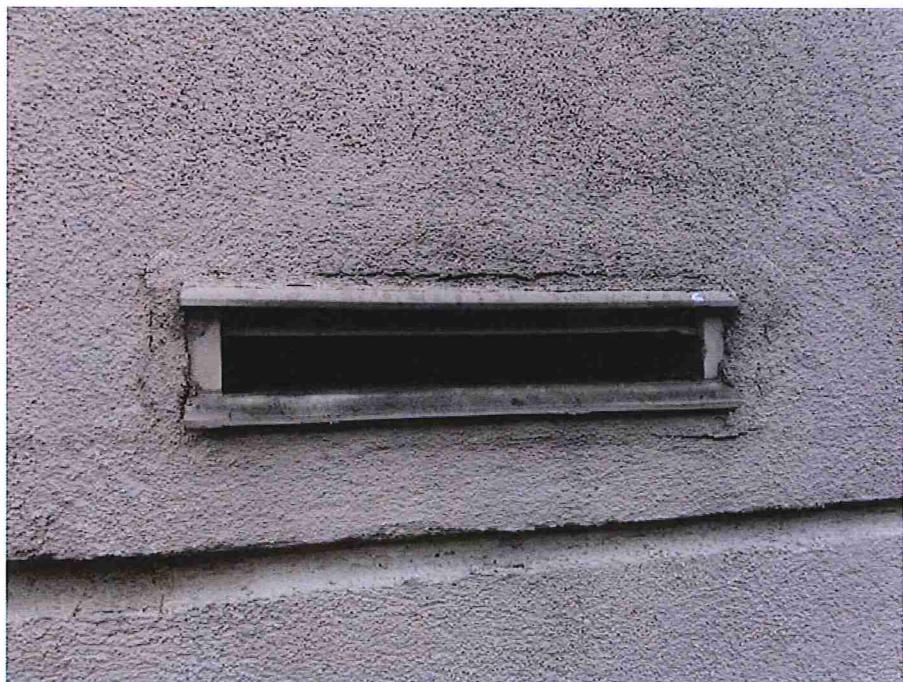
Photos No. 115 and 116

3.6.6 The in-slab exhaust vents located at the lower levels have spalled concrete at their perimeter. The vents also have minimal weather protection. Vent hoods with gum lip terminations are recommended once the spalls are removed and the concrete patched and re-coated.	116	M

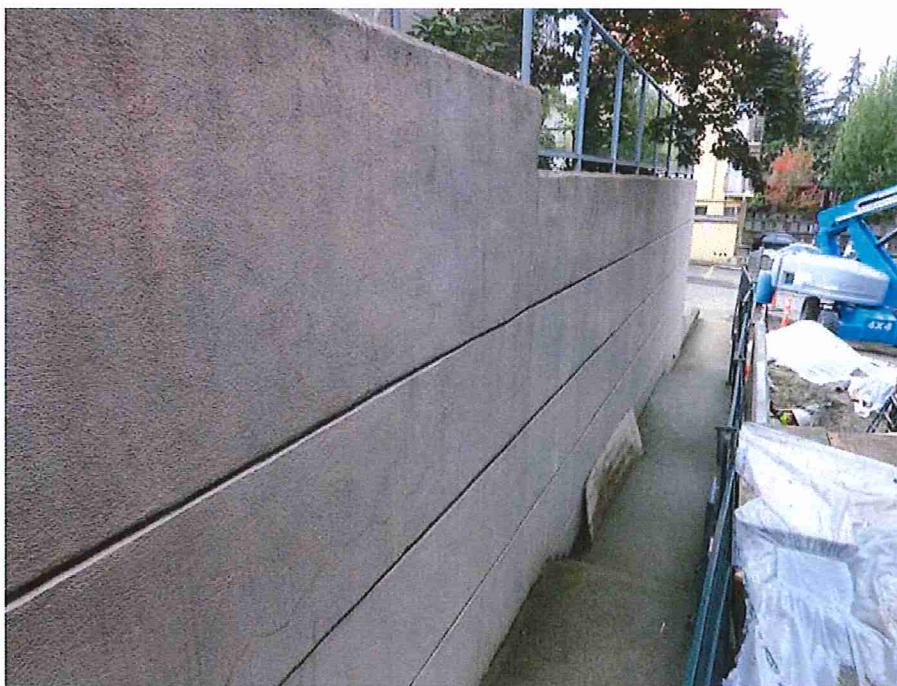
Photos No. 119 and 120

3.6.9 The gated exit to the west stairwell appears to be in good condition. The side wall consists of glass blocks which are capped with mortar. The mortar cap is cracked and should be replaced and covered with a metal flashing.	119	M

3.6.10 Cracks through mass concrete as seen at Level 1 should be routed and sealed to mitigate the risk of water ingress.	120 and 121	M
3.6.11 Horizontal reveals in mass concrete do not have sealant and show signs of cracking. Horizontal reveals should be sealed as part of global building envelope maintenance work.	122	M

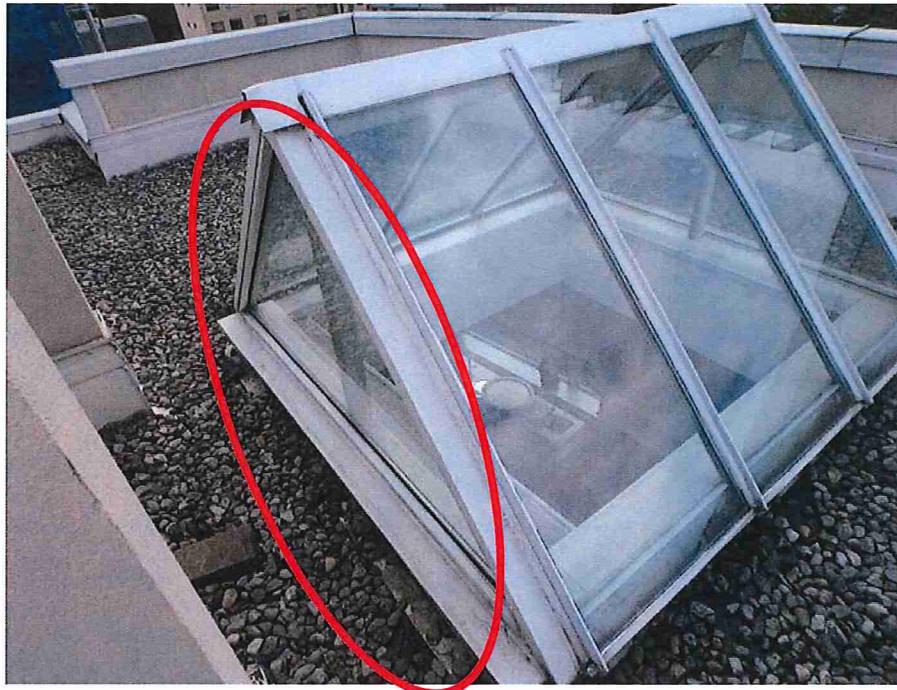
Photos No. 135 and 136

3.7.7 South Skylight: There is condensation between the panes of glass on the north triangular glazing unit indicating the IGU has failed. Replacement of the IGU is required.	135	M

3.7.8 The metal staircase leading to the mechanical penthouse level is heavily corroded and should be repainted with new exterior-grade enamel paint.	136 and 137	M

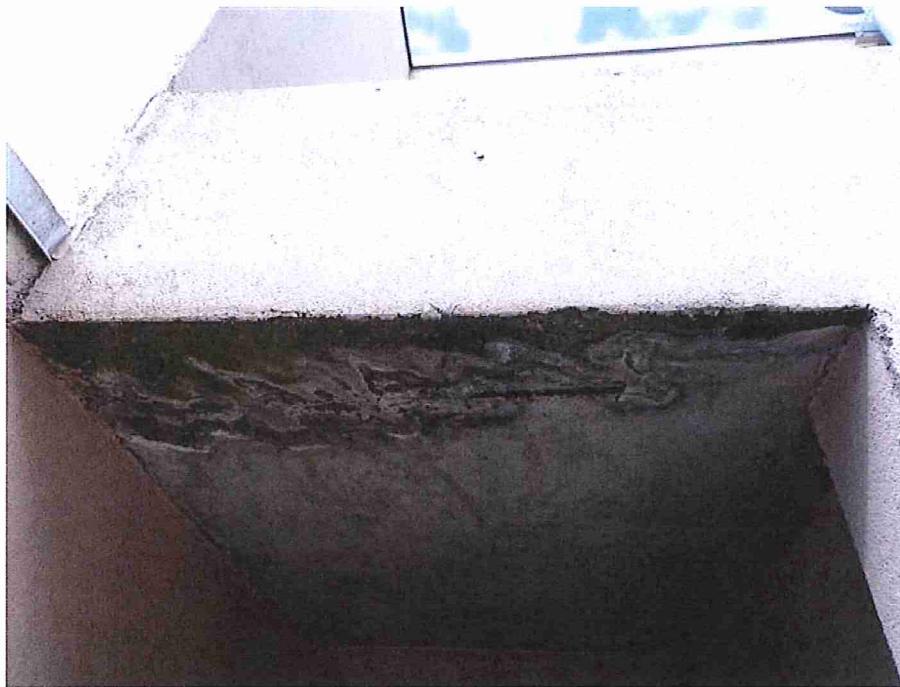
Photos No. 139 and 140

3.7.9 At the bottom of the metal staircase at the roof level, there is a small alcove. The concrete ceiling lacks a drip edge which has led to spalled concrete and exposed corroded steel reinforcement. Repairs should be made to the rebar and concrete and a drip edge can be made with a bead of polyurethane sealant outboard of the repair.	138 and 139	M

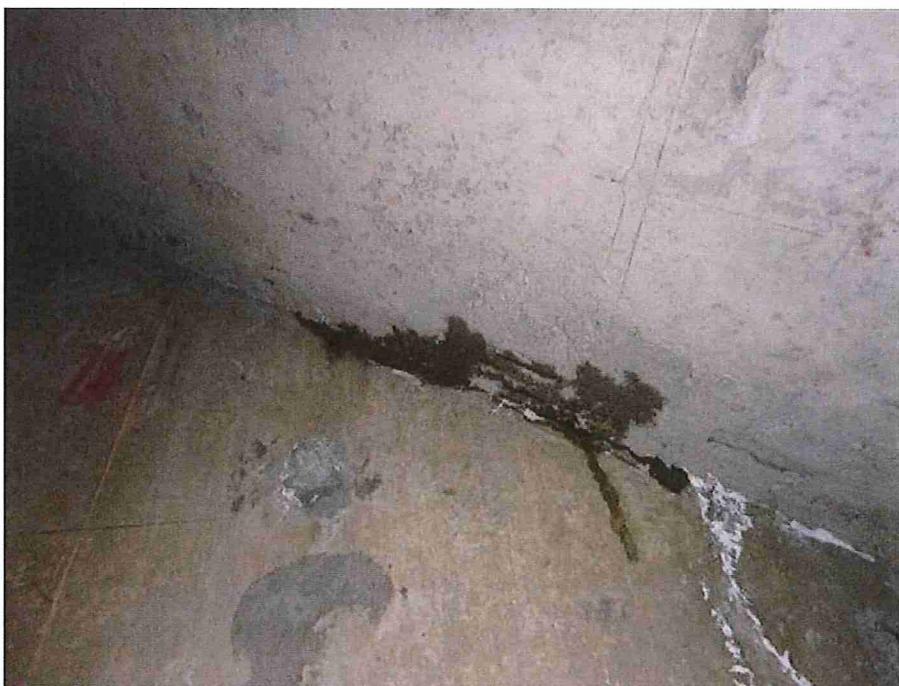
Photos No. 141 and 142

3.8.2 There is active water ingress in the lower parkade exit stairwell. SEE recommends repair by injection.	141 and 142	M
3.8.3 Parking Stall 1: Efflorescence around the drain pipe terminations indicates possible water ingress. SEE recommends monitoring.	143	O

4.4 Active and possible water ingress was observed in the parkade foundation walls. The observed active water ingress should be repaired by injection. Areas of potential water ingress can be monitored through the wet months and repaired by injection if necessary.

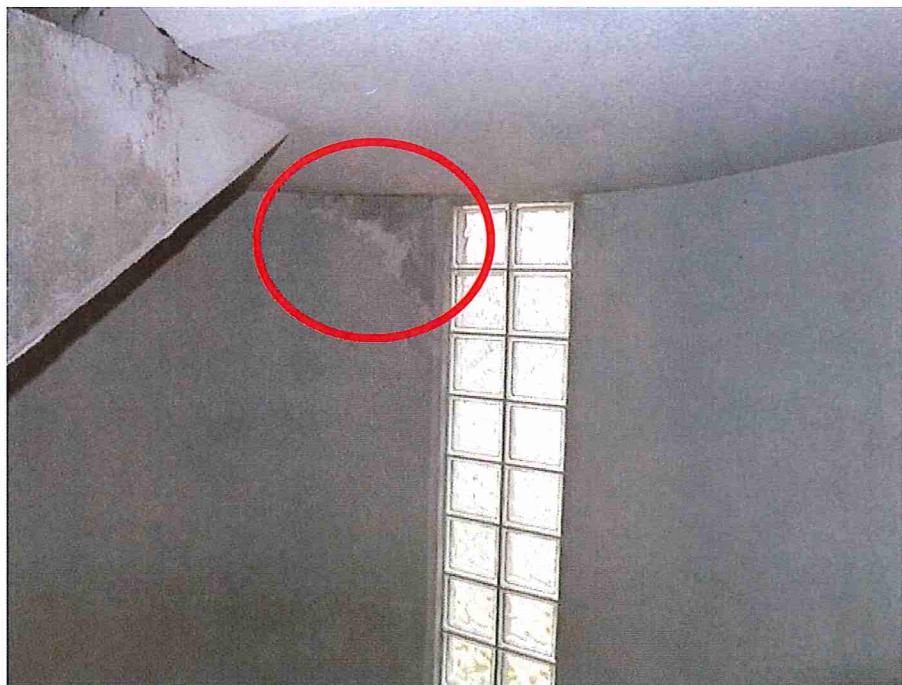
Photos No. 145 and 146

3.8.4 The east stairwell was reviewed from the interior. Areas with evidence of water ingress were observed near cold joints at the outer landing floor slabs. Due to relatively dry weather up to the time of the site visit, it is unclear if areas of water staining are actively leaking or not. Exterior wall recoating with elastomeric products would help address any water ingress.	144 to 146	M

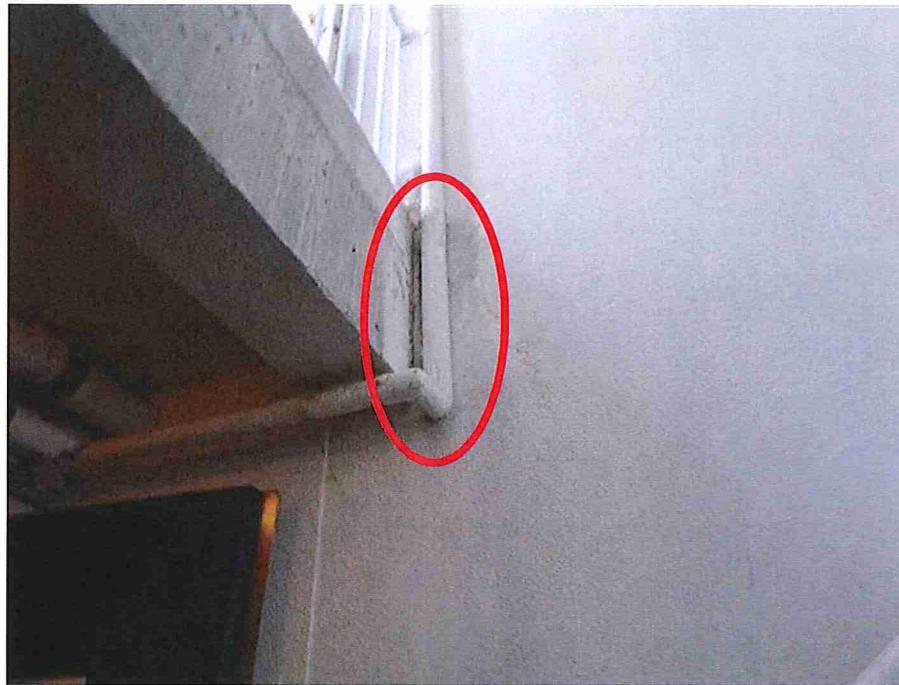
Photos No. 149 and 150

3.8.5 The west stairwell is in similar condition to the east stairwell. Past repairs performed from the negative side are observed at the upper level.	147 to 150	M
