OBSERVATION REPORT

Project: **Strata Plan LMS 280 – Chateau Comox** File No. S18-558
1272 Comox Street Report No. **1**
Vancouver, B.C. Date: May 08, 2019

ITEM: Building Envelope Field Review

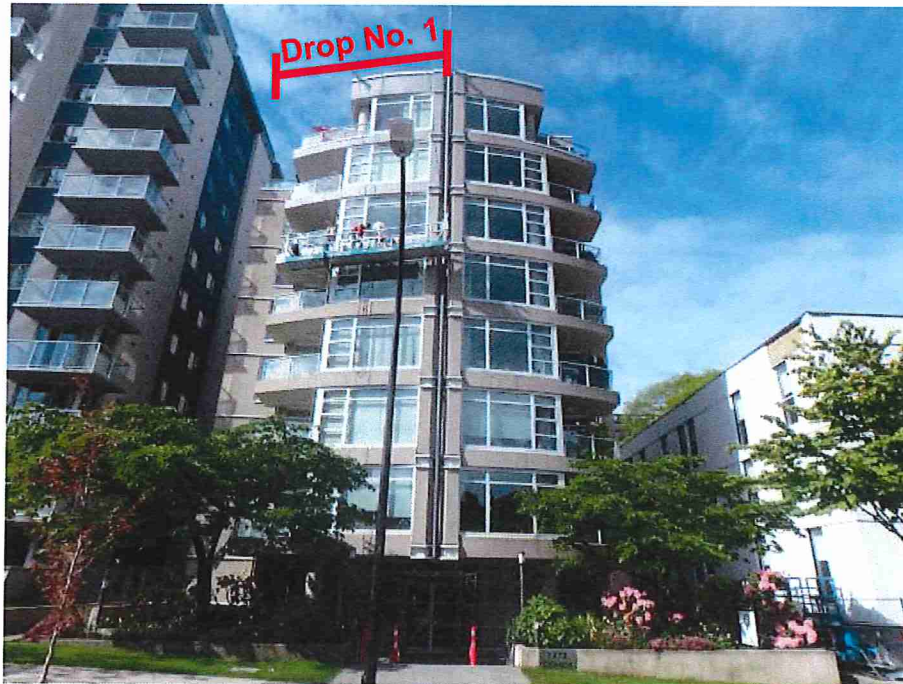
Photos No. 1.1 and 1.2

1.2	Spectrum Painting has begun work on the first drop of this project, Drop No. 1, located on the east half of the north elevation. At the time of review, pressure washing was complete and first coat paint application was underway on the stucco walls (Photo No. 1.1).

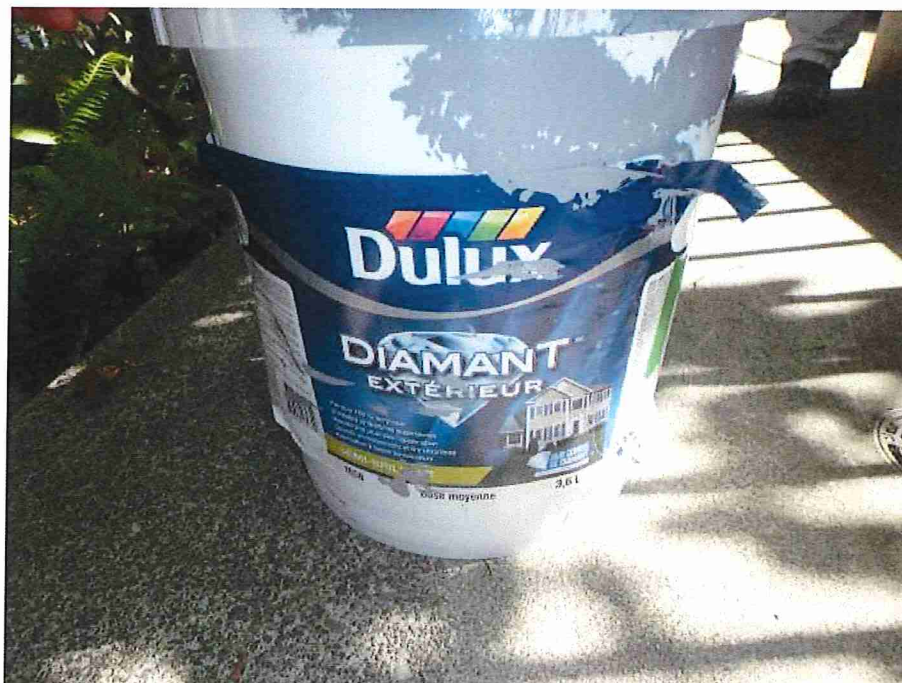
1.3	For field walls areas, the contractor is utilizing Dulux Diamond exterior latex paint. Balcony guardrails and other metal components will be painted with Devoe Devlac 1437 enamel. Strata Council has approved the colour match for both products. SEE will send under separate cover a record of the products and colour match formulas for the strata's records (Photos No. 1.2 and 1.3).

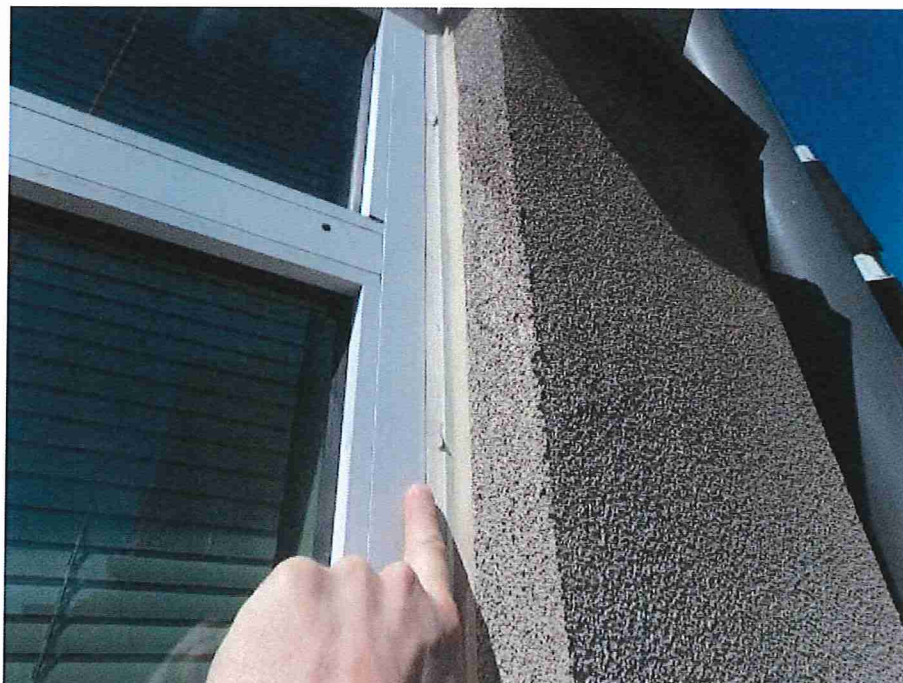
1.4	SEE reviewed the scope and extent of repainting. At window jambs, the paint application shall extend across both window perimeter sealant beads, terminating at the edge of the window frame. At the balcony soffits, the soffit shall be coated with flat sheen paint while the vertical surfaces and walls shall receive semi-gloss. The transition from flat to semi-gloss shall occur in the drip edge where available, or at the lowest edge of the 45° cant where no drip edge is cast into the concrete (Photos No. 1.4 to 1.6).

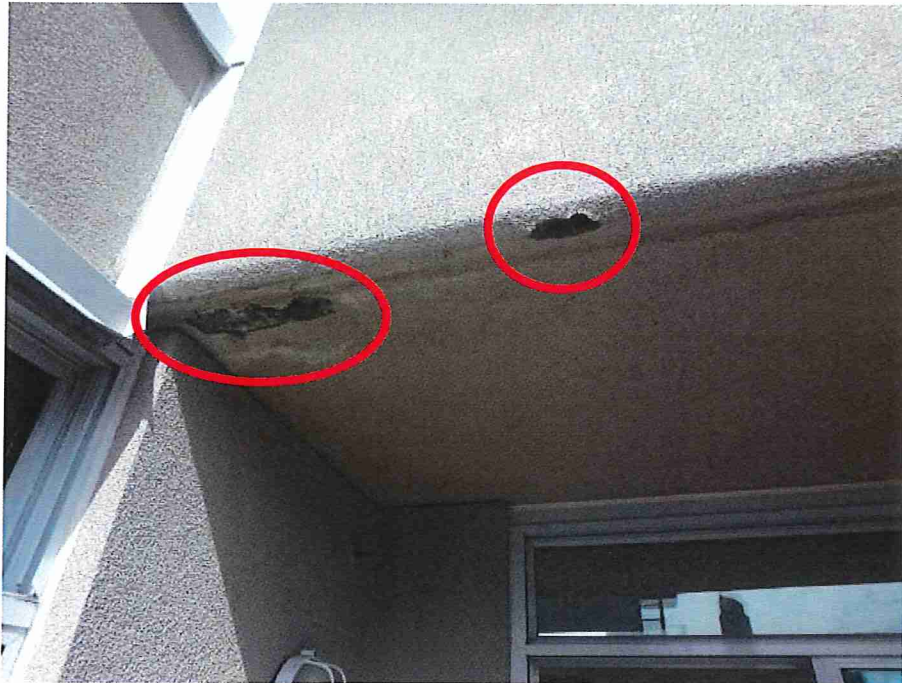
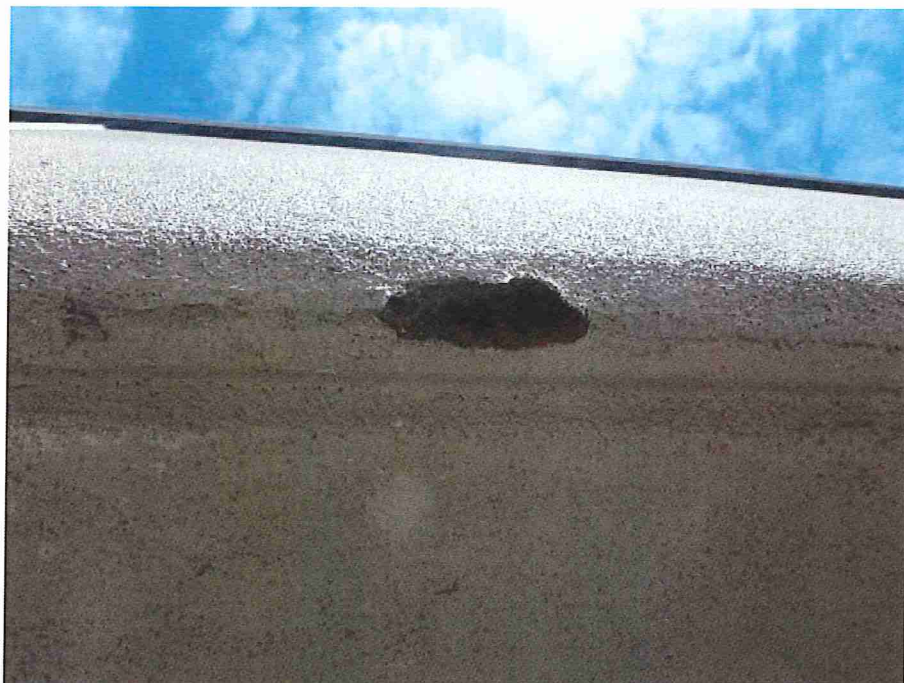
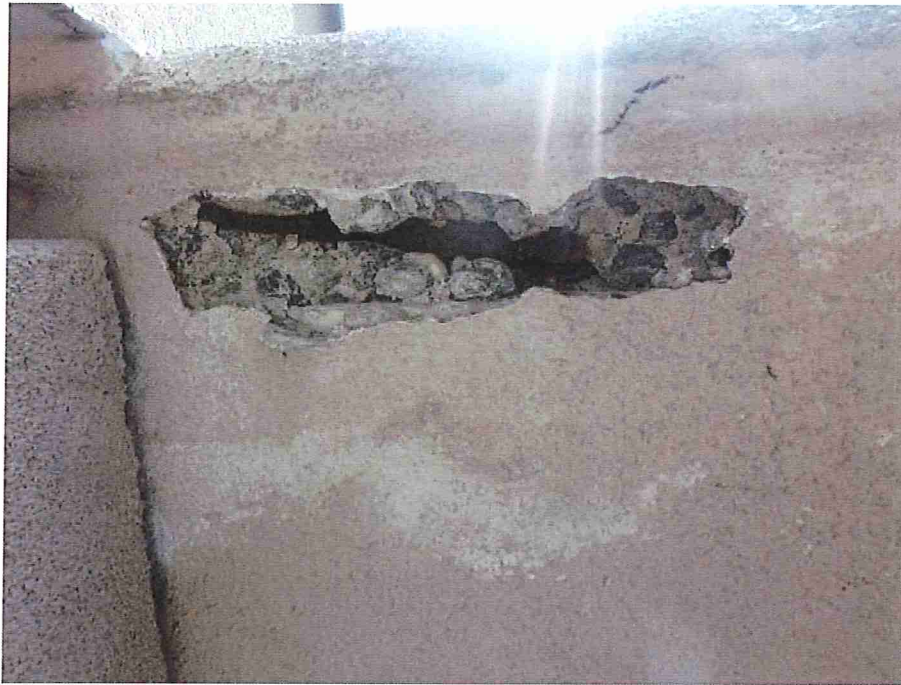
- 1.5 Drop No. 1, Level 8: Rusted steel and minor concrete spalls were uncovered along the concrete overhang and drip edge at the balcony. All loose concrete must be chipped away to expose 1" clear around the steel. The exposed steel shall be cleaned to a bright metal finish with a grinder then protected with a high zinc solid primer such as Galvacon. The concrete profile shall be reinstated with an overhead patching mortar such as Mapei Planitop and once secured, the acrylic stucco finish shall be reapplied (Photos No. 1.7 to 1.9). SP
-
- 1.6 In preparation for the next drop which has known areas of delaminated acrylic stucco finish, SEE has requested Spectrum Painting provide a sample board of the acrylic stucco repair material for texture approval by the Strata Council.
-
