OBSERVATION REPORT

Project: **Strata Plan LMS 280 – Chateau Comox** File No. S18-558
1272 Comox Street Report No. 4
Vancouver, B.C. Date: May 31, 2019

ITEM: Building Envelope Field Review

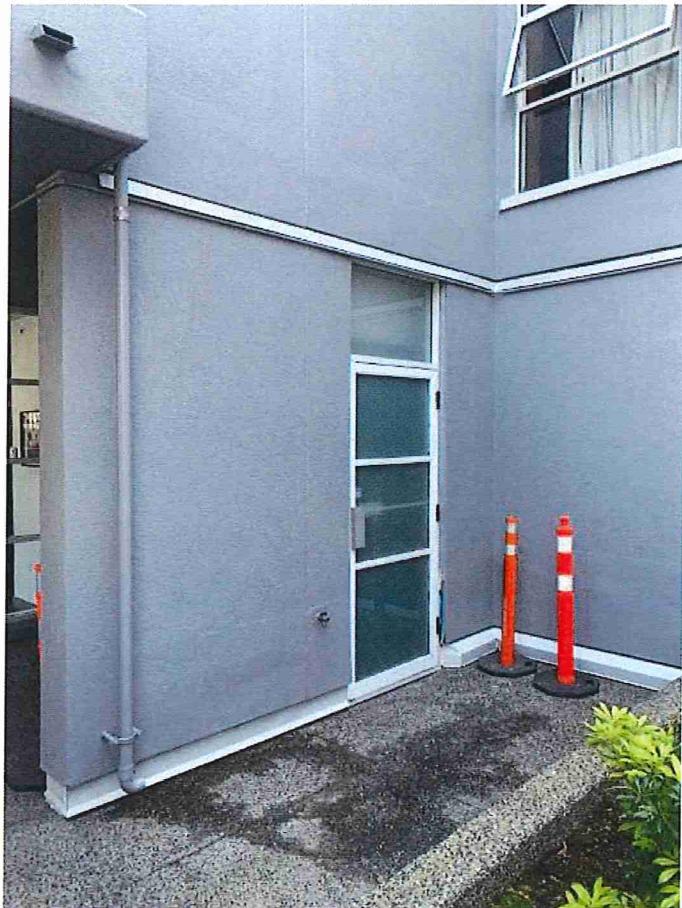
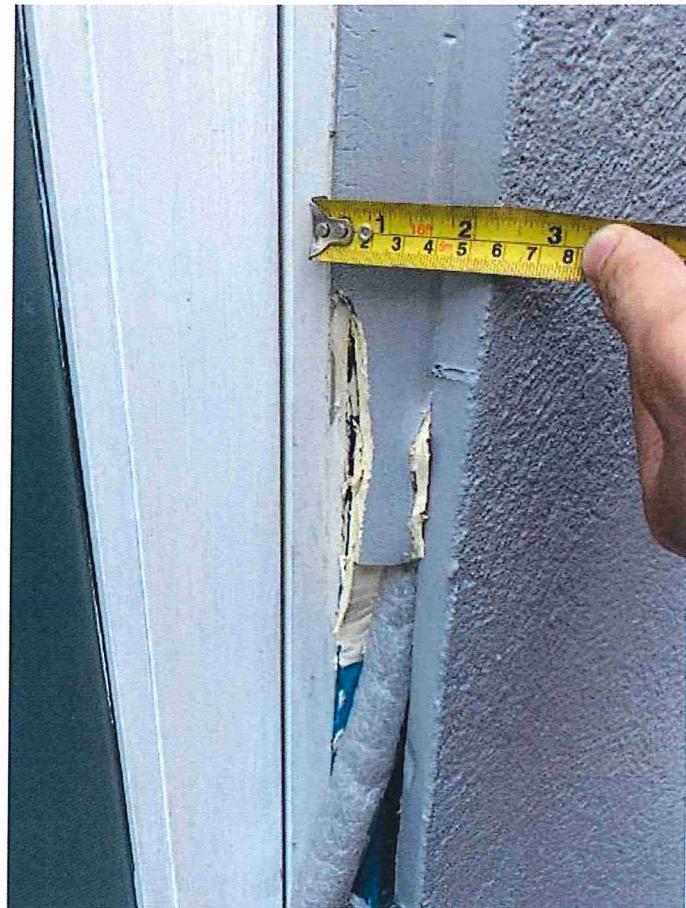
Photos No. 4.1 and 4.2

4.2	A caulking detail was inspected on a metal framed swing door on the ground floor off the amenity room. The existing caulking was applied to the stucco and frame as a bridge across the rainscreen cavity; however, the underlying peel and stick membrane was also caulked. Removal of existing caulking will likely damage the edge of the membrane, which must be preserved. The gap between the stucco and frame is approximately 1.5". SEE has instructed Spectrum Painting to cease removal of existing caulking to prevent damage (Photos No. 4.1 to 4.3).

4.3	SEE discussed a metal flashing detail to replace the existing caulking; however, there is no way to mechanically fasten the flashing. The other solution is to use Dow Corning 123 Silicone Seal to bridge the gap. SEE requests Spectrum Painting produce a mock-up for further review.
