OBSERVATION REPORT

**Project:** **Strata Plan LMS 280 – Chateau Comox** File No. S18-558  
**1272 Comox Street** Report No. 5  
**Vancouver, B.C.** Date: Jun 03, 2019

**ITEM: Building Envelope Field Review**

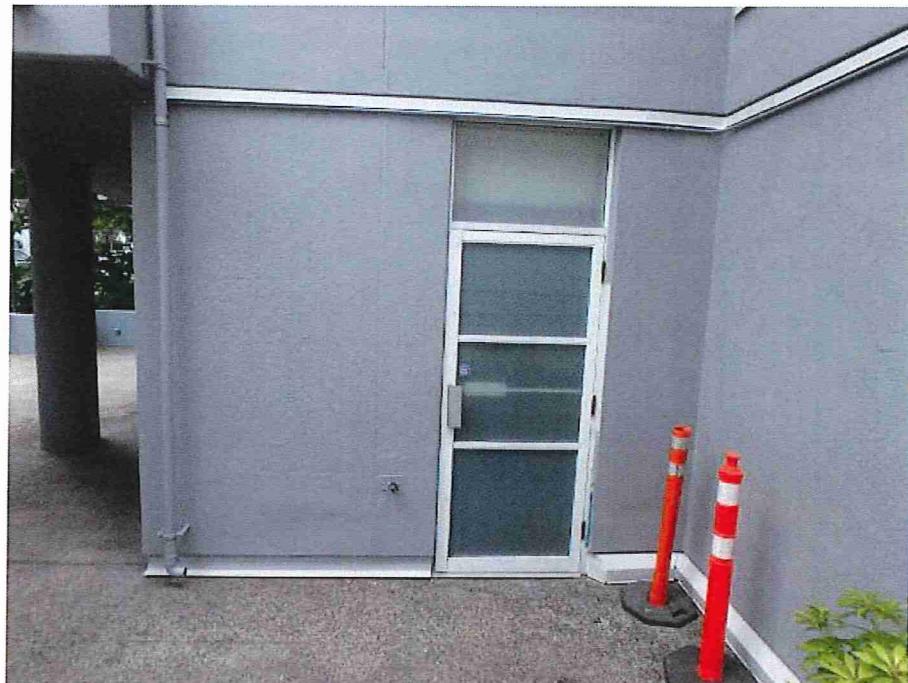
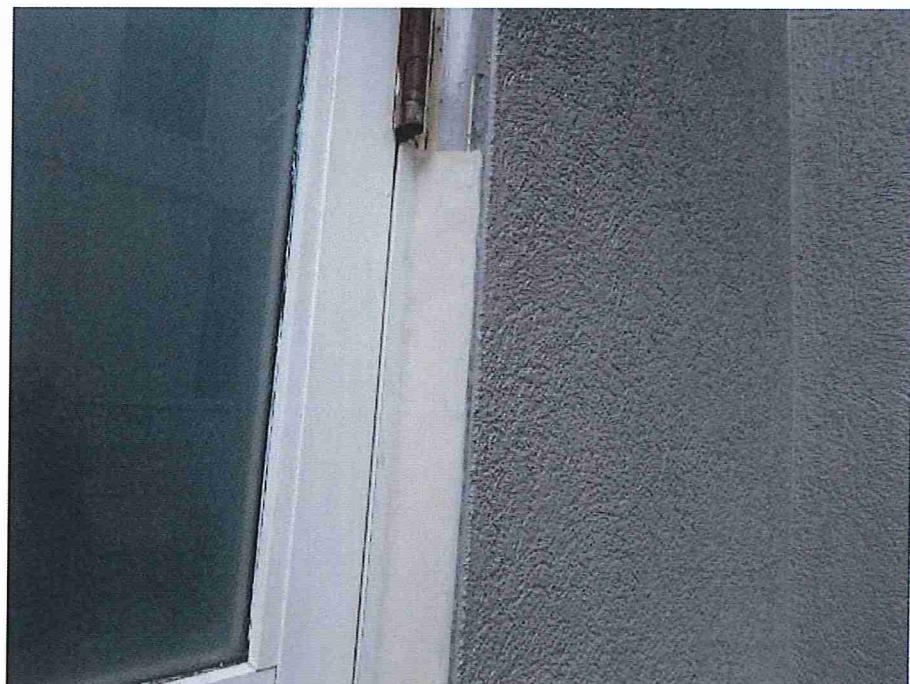
**Photos No. 5.1 and 5.2**

5.2	As requested, Spectrum Painting Ltd. has prepared a sample installation of Dow Corning 123 silicone seal in lieu of caulking replacement at the ground floor amenity room door. The pre-cured silicone tape is installed with two beads of caulking, one placed over the galvanized J-bead of the stucco and the second on the door frame. The 123 Tape and silicone caulking are neatly installed with no significant wrinkles or bulges (Photos No. 5.1 to 5.4).

5.4	SEE has accepted the installation. Spectrum Painting shall supply and install 123 Tape in the factory colour closest matching the wall paint. Once installed the 123 Tape shall be overcoated with two coats of Dow Corning AllGuard tinted to the building colour.

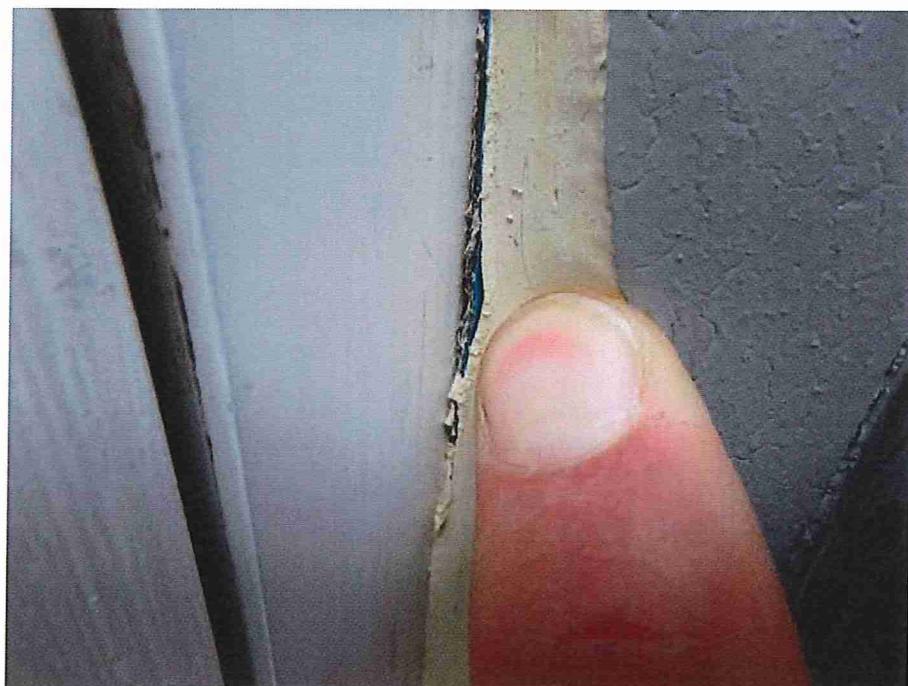
**Photos No. 5.5 and 5.6**

5.3	The existing caulking bead is left in place and will serve as mechanical support for the 123 Tape. Minor trimming of the caulking bead was done to accommodate installation of the 123 Tape. This was done without causing damage to the underlying Blueskin peel-and-stick membrane (Photo No. 5.5).

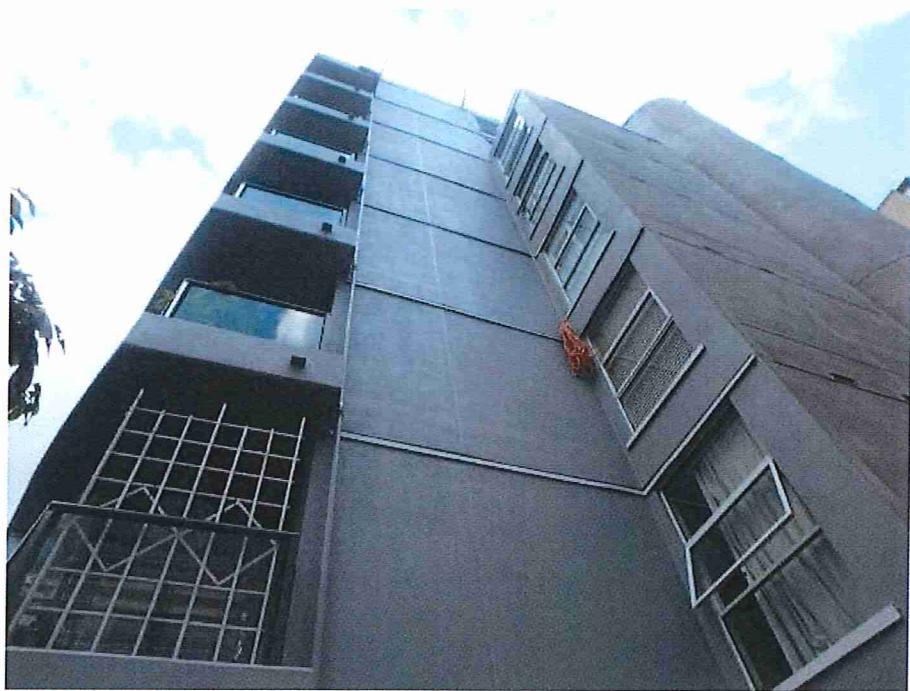
5.5	Painting work on Drop No. 3 is substantially complete and at the time of review the Contractor was beginning work on Drop No. 4. SEE will perform a complete review of Drops No. 3 and 4 when Drop no. 4 is complete. Elsewhere on the project, painting is substantially complete at the ground floor planters around the front entry with excellent workmanship observed (Photos No. 5.6 to 5.8).
