OBSERVATION REPORT

Project: Strata Plan LMS 280 – Chateau Comox File No. S18-558
1272 Comox Street Report No. 6
Vancouver, B.C. Date: Jun 14, 2019

ITEM: Building Envelope Field Review

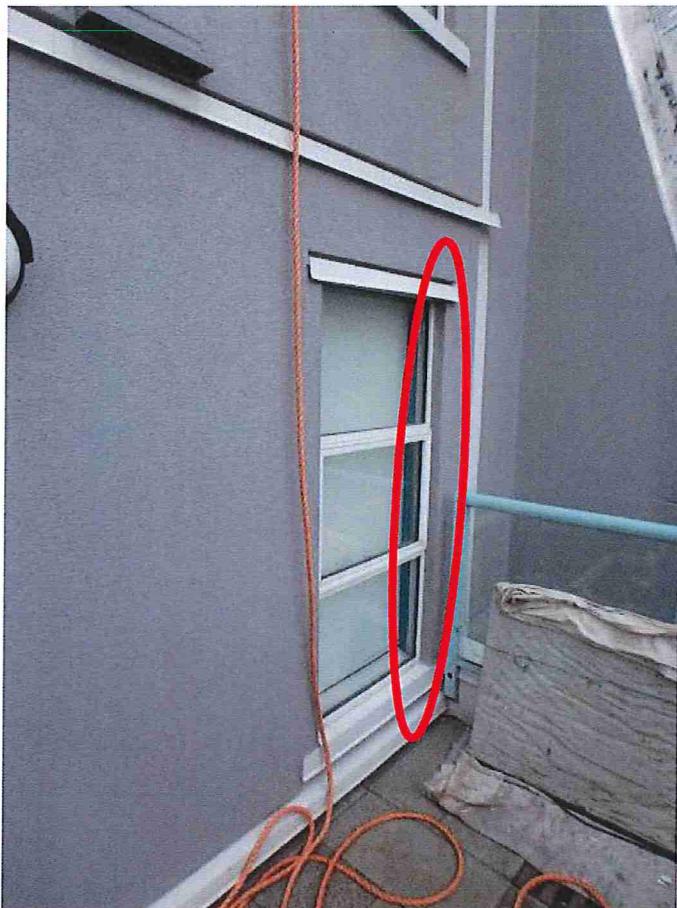
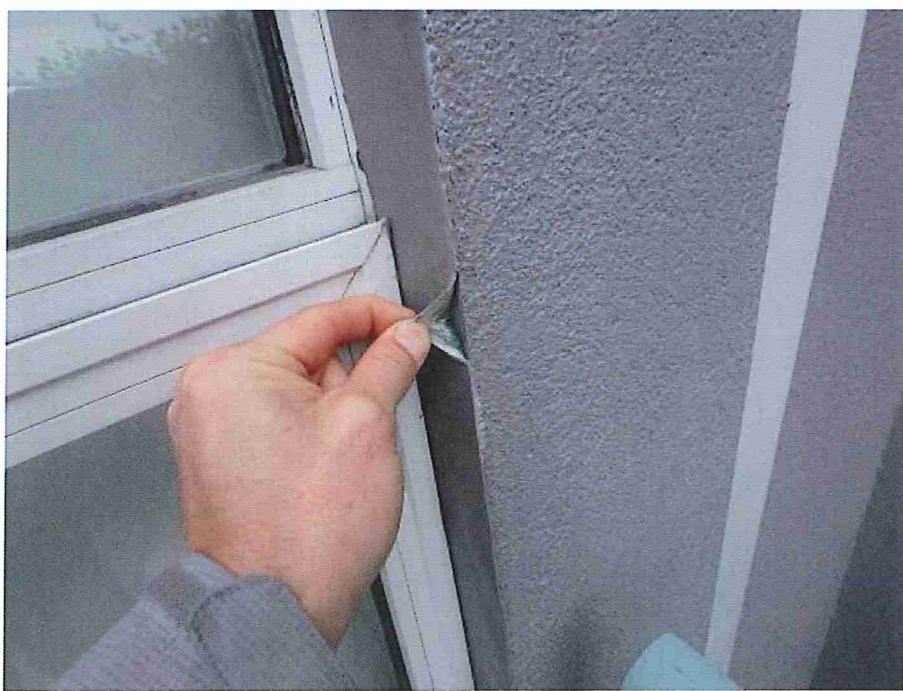
Photos No. 6.1 and 6.2

Item	Comment	Action By	Date Cleared	Cleared By
6.1	John Drinkwater, P.Eng. of Spratt Emanuel Engineering Ltd. (SEE) attended the above noted development on June 14, 2019 to conduct a building envelope field review. The following are the observations of the writer.			
6.2	Drop No. 4: Total extra work on this drop includes 45' of new silicone 123 Tape, 1 sq.ft. of concrete spall repair, 18 sq.ft. of acrylic stucco patching, and T&M sheet metal repairs and flashing painting at the Unit No. 701 west deck.			
6.3	Unit No. 701: The owner provided access to his left deck, allowing review of the completed painting and caulking work at the exterior. As requested, Dow Corning 123 Tape has been installed jambbed up the windows and doors. The right hand jamb up deck level window requires rework with 123 Tape as edges are not fully adhered (Photos No. 6.1 and 6.2).

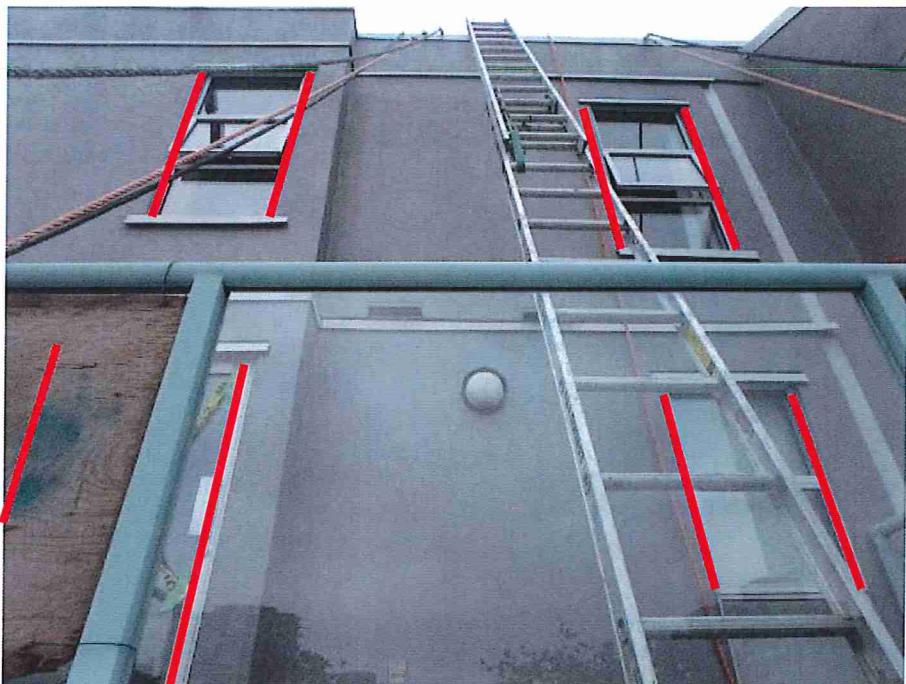
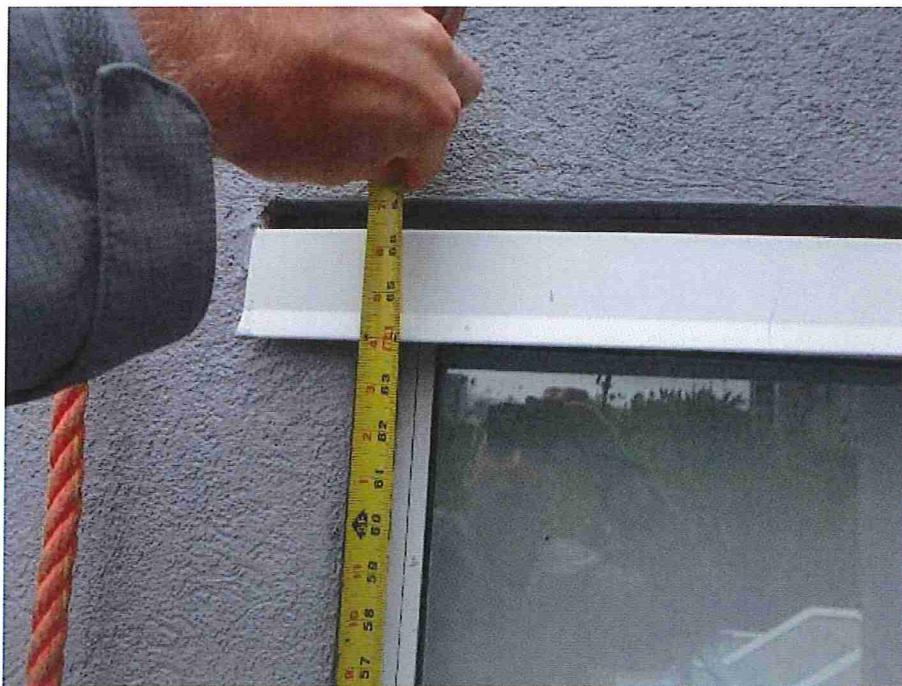
Photos No. 6.3 and 6.4

- 6.4 Unit No. 701: Extra work at the west deck and at the Level 8 windows above includes six window jambs with 123 Tape at 5'6" each, and one door with 6' jambs (Photos No. 6.3 to 6.5).

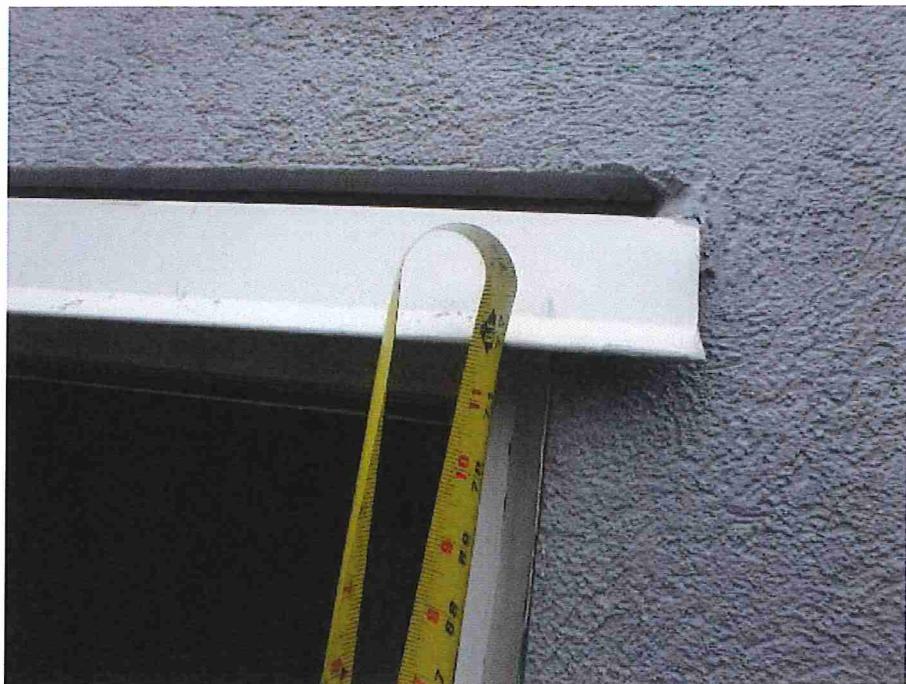
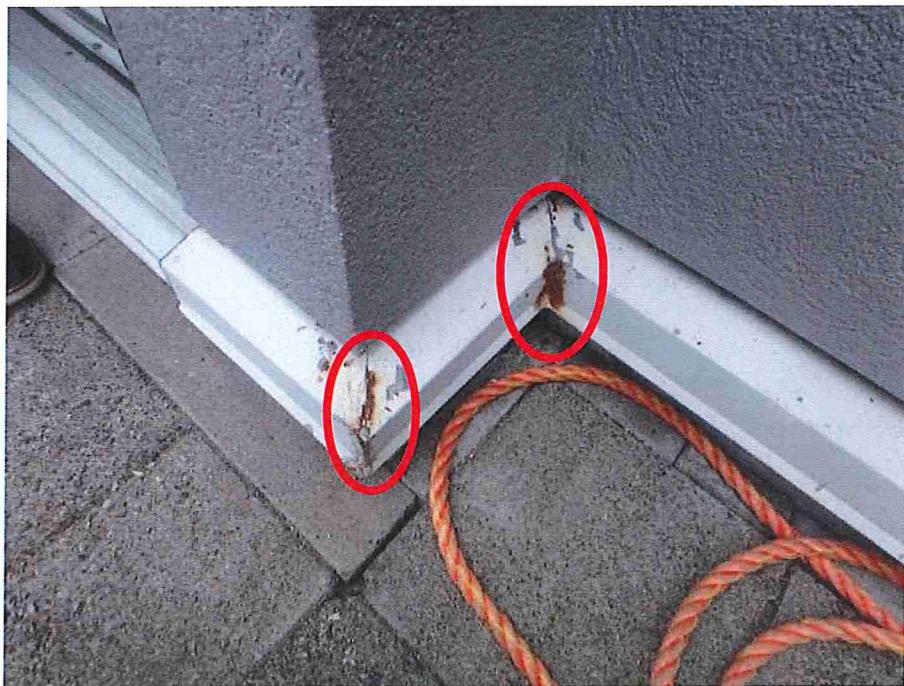
Photos No. 6.5 and 6.6

- 6.5 Unit No. 701: The roof deck parapet cap flashing and through-wall flashings have rust which should be recoated. SEE instructed Spectrum Painting to clean and repaint two through-wall flashings on the building's west elevation as well as the balcony parapet cap flashings. The corners of the through-wall flashings were originally constructed with soldered joints which have cracked. SEE instructed Spectrum Painting to repair the flashing by installing a back-caulked sheet metal repair secured with stainless steel rivets over the broken joints (Photos No. 6.6 to 6.8).

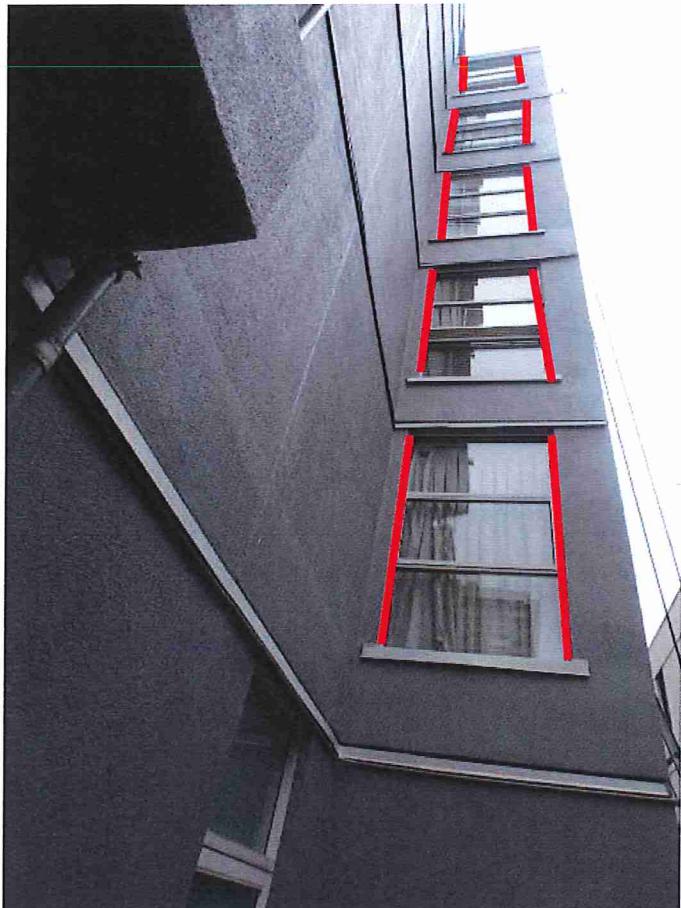
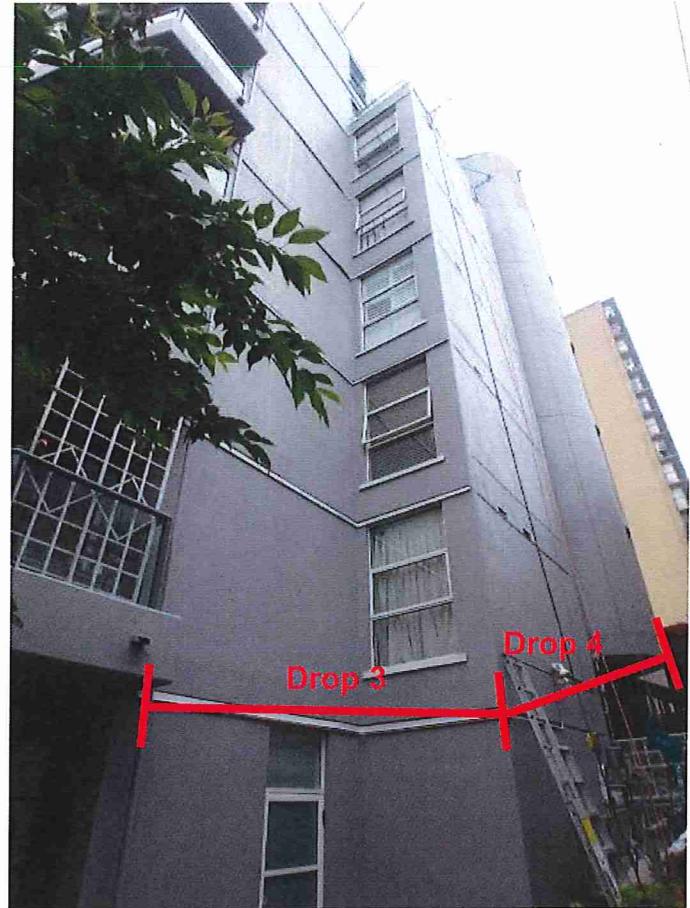
Photos No. 6.9 and 6.10

- 6.6 Drop No. 3: A total of five north-facing windows were resealed at the jambs with new 123 Tape. Each jamb measures 6'6" long. Additionally, the ground floor amenity room was sealed in a similar manner, measuring 7'6" each jamb (Photo No. 6.9).

- 6.7 Drops No. 3 and 4: SEE reviewed completed work on Drops No. 3 and 4 from the Drop No. 4 swing stage. Work is completed to a good standard (Photos No. 6.10 to 6.12).

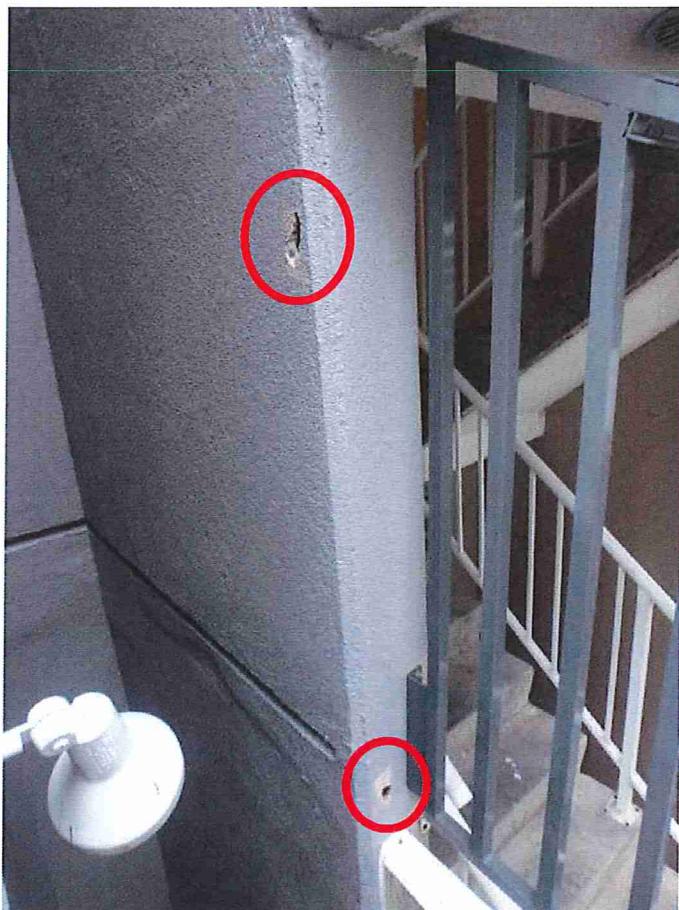
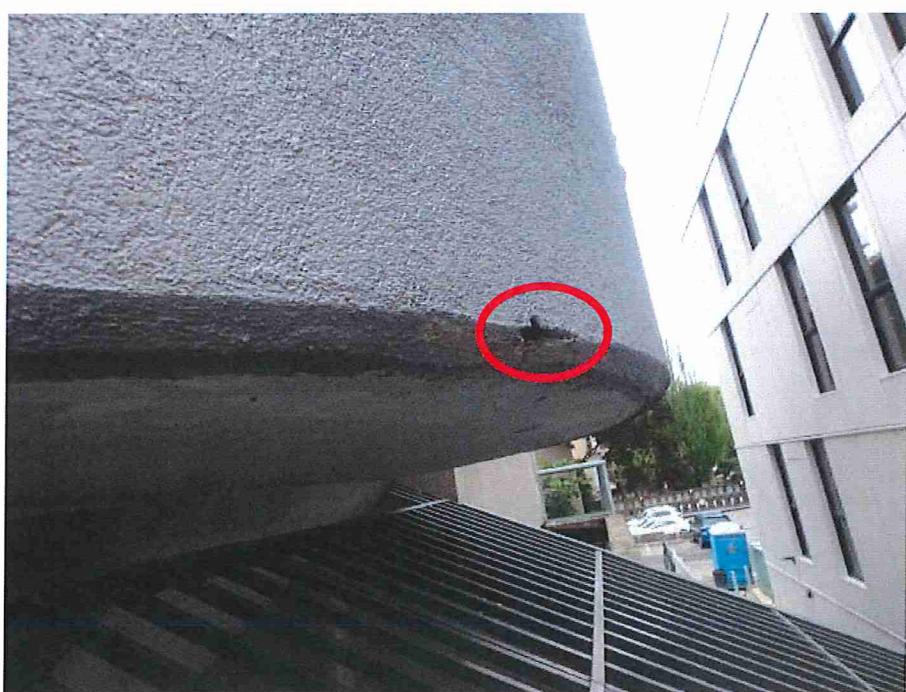
Photos No. 6.13 and 6.14

- 6.8 Drop No. 4: At the bottom of the barrel wall on the north face, there are three locations of exposed steel rebar of the concrete structure. At two locations on the wall face, SEE instructed the contractor to clean the steel to a bright metal finish, prime with a zinc rich primer then apply a patch of polyurethane sealant over and recoat with paint. The third spall located at the drip edge at the base of the barrel wall requires full concrete repair treatment. The concrete should be chipped away from the rusted steel to expose a minimum of 1" all sides. The steel should be cleaned to a bright finish and zinc rich primed, then new overhead concrete patching mortar shall be formed in place. Once secured, the concrete patch can be primed, new acrylic stucco finish laid overtop, and painted to match the walls (Photos No. 6.13 and 6.14). SP

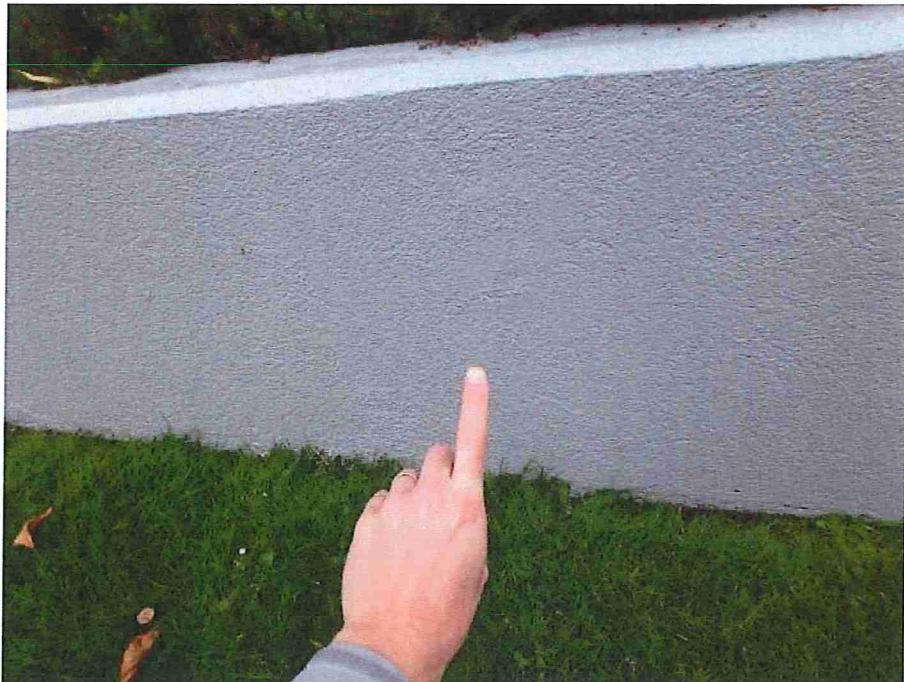
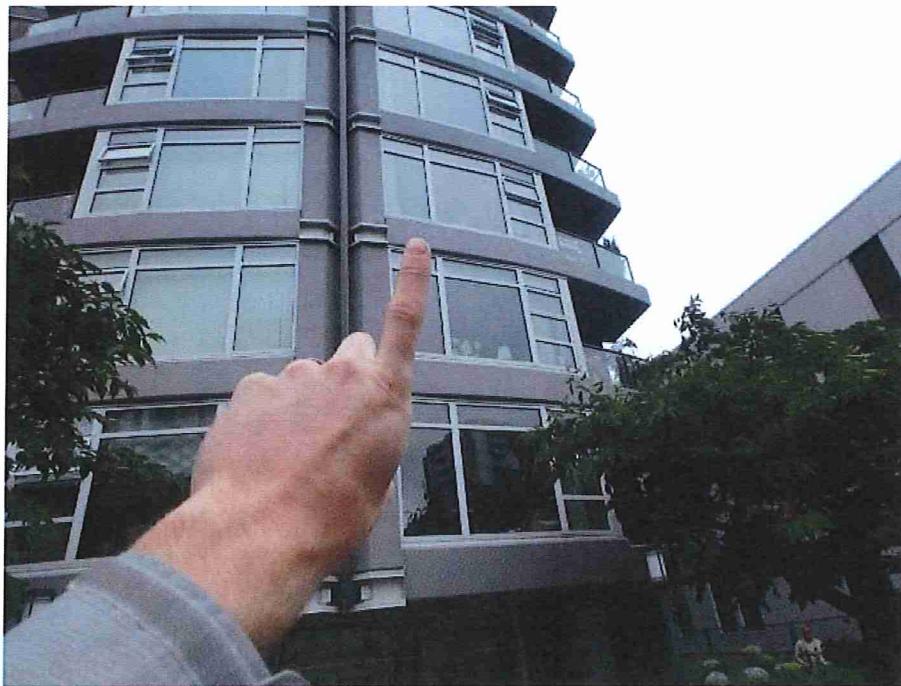
Photos No. 6.15 and 6.16

- 6.9 Approximately 18 sq.ft. of acrylic stucco repairs were done on the walls of the ground floor planters at the building entry. An additional 2 sq.ft. were done on Drop No. 2. Work is complete to a good standard with a close match to the existing finish (Photos No. 6.15 and 6.16).
