OBSERVATION REPORT

Project: **Strata Plan LMS 280 – Chateau Comox** File No. S18-558
1272 Comox Street Report No. 8
Vancouver, B.C. Date: Jul 30, 2019

ITEM: Building Envelope Field Review

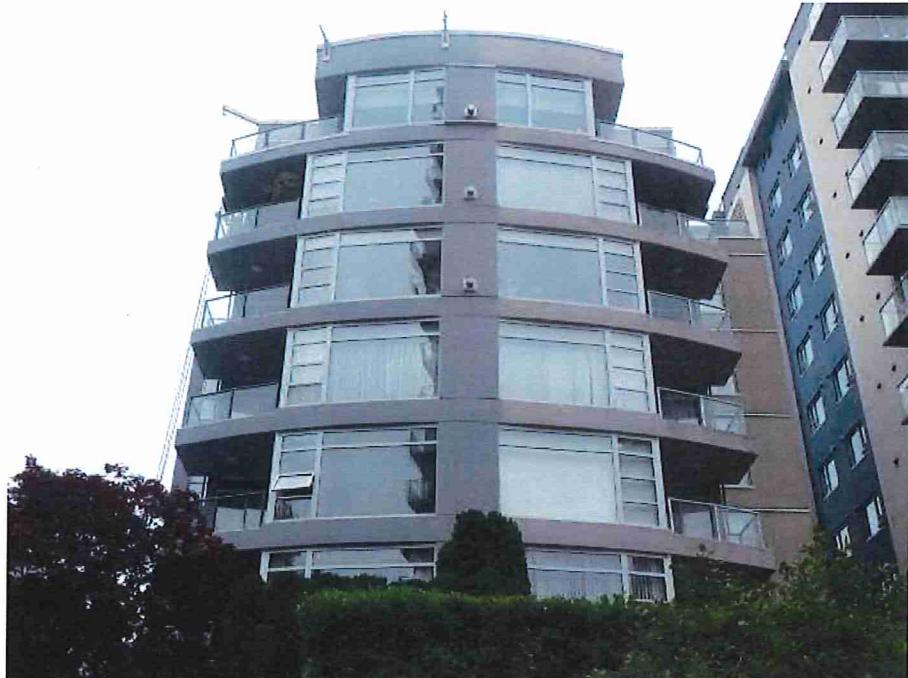
Photos No. 8.1 and 8.2

8.2	Painting and caulking work is substantially complete on the west half of the south elevation. The Dow Corning AllGuard silicone elastomeric coating has been applied to the exterior wall surfaces with good finish observed. At the time of review, the swing stage set up was being moved to cover the east half of the elevation so access was not immediately available. Detailed review will be conducted after the new swing stage set up is complete (Photo No. 8.1).

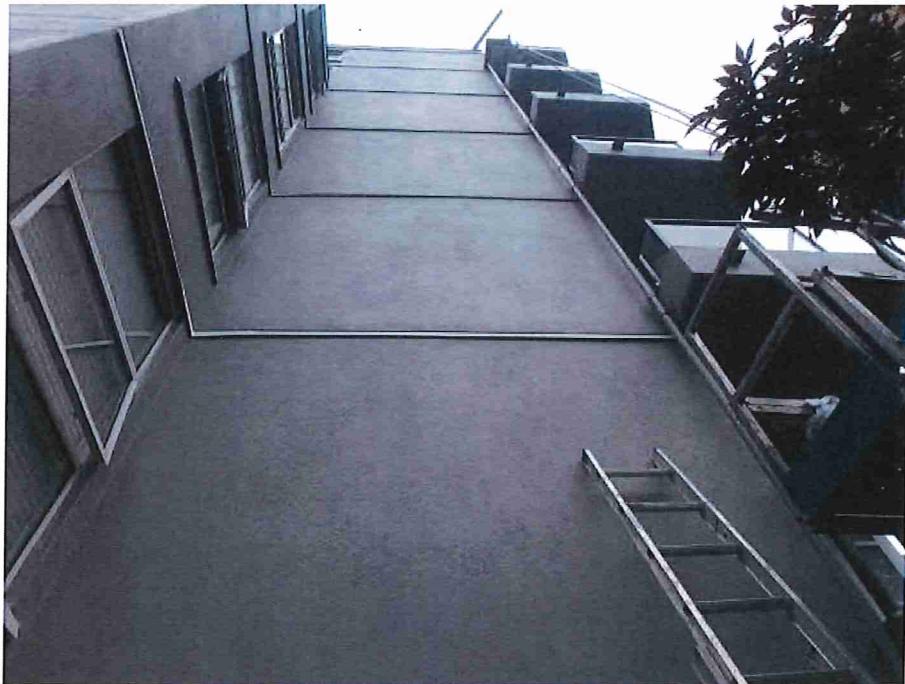
8.3	Work is continuing on the southwest corner balconies where new polyurethane traffic membrane is being installed. At the lower balconies, very good workmanship is observed. The membrane is applied to sufficient thickness and the broadcast sand is evenly distributed and back rolled into the top coat has required. Traffic membrane has been extended up the inside face of the parapet walls and onto the top surface of the parapet as requested (Photos No. 8.2 and 8.3).

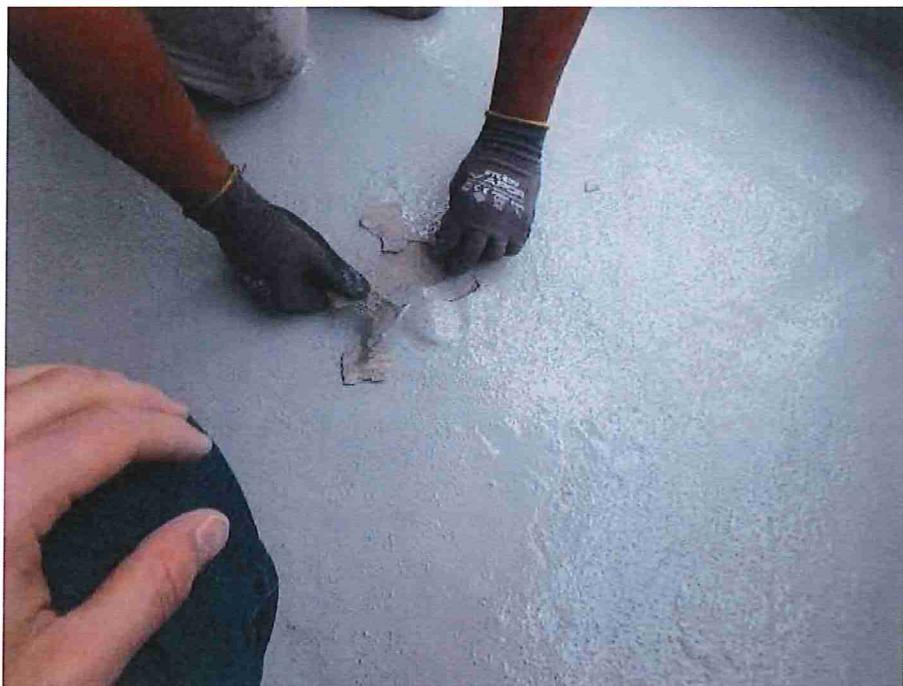
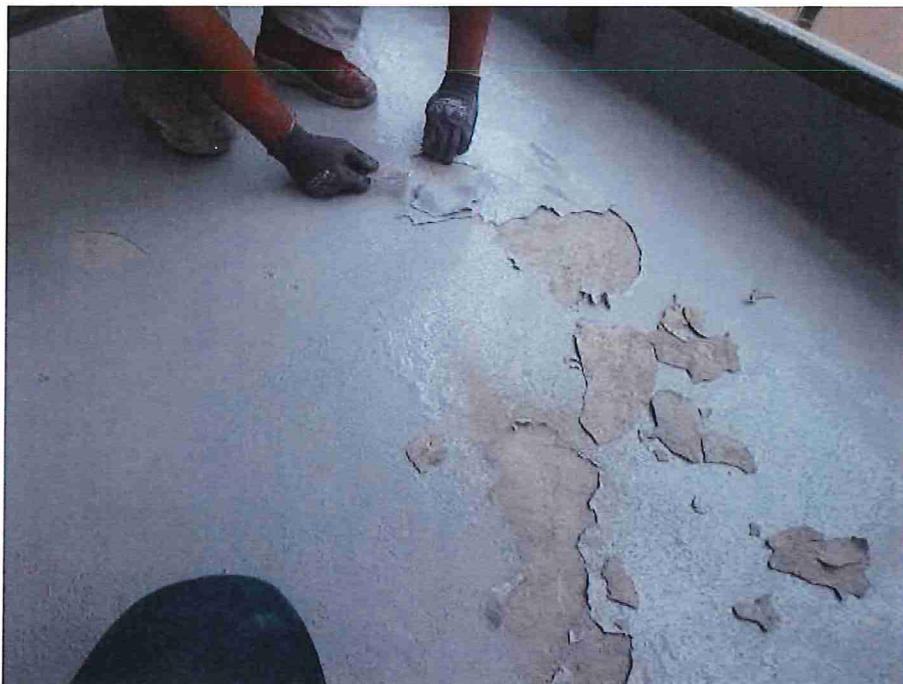
Photos No. 8.3 and 8.4

8.4 At one balcony only, the polyurethane traffic membrane application showed signs of delamination – blisters and pock marks in the finished surface. SEE conducted a small cut test which revealed a significant issue with concrete dusting on the existing balcony slab. Additional cut tests were done which showed the concrete dusting issue to be wide spread on this balcony. Unfortunately, the newly applied membrane on the balcony horizontal surface must be peeled off to expose the bare concrete slab. At the perimeter edges, and any location where tenaciously adhered membrane is discovered, the surface of the remaining membrane should be lightly touched with a grinder to provide a feathered edge into the bare concrete. After removal, the entire concrete surface must be heavily power washed, possibly with multiple passes until the entire weak layer of concrete on the top surface of the slab has been removed. We recommend testing during power washing with a scraper or stiff bristle brush – any areas which produce muddy water must receive further power washing until scraping or rubbing the bare concrete surface produces no residue.

8.5 After washing is complete, the deck must be allowed several days to dry. We recommend an adhesion test be performed on a small area of the deck, 6" wide by 12" long to confirm the surface prep procedures successfully removed all weak dusting concrete. In the test patch, embed scrim cloth within a standard application of membrane base coat and allow to dry. Please notify SEE in advance so that we can witness the pull off and confirm adhesion of the base coat is satisfactory.

8.6 After successfully completing the adhesion test, new base coat membrane should be applied to the bare concrete areas, feathered into the existing membrane application. New top coat shall be applied to the entire horizontal surface of the deck. All locations of existing membrane must be prepared with a heavy solvent wipe of xylene to ensure a good bond with the new top coat.

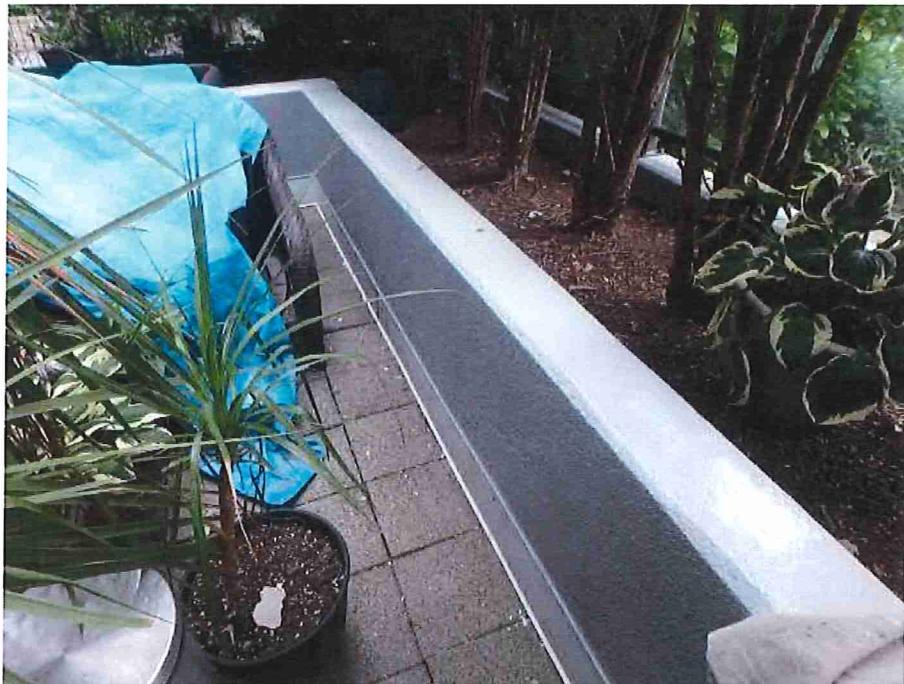
Photos No. 8.5 and 8.6

8.7 At the southwest ground floor deck, planter walls are painted and horizontal surfaces have been prepared with new polyurethane traffic membrane. Work appears very good. In multiple locations on the planter and building walls, the contractor has removed failed acrylic stucco and applied new with an excellent match to the existing texture (Photos No. 8.6 to 8.8).

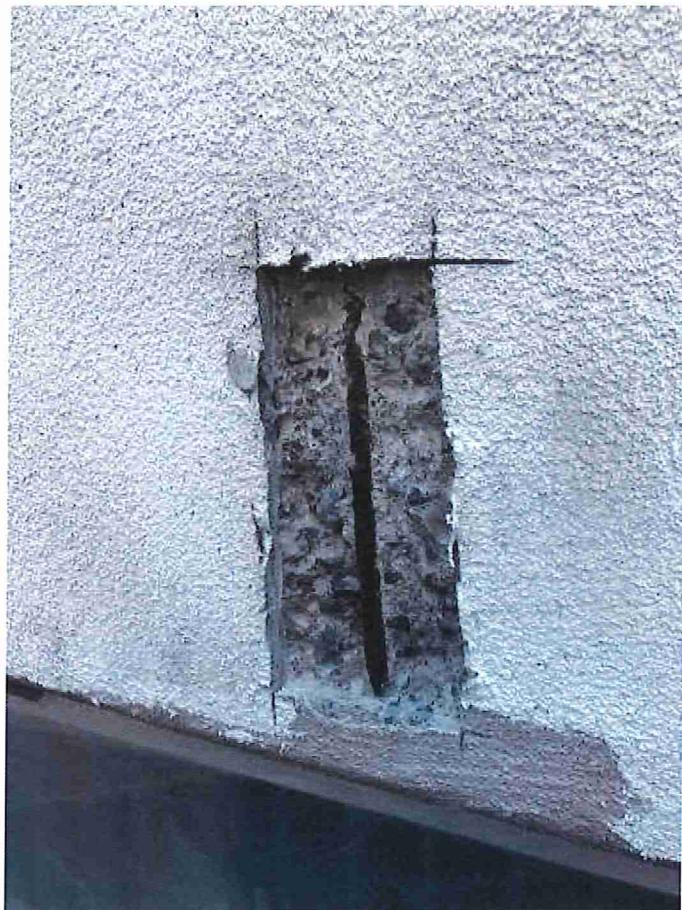
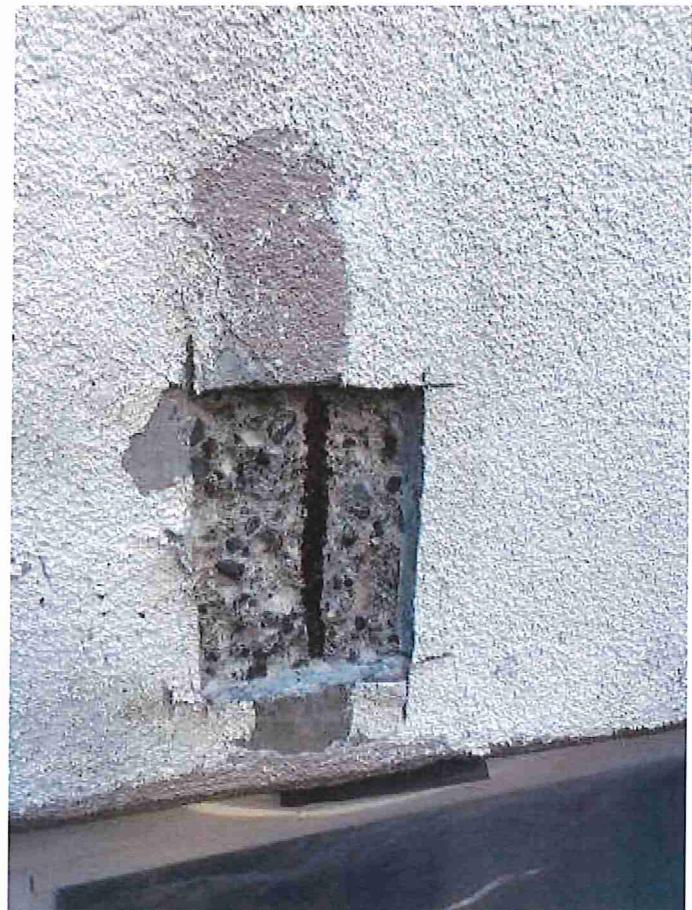
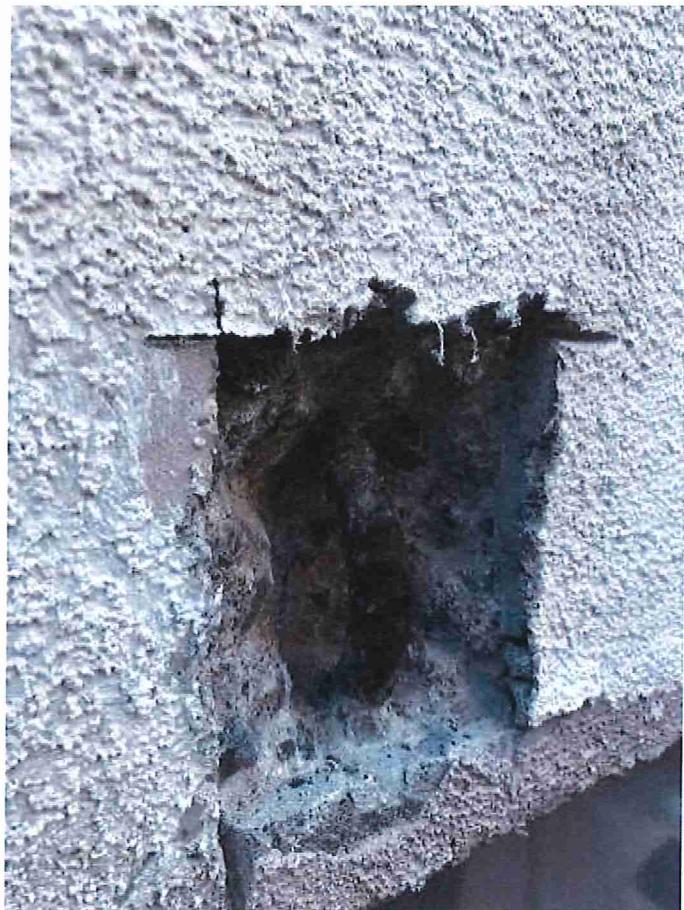
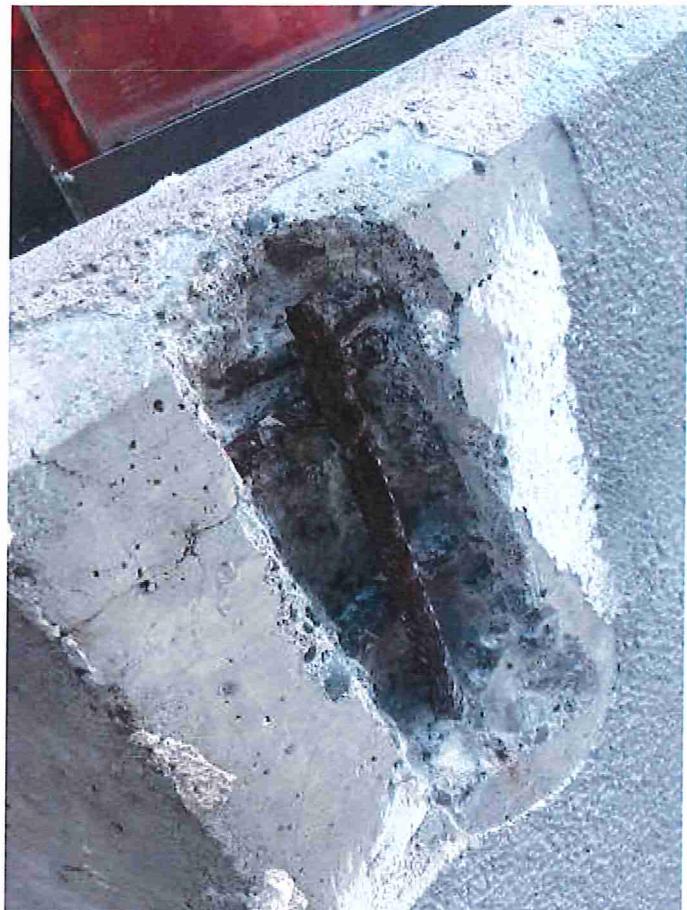
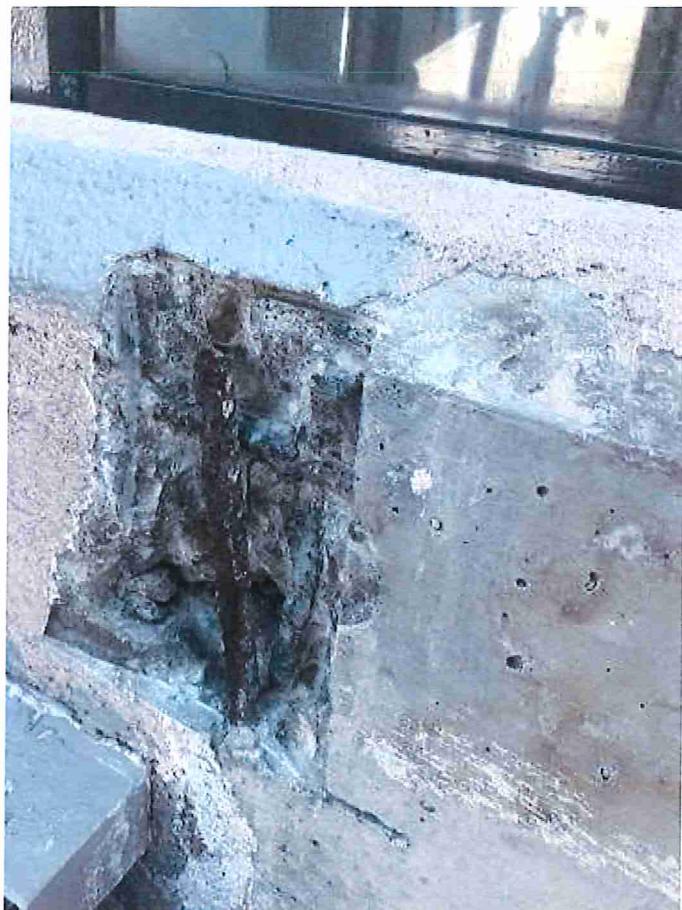
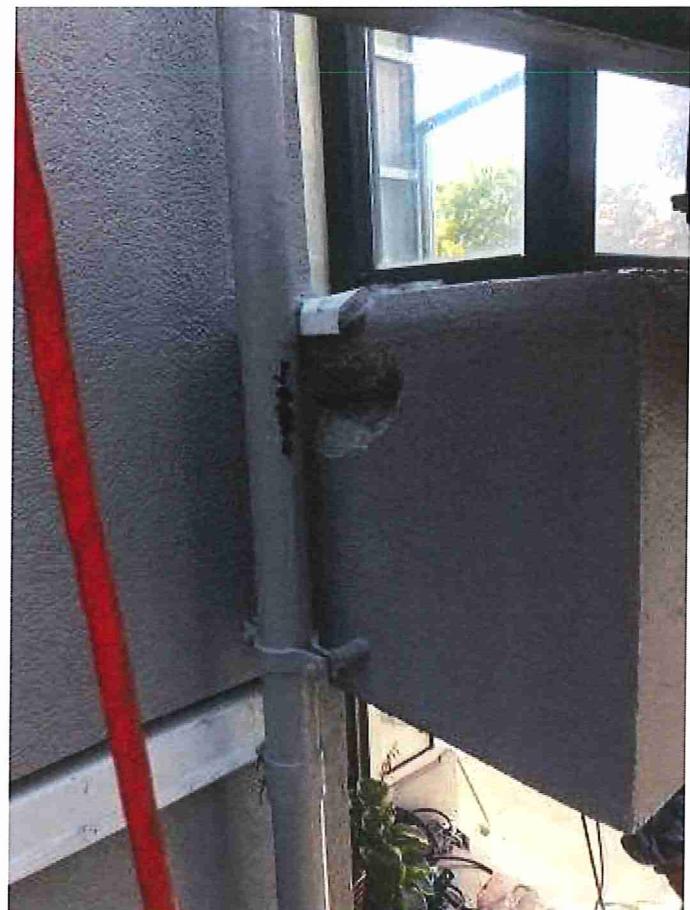
8.8 On the south elevation drop, numerous concrete repairs were required due to reinforcing steel with insufficient concrete cover. The steel began to rust resulting in spalling concrete. The contractor has been making repairs at the direction of SEE with their progress photos attached to this item (Photos No. 8.9 to 8.18).

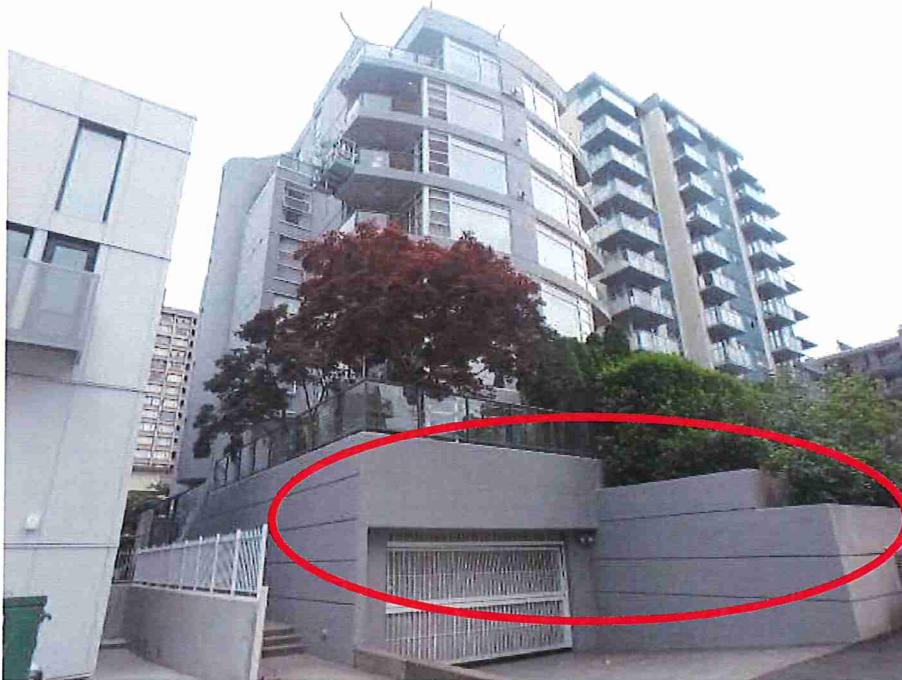
Photo No. 8.19

8.9 On the west elevation at the side yard walkway the walls have been painted with good finish observed. Many rout and caulk repairs have been completed in the exterior concrete walls (Photo No. 8.19).
