OBSERVATION REPORT

Project: **Strata Plan LMS 280 – Chateau Comox** File No. **S18-558**
1272 Comox Street Report No. **9**
Vancouver, B.C. Date: **Aug 12, 2019**

ITEM: Building Envelope Field Review

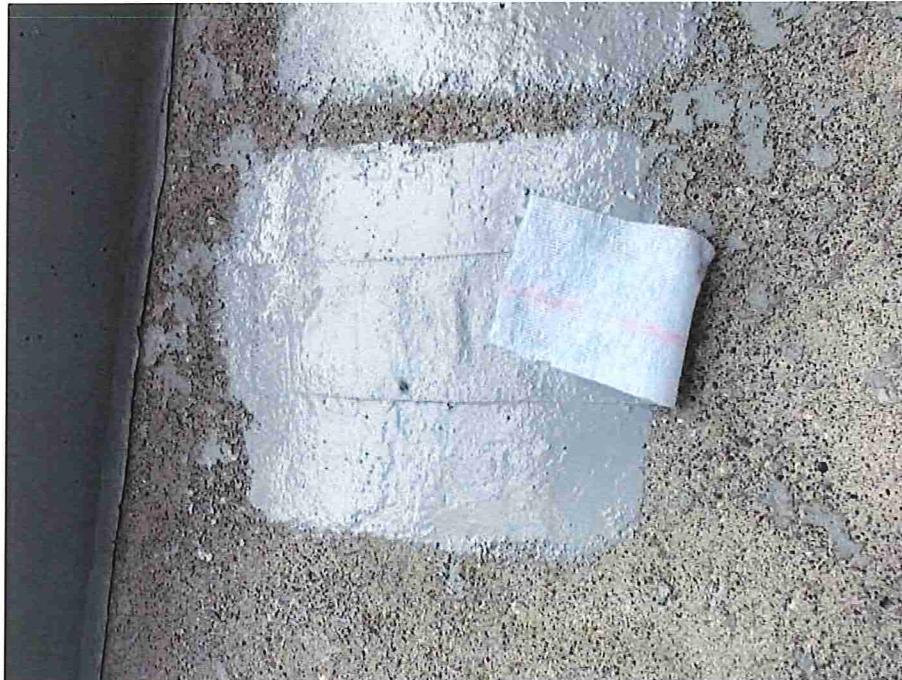
Photos No. 9.1 and 9.2

9.2	Upon arrival, a test strip of reinforcement fabric sandwiched by two base coat layers was mocked up for a pull test at Unit No. 602 (Photo No. 9.1). The system specified for balcony surfaces is Tremco Vulkem 360NF Waterproof Traffic Deck System. Because of potential adhesion failures on these balconies due to substrate preparation issues, this pull test would determine if the system will fail through adhesion, the bond between the base coat and substrate. It was noted that the concrete surface was devoid of large cavities or existing coatings, and was sufficiently clean for membrane application.

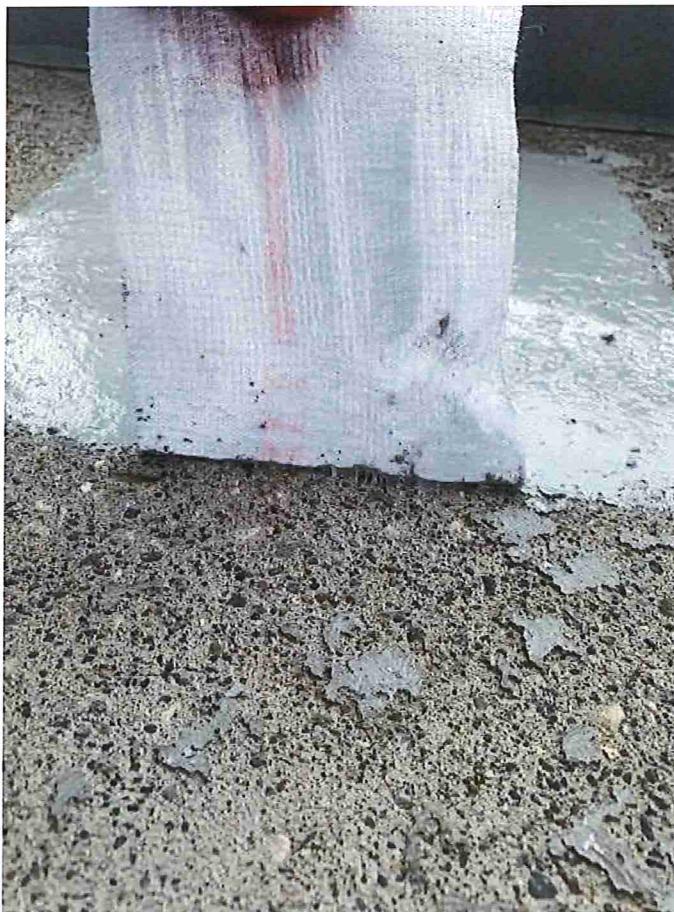
9.3	While pulling the reinforcement fabric upwards at a 90° angle, the mode of failure for the system was evidently the tensile ripping of the reinforcement fabric (Photos No. 9.2 and 9.3). As the adhesion of the substrate exceeds the cohesion of the system, the mode of failure was not the adhesion of the base coat to the substrate, SEE confirms that the pull test meets requirements for installation.
