OBSERVATION REPORT

Project: **Strata Plan LMS 280 – Chateau Comox** File No. S18-558
1272 Comox Street Report No. 10
Vancouver, B.C. Date: Aug 15, 2019

ITEM: Building Envelope Field Review

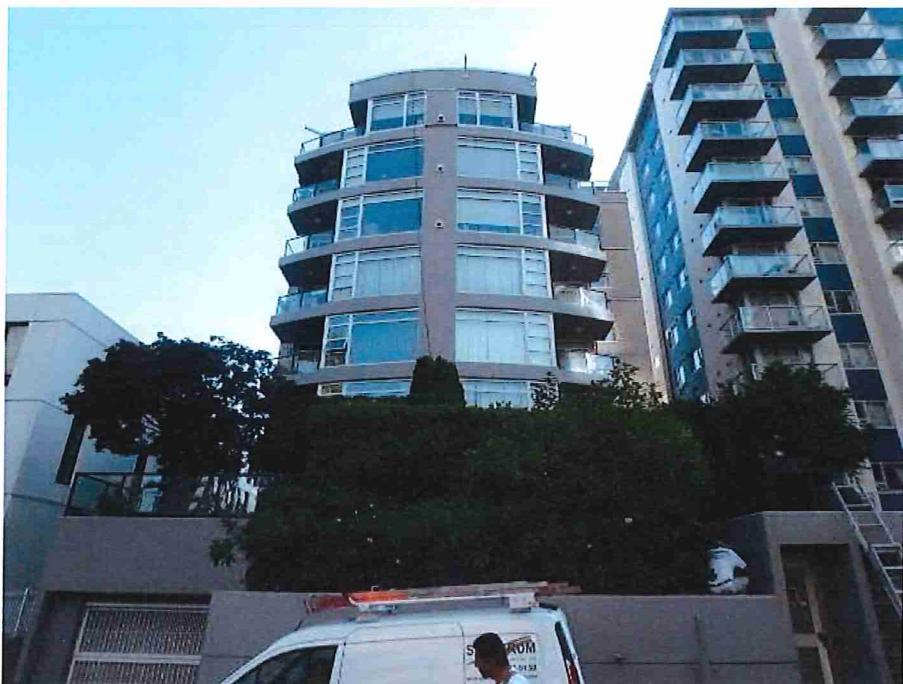
Photos No. 10.1 and 10.2

10.2	Painting and caulking work is nearly complete on the south elevation. The contractor has installed Dow Corning 123 Tape at all horizontal stucco expansion joints as required. The silicone tape spans across the vulnerable metal stucco expansion joint which had been observed to be rusty and failing on our condition review from last year. The lower edge of the silicone tape is provided with intermittent weeps which will allow any water which potentially gets behind to drain out. The tape is well installed over the uneven surface with no excessive bulging or wrinkling observed (Photos No. 10.1 to 10.3).

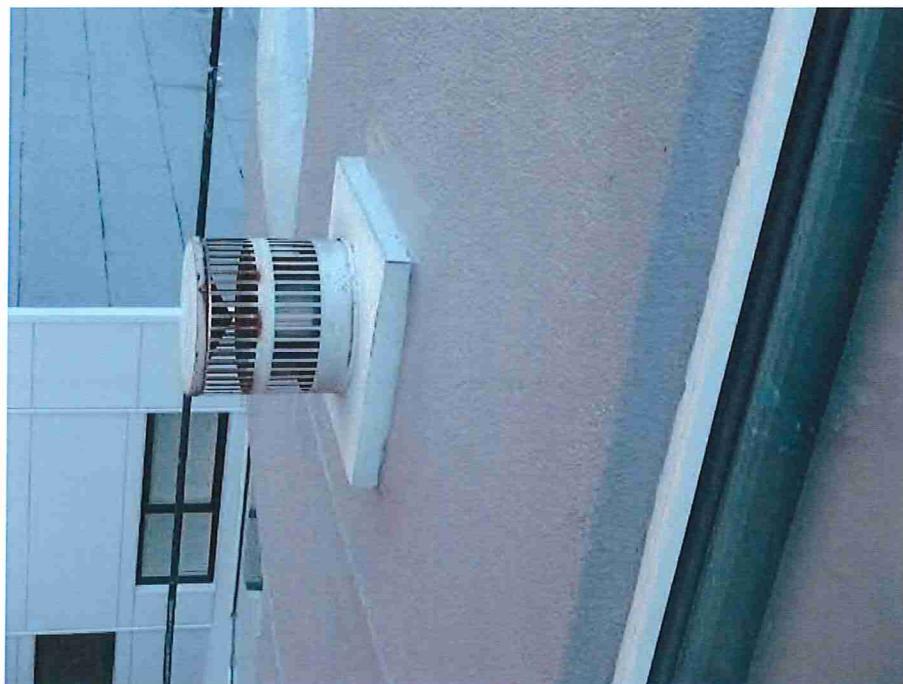
10.3	At the top of the drop, there are three fireplace vents, two of which are installed in original face sealed construction. Silicone 123 Tape is required at the head and jambs of the lower two vents (Photo No. 10.4).

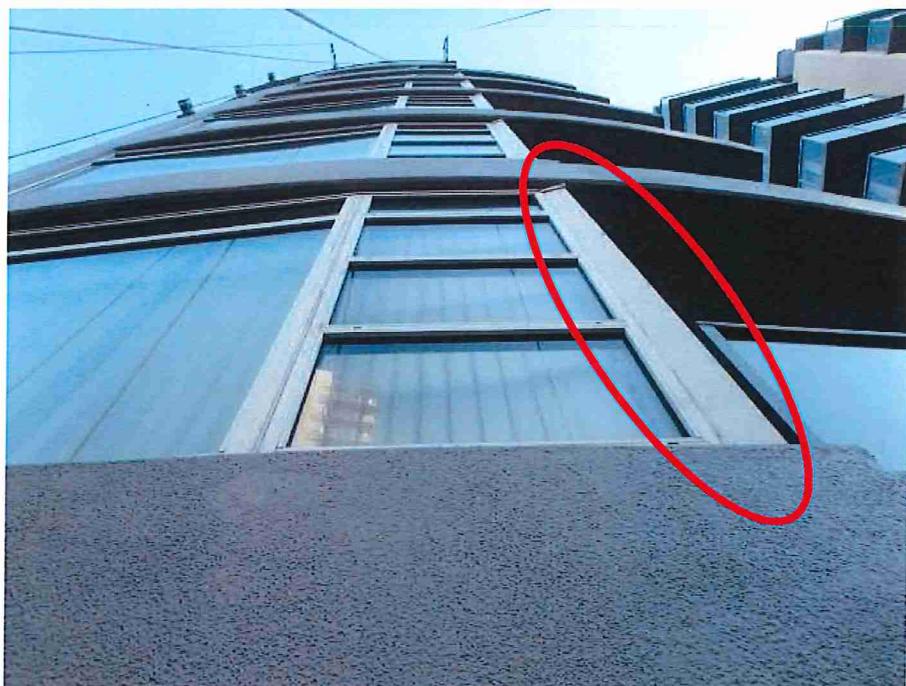
Photos No. 10.5 and 10.6

10.4	At the southeast corner of the drop, caulking replacement is also required at the vertical joint between the window frame and corner flashing. The existing caulking must be removed and replaced with new. SEE requested the contractor apply sufficient pressure and caulking so that the material is injected between the mating surfaces to provide strong adhesive bond (Photo No. 10.5).

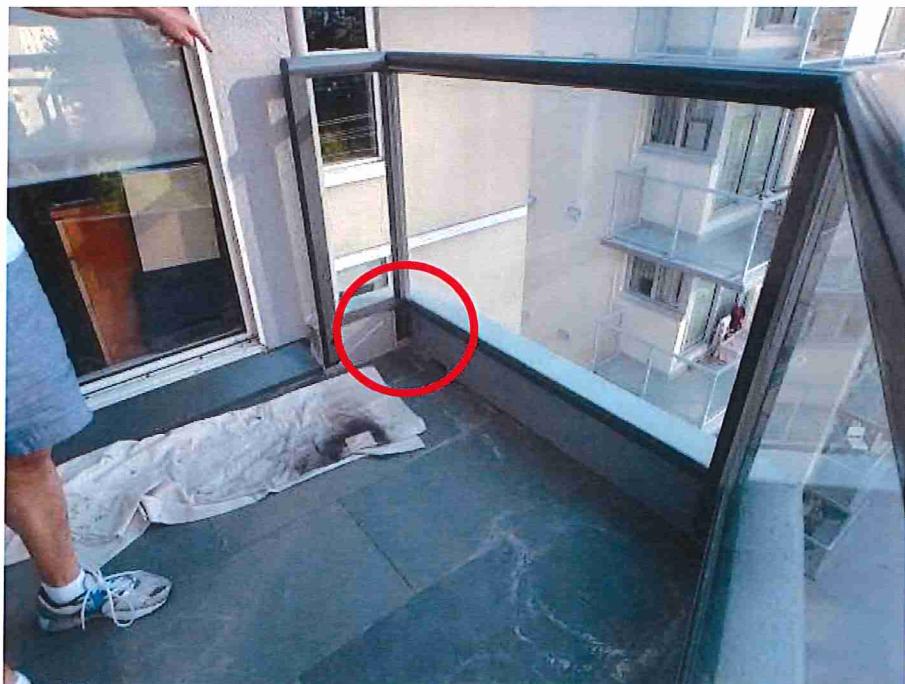
10.5 At Suite No. 702, acrylic stucco patching is required on the interior face and top horizontal surface of the balcony parapet (Photos No. 10.6 and 10.7).

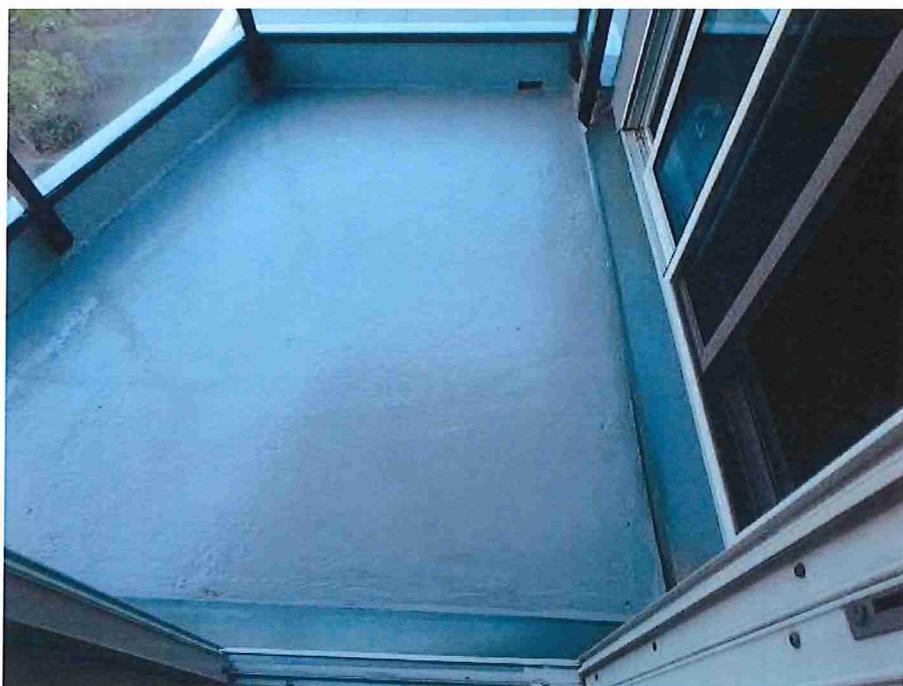
10.6 At Suite No. 602, the membrane base coat has been reapplied to the balcony with good workmanship observed (Photo No. 10.8).

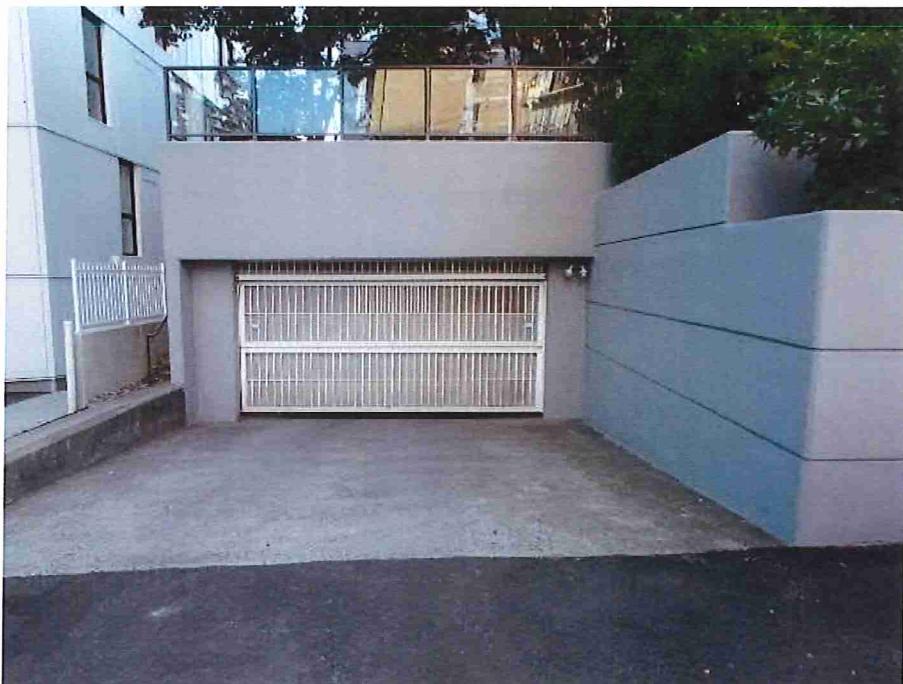
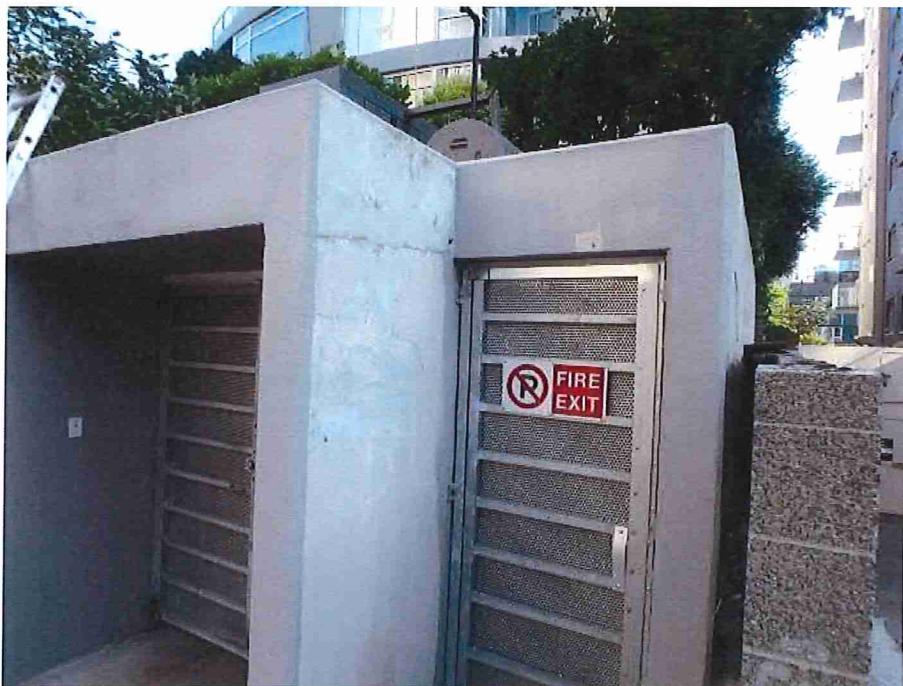
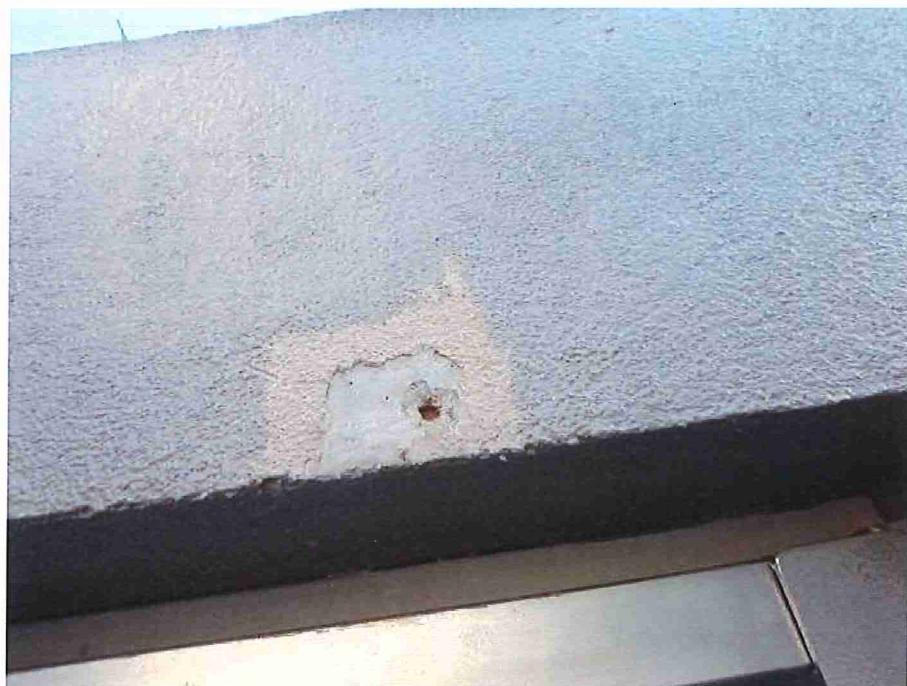
10.7 At the time of review, painting work was underway at the exterior walls facing the alley. Several locations with peeling acrylic finish have been uncovered and are in the process of being repaired. Typical rebar ends will be ground clean, primed, and covered with caulking prior to refinishing. Work in progress is good (Photos No. 10.9 to 10.11).
