OBSERVATION REPORT

Project:	Strata Plan LMS 280 - Chateau Comox 1272 Comox Street Vancouver, B.C.	File No: S18-558
Client:	Strata Plan LMS 280 - Chateau Comox c/o Southview Property Management 110 - 7580 River Road Richmond, B.C. V6X 1X6	Report No: 11 Date: Sep 11, 2019 Weather: Overcast, 17°C
Attention:	Mr. Kevin Green Chateau Comox Strata Council Mr. Chris Clark Mr. Don Davidson Mr. Kevin Wice	kevingreen@telus.net chateaucomox@gmail.com dcclark333@gmail.com dondavidson67@yahoo.ca krw@krw.ca
Contractor:	Spectrum Painting Ltd.	
Attention:	Mr. Adam Racanelli Mr. Sam Zukanovic	adam@spectrumpaintingltd.com sam@spectrumpaintingltd.com

ITEM: Building Envelope Field Review

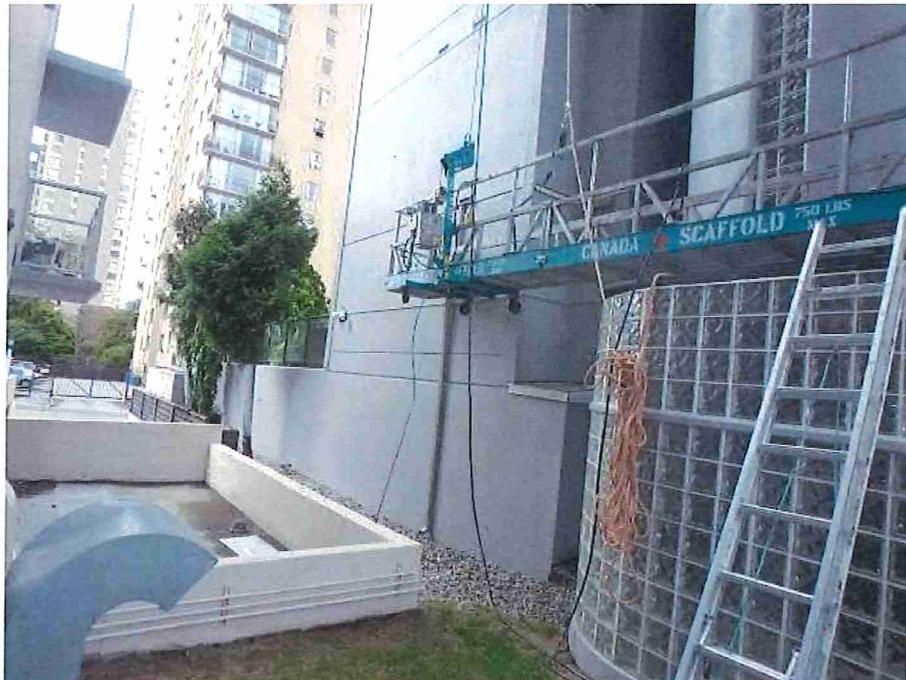
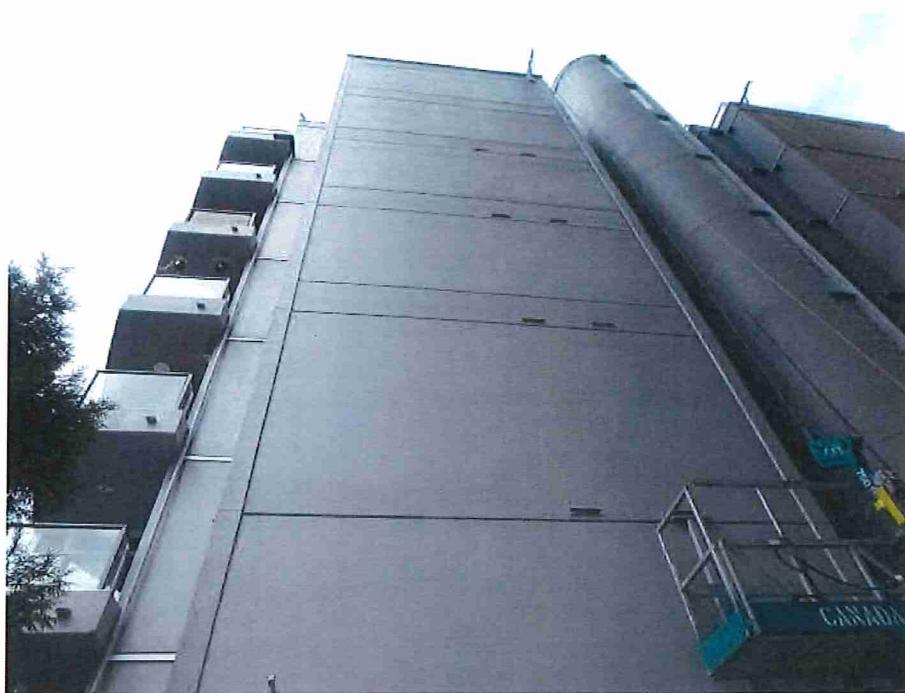
Photos No. 11.1 and 11.2

11.2	Work is now complete on the south half of the east elevation with good workmanship observed. New caulking has been applied and tooled to a smooth finish between the replacement stucco and existing exposed concrete (Photos No. 11.1 to 11.3).

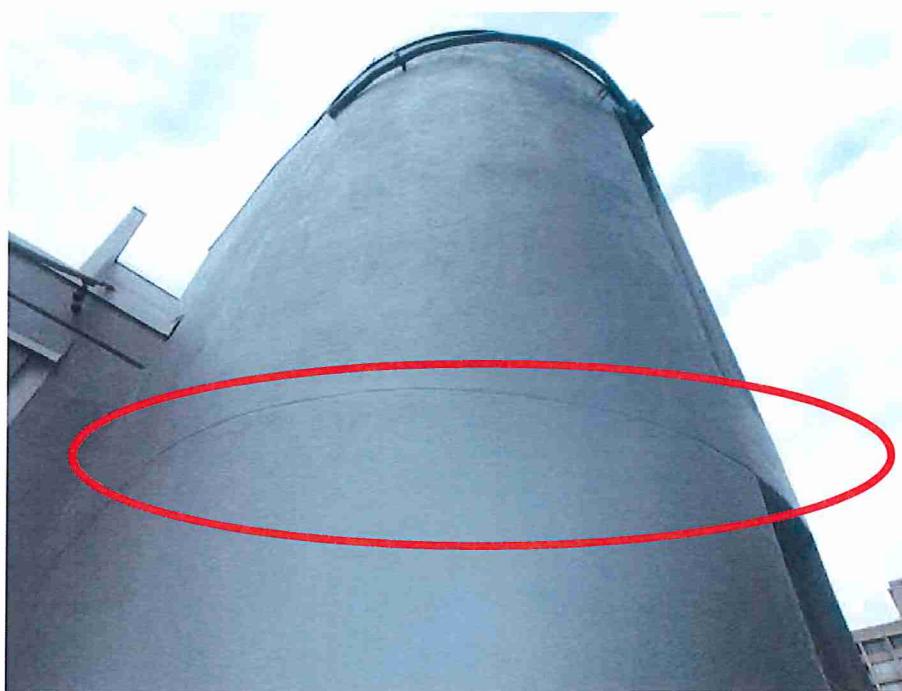
Photos No. 11.3 and 11.4

11.3	Floor line reveals, not previously caulked on the stairwell barrel wall, typically result in leaks to the interior. SEE instructed Spectrum Painting to apply new polyurethane caulking to each point. Where accessible from the swing stage, work will be done from the current drop. The returning portions of each joint will be accessed via Bosun's chair and work will be completed at hourly rates (Photos No. 11.4 and 11.5).

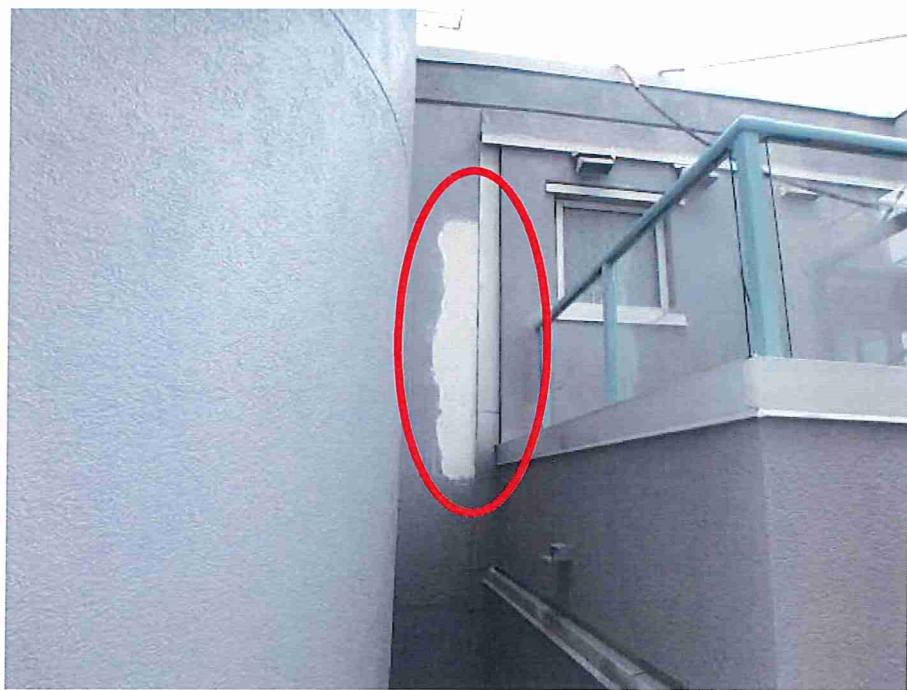
Photos No. 11.5 and 11.6

11.4 Stucco repairs continue to be done as loose areas are identified. At the base level of the east exit stairs there is failed acrylic stucco finish which has been scraped. It appears the stairs were faired with interior drywall compound which is relatively soft and susceptible to future water damage. Given the concealed location and limited visibility, SEE instructed Spectrum Painting to not reinstate new stucco finish but rather blend the edges of the removed areas and repaint over (Photos No. 11.6 to 11.8).

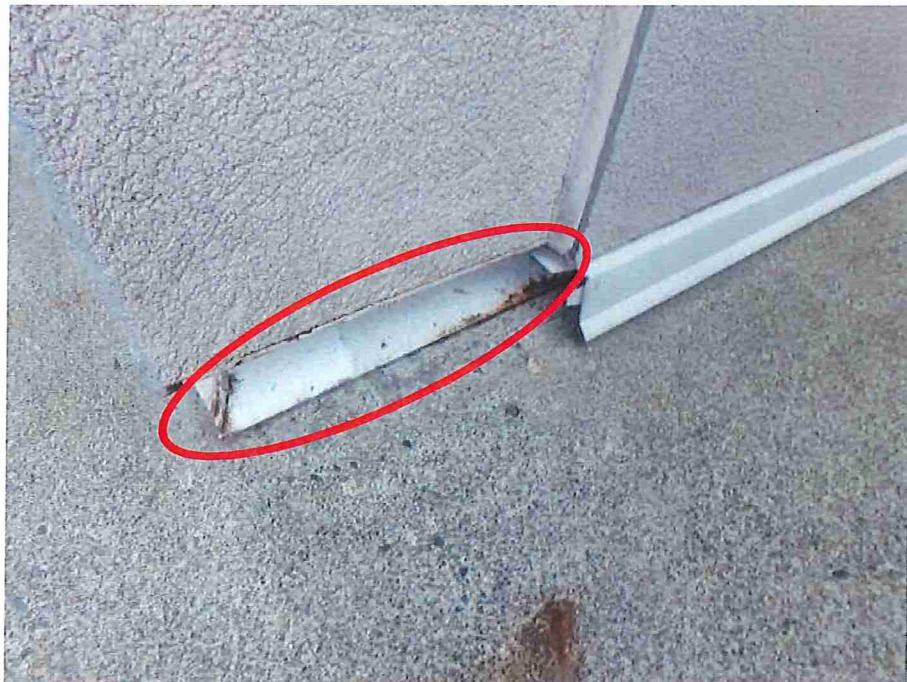
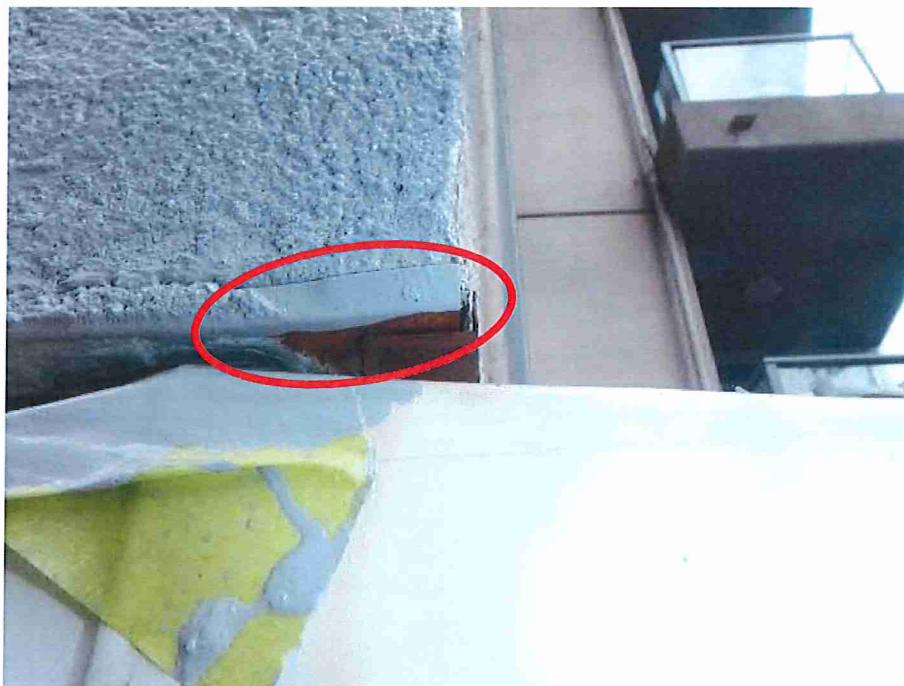
Photos No. 11.9 and 11.10

11.5 At the next drop located on the east elevation at the north corner, repainting of some metal flashings where rusted is required as is repainting of stucco J-beads (Photos No. 11.9 and 11.10).
