Strata LMS 280 - 1272 Comox Street

by Inter-Provincial Roof Consultants Ltd.

April 28, 2008

Job Ref. No.: 08-109 S

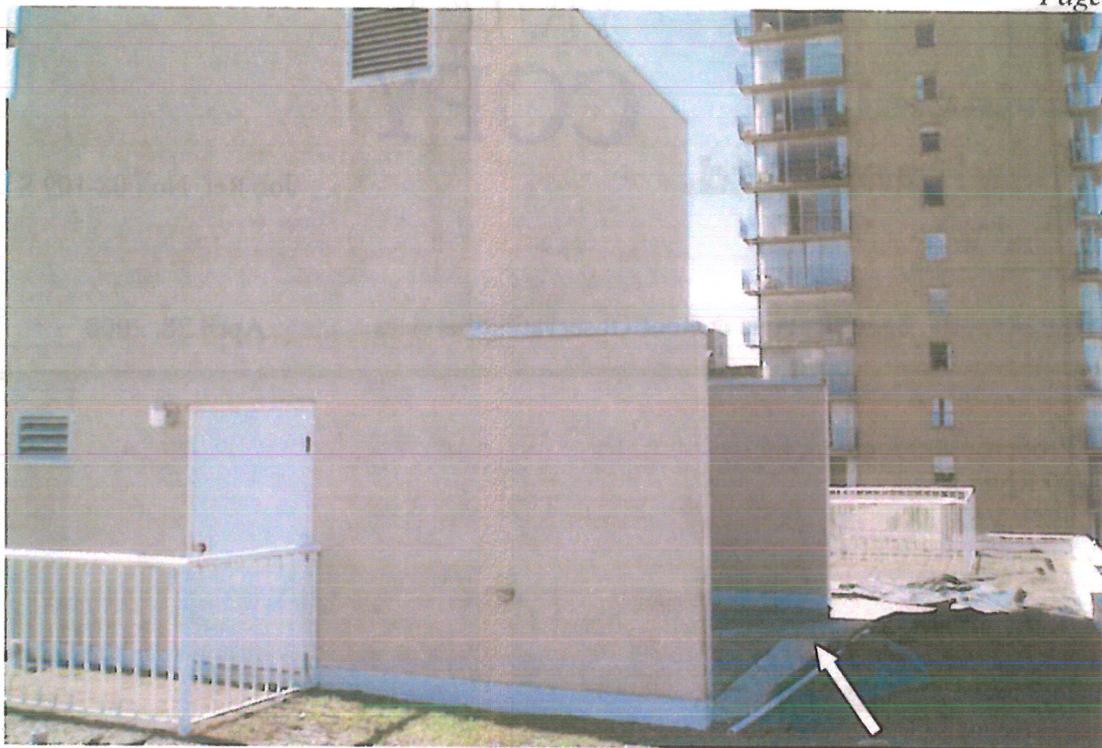
1 – This overview shows the main roof area as well as the upper elevator shaft roof. Notice the large area where the insulation and ballast has been removed in an attempt to locate the source of ingress in # 802. Also notice the paving stones and the metal railings which have been incorporated into the roof assembly.

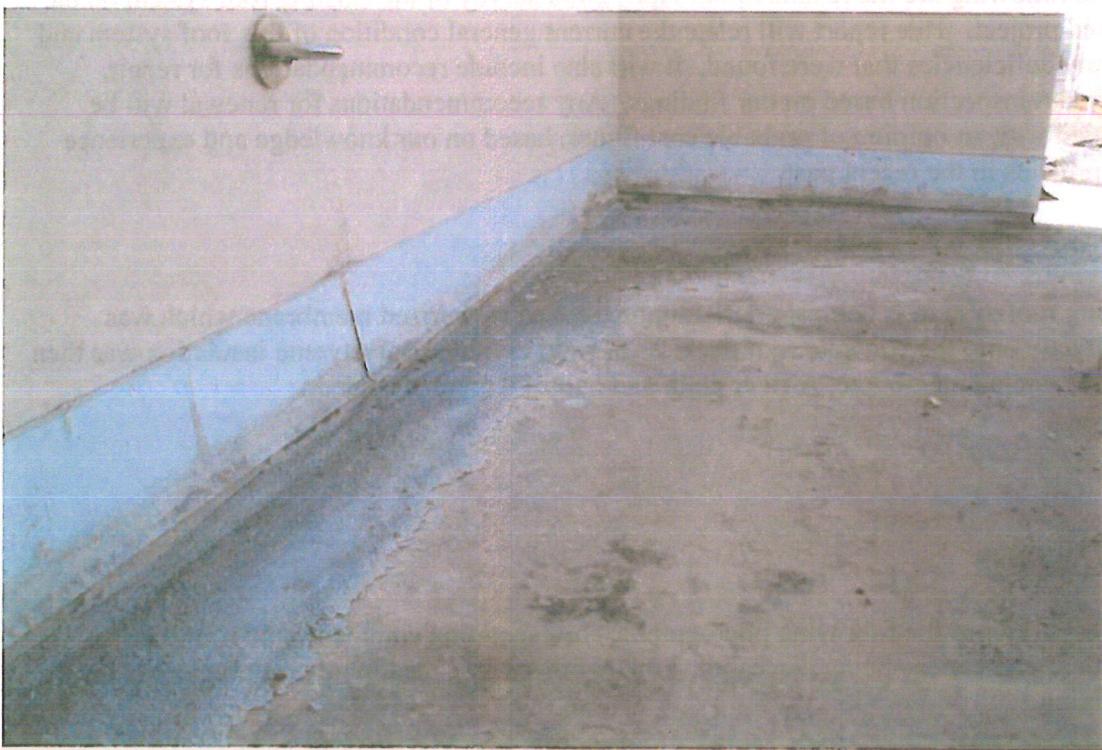
2 – This photo shows a large amount of dry portland cement which was probably spread out in an attempt to prevent ingress during inclement weather. Although this product is commonly used for this application it is considered to be a temporary correction at best. Other products would be better suited for temporary repairs on this type of roof membrane as removing it may prove difficult and result in excess damage to the roof system.

Several temporary repairs with dry portland cement are evident throughout the building. The cement may prove difficult to remove without causing extensive damage to the membrane.

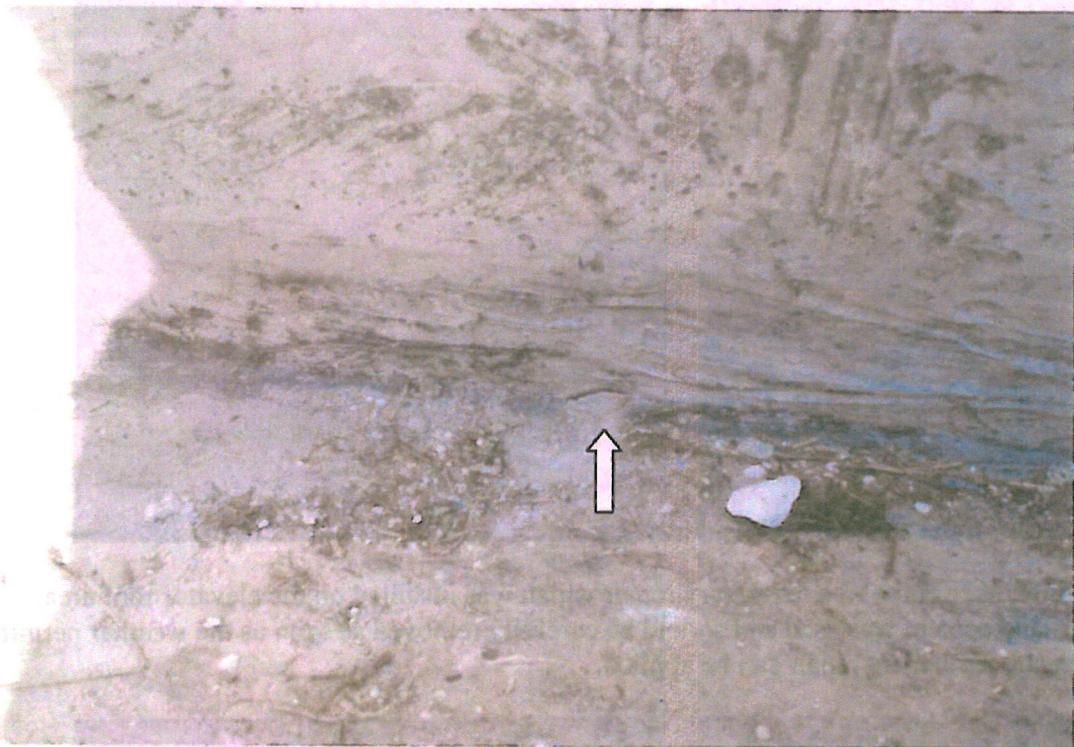
3 – This is a photo of a crack in the membrane. Typically a strip of reinforcement membrane is installed to all the transitions in the uprights during the original membrane application. This photo of the upper elevator shaft roof indicated no membrane was present. This hole in the membrane could potentially allow water to ingress the building.

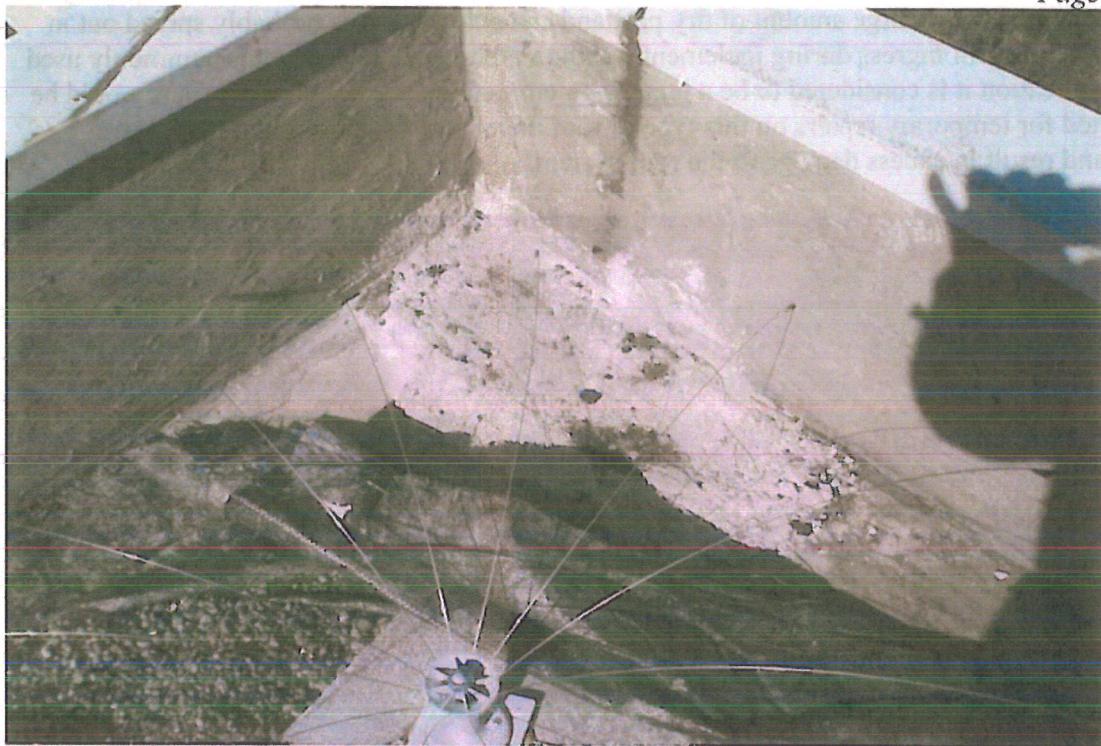
4 – This is another photo of a temporary repair which was installed on the elevator roof area. Again portland cement was used and should be carefully removed as soon as the weather permits so an adequate permanent repair can be applied.

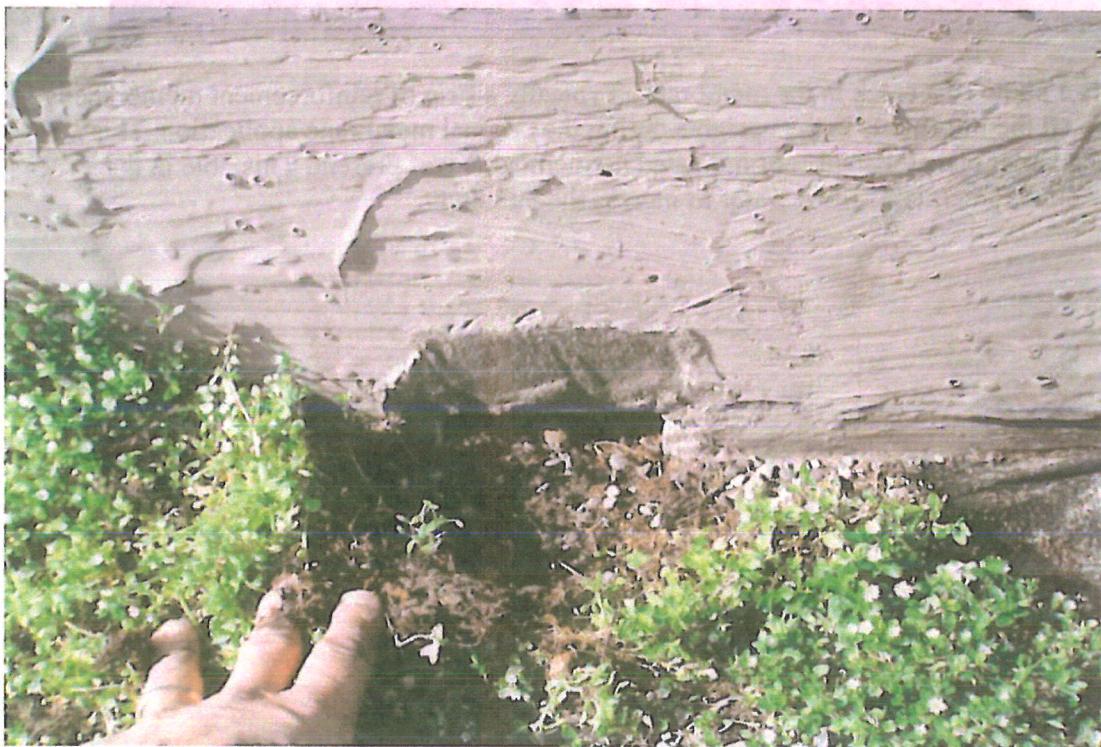
5 – The roof surface of the elevator shaft roof is completely covered with organic debris. The scupper drain which services the roof system is restricted with debris which could impede drainage from this roof area resulting in water ingress to the building.

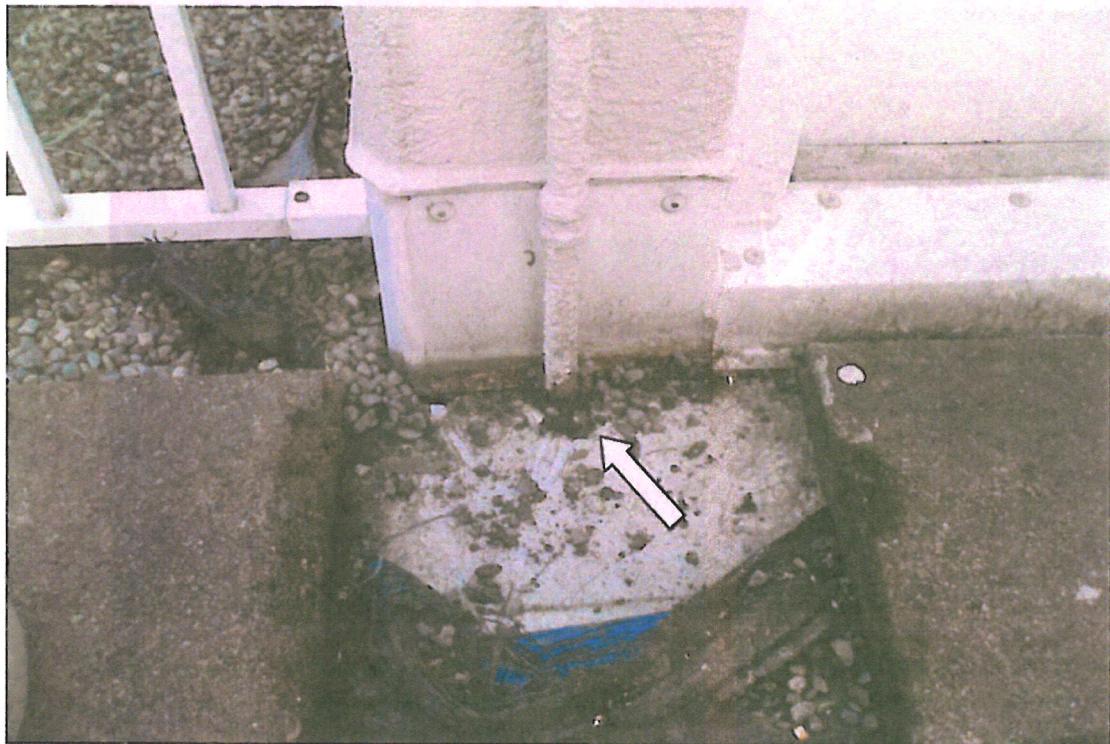
6 – The insulation was not removed as it may have resulted in damage to the roofing membrane. It appears that two electrical conduits like the one shown in this photo extend through the deck and are reliant on the rubber membrane to remain watertight. This should not be considered a reliable seal and could result in water ingress. Also notice the corrosion on the conduit as well as the bottom edge of the flashing.

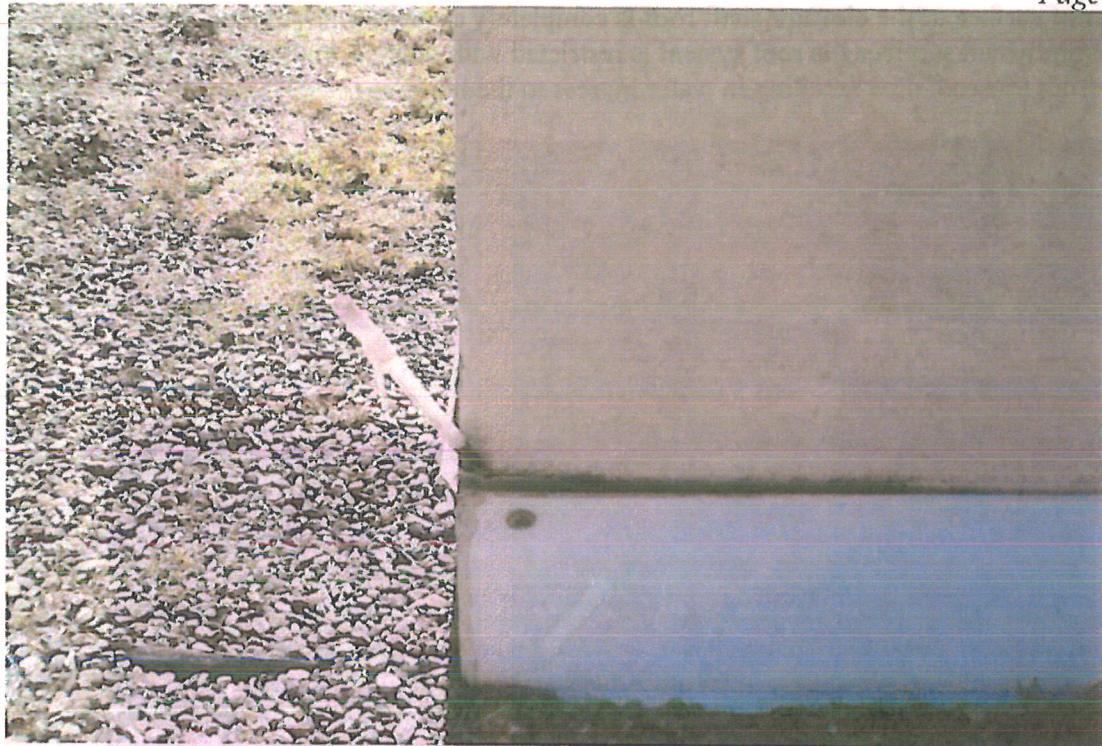
7 – The solvents in the caulking have dried out and as a result the caulking has shrunk and cracked. Water ingress through this flashing could attack the leading edge of the membrane and enter the building.

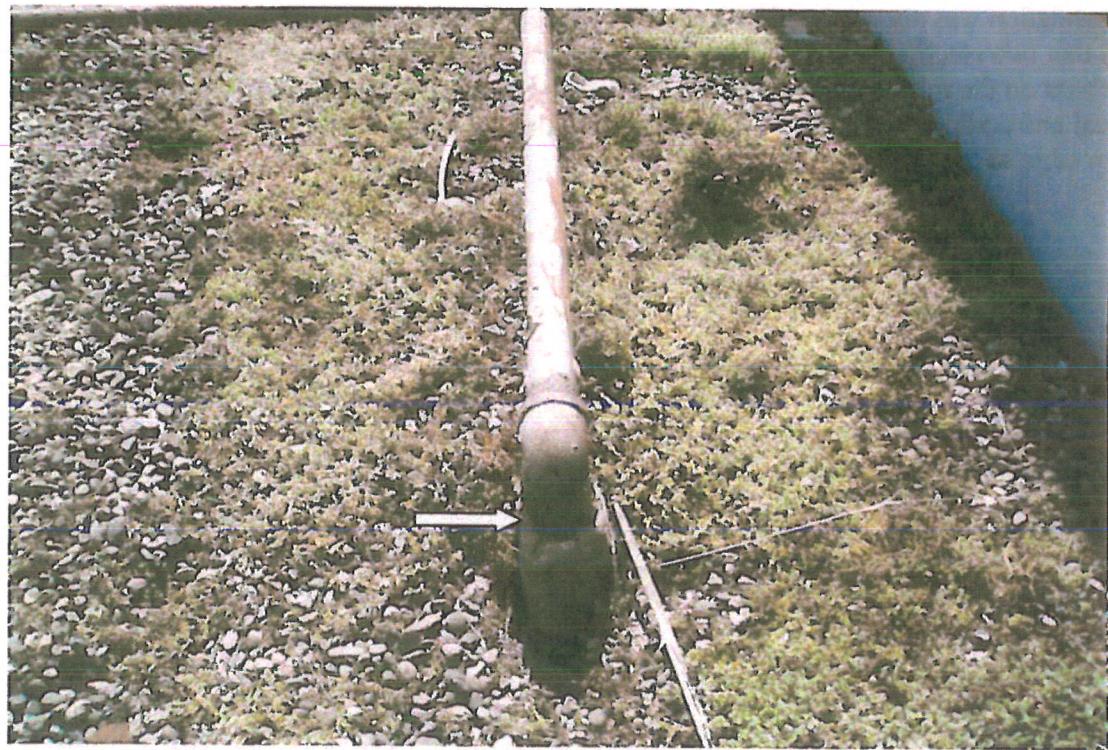
8 – The top edge of the flashing which services this gas line is approximately 3 "off the finished roof surface and sealed with deteriorated caulking. This has a high potential to allow water to

ingress the building. The gas line appeared to be capped off so eliminating the line and flashing may be a possibility. A licensed gas fitter may need to verify that the gas has been shut off before it can be eliminated.

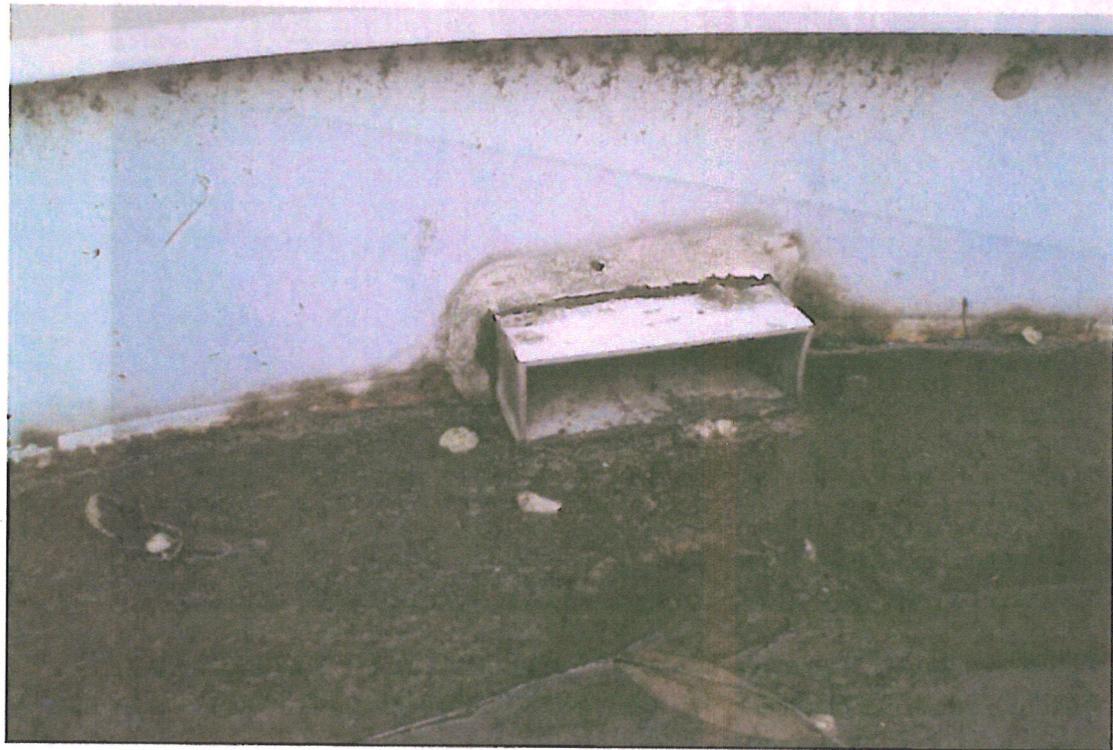
9 – This photo of the stairwell roof shows an aluminium sleeve which appears to have been installed into the scupper drain hole. It does not appear to be sealed with membrane only a bead of caulking around the flashing. The caulking on the outside of the flashing would do very little to prevent water from flowing under the flashing and attaching the seal on the scupper. Also notice the corrosion that has developed on the bottom edge of the flashing.

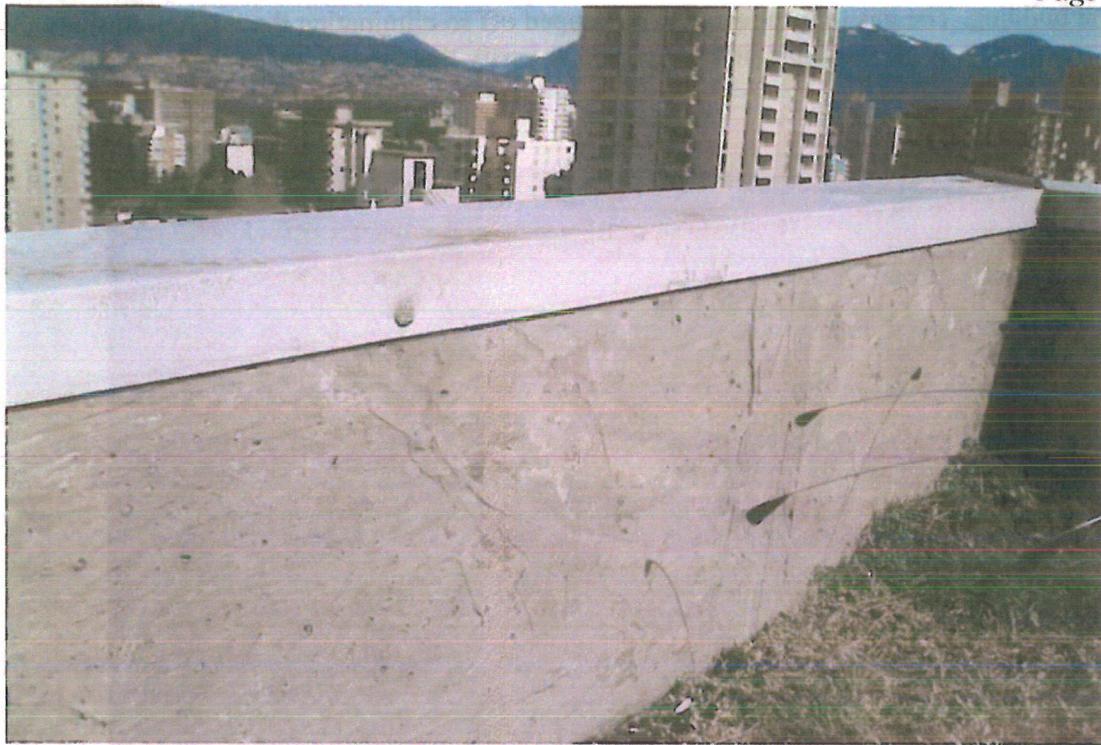
10 – The rubber membrane on some of the walls is very thin which has resulted in exposed concrete. Again these areas have potential to allow water to ingress the building.

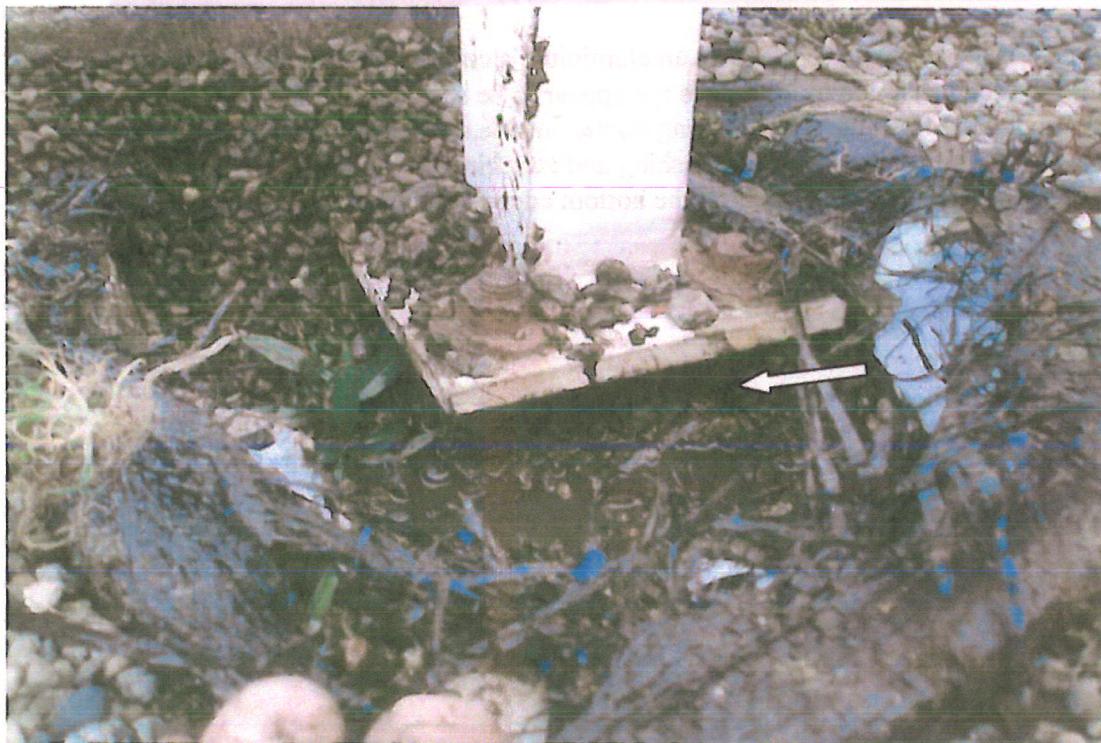
11 – The aluminium rails which surround several of the areas on the main roof were installed directly into the roofing membrane. The bolts which support it have suffered extensive corrosion

and no longer have a reliable seal to the membrane. This design should be considered poor and could potentially allow water to ingress the building.

The supports for the aluminium rail were installed directly through the rubber membrane which should not be considered a quality detail and offers a high risk of water ingress to the building as these bolts begin to corrode.

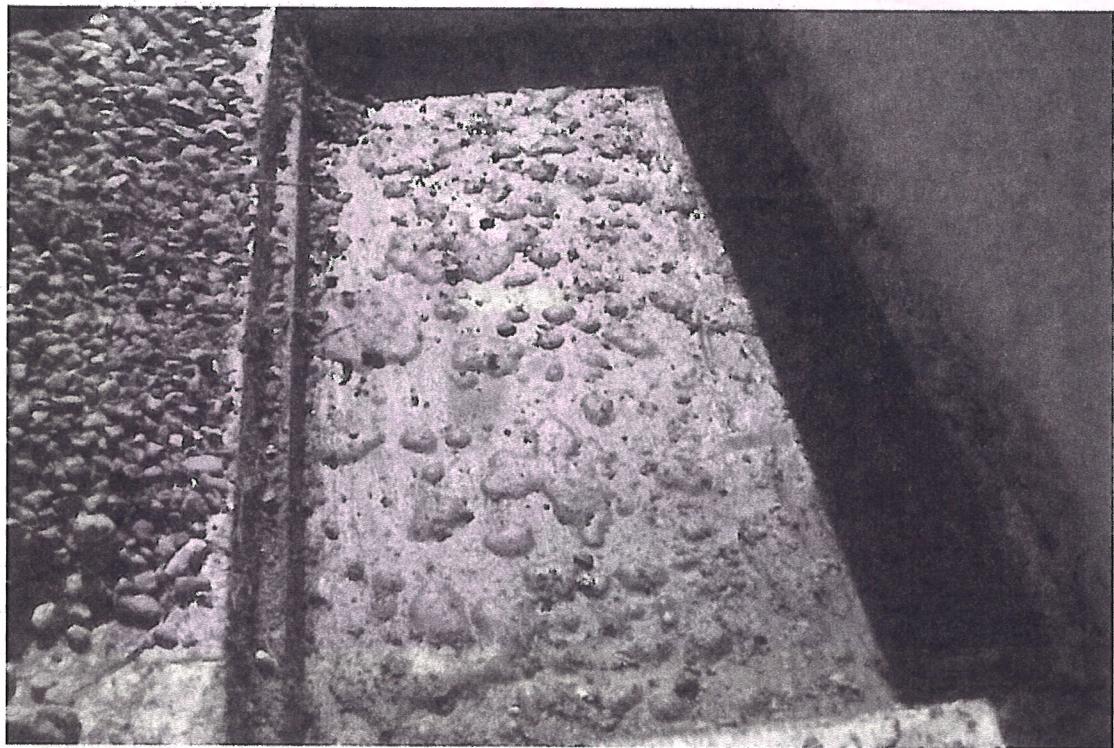
12 – The liquid applied rubber membrane which serves as this building's roof system is reliant on being fully bonded with the concrete substrate for its longevity and waterproofing integrity. Blisters such as the ones shown in this photo become easily ruptured potentially allowing water to ingress the building.

The membrane on this building is very thin with blisters developing in many areas. These blisters could potentially rupture like balloons under pressure and result in water ingress.

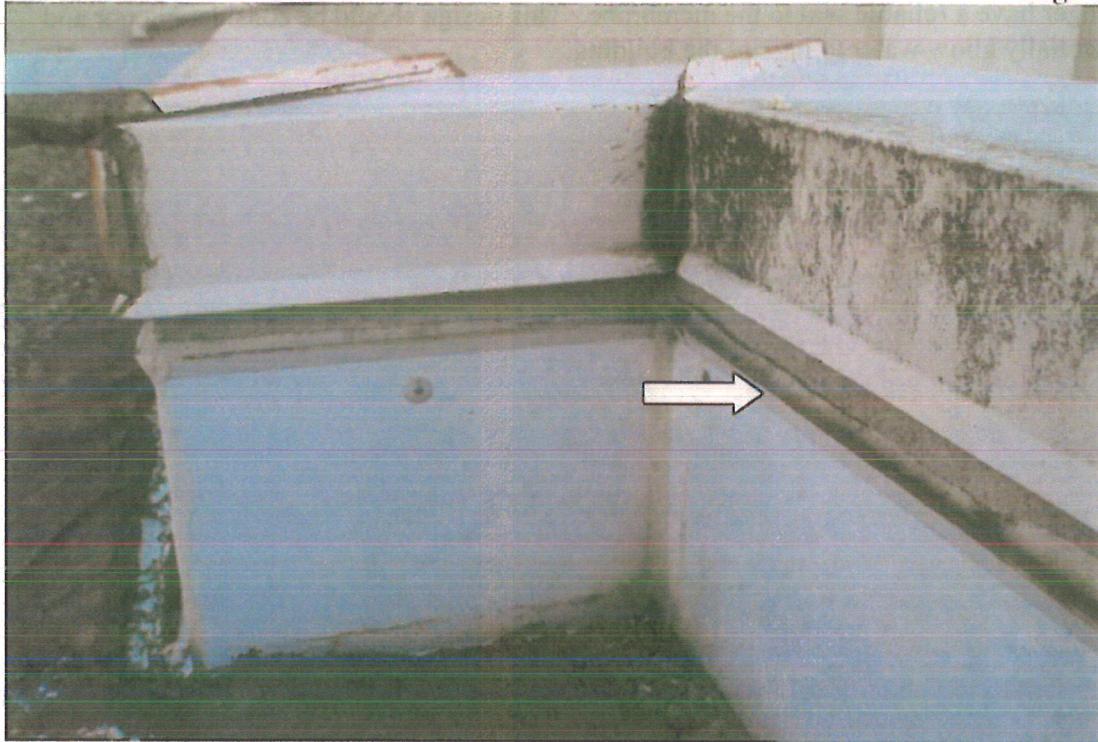
13 – The caulking which serves this wall flashing has shrunk and cracked which could potentially allow water to attack the leading edge of the roof system. Typically the wall flashing would extend up and under the edge of the cap flashing which would shed the water and eliminate the need for caulking. Again this should be considered a poor design.

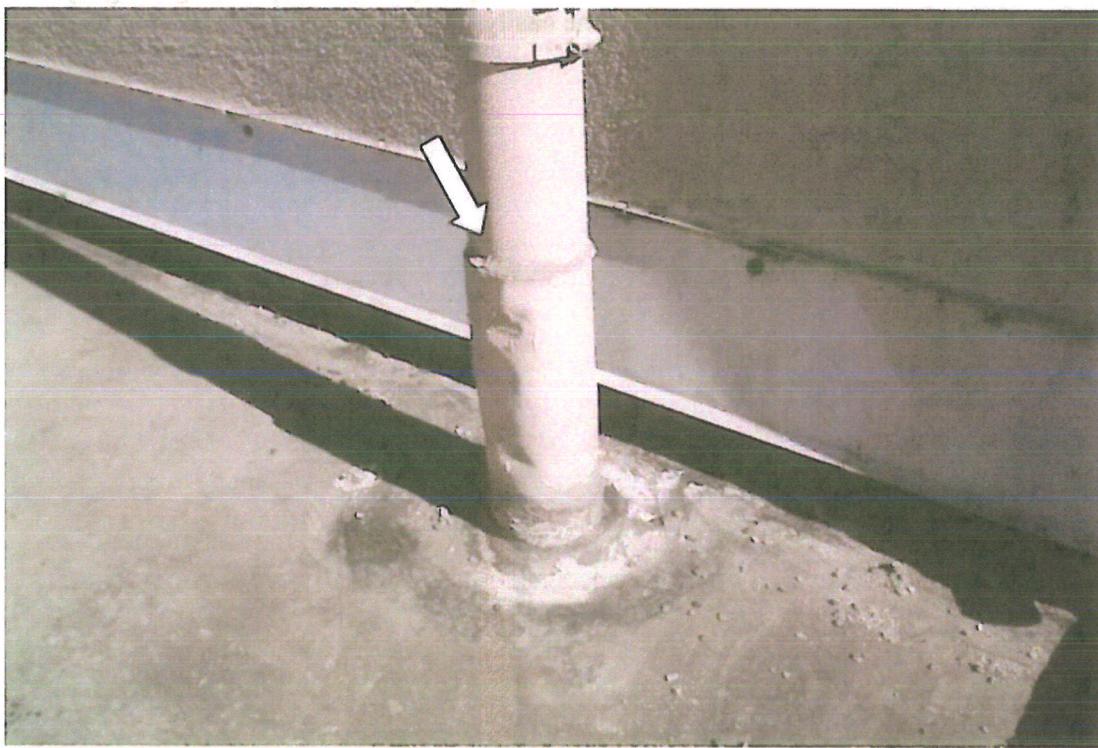
14 – A small amount of concrete can be seen around this plumbing vent flashing. As no permanent correction was observed this area may still be responsible for water ingress. The pipe was extended in order to eliminate odours from entering the building. This has resulted in this pipe becoming reliant on caulking to remain watertight. This deteriorated caulking could potentially allow water to ingress the building.

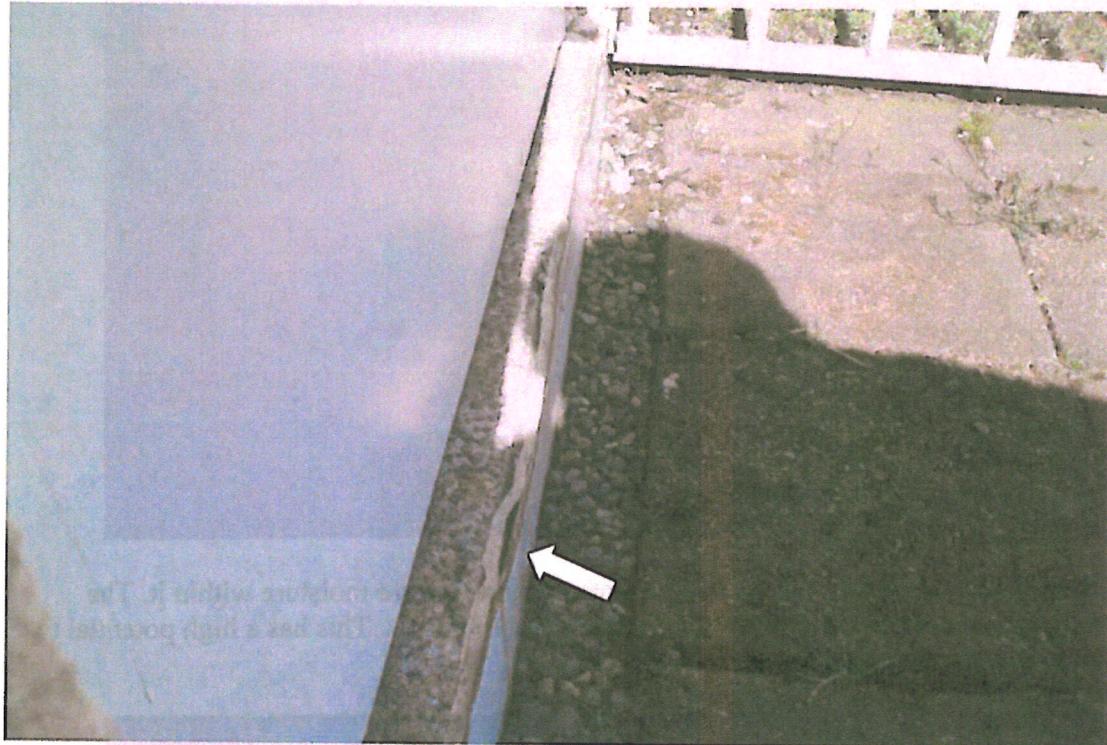
15 – The caulking used to seal the flashing to this doorway threshold is no longer bonded and could potentially allow water to ingress the flashing and attack the leading edge of the roof system.

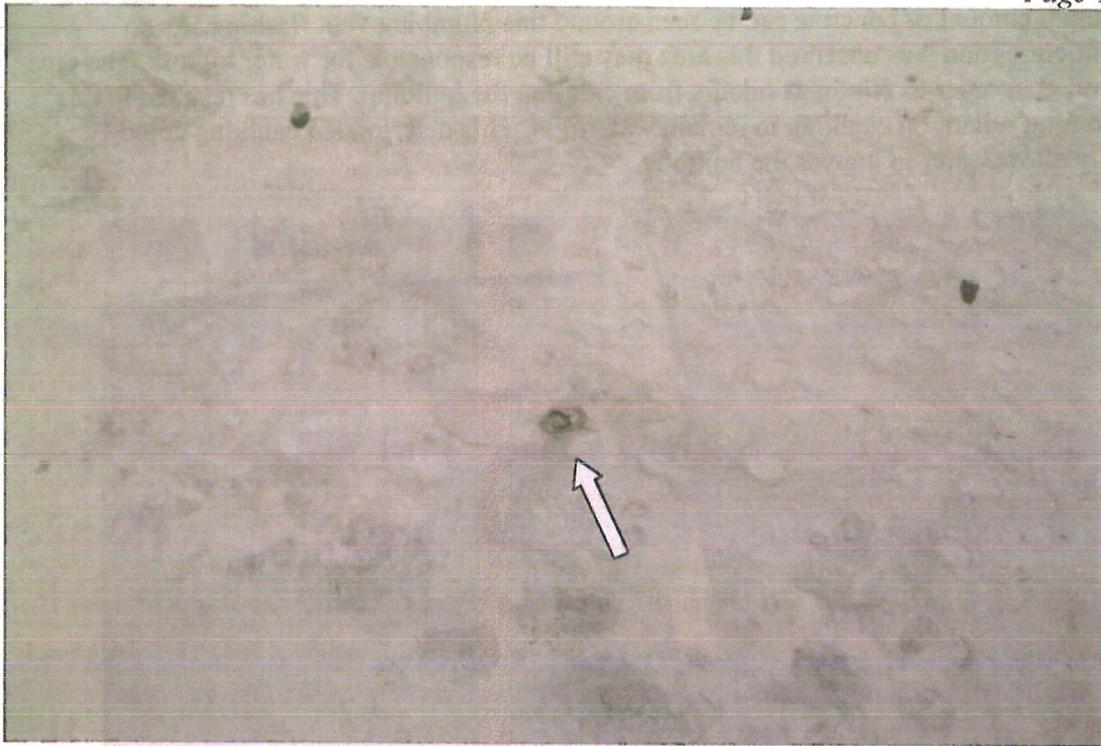
16 – The hole in the membrane shown in this photo appears to have moisture within it. The membrane in this area appeared to be very thin with several blisters. This has a high potential to allow water to ingress the building.

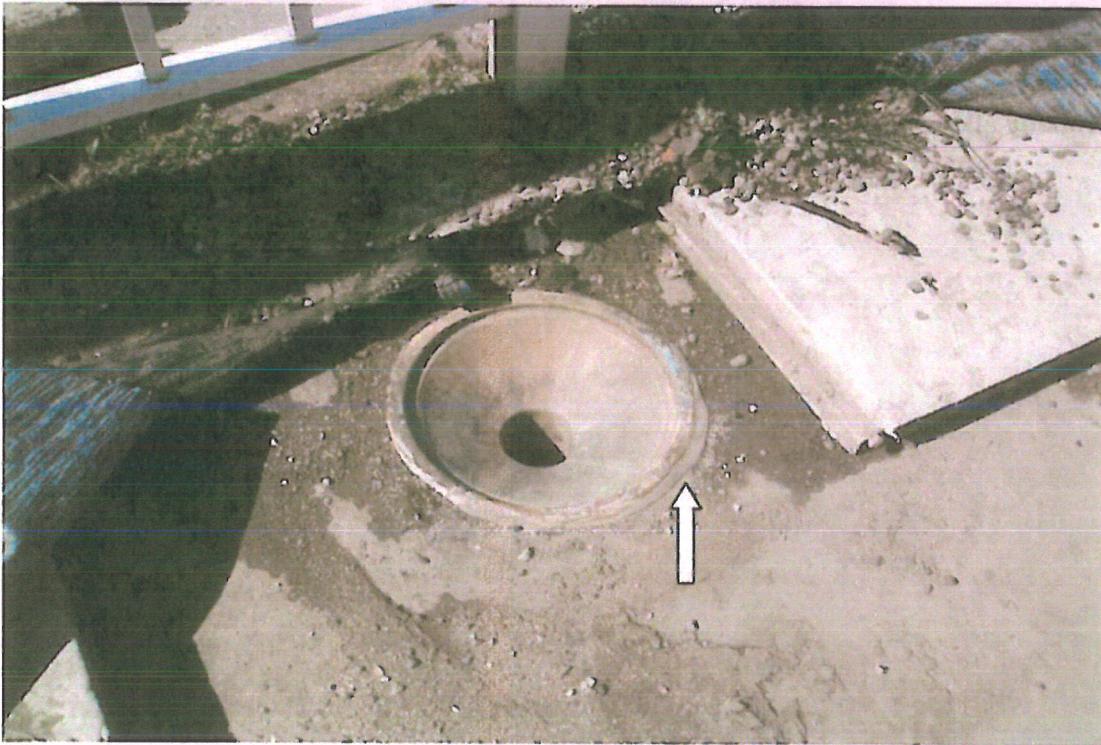
17 – The drain shown in this photo is part of the area which was cleared off in order to locate the source of water ingress. The drain screen was removed and could potentially allow debris to

enter the drainage pipes resulting in blockages in the pipes. This could result in costly repairs to the pipes as well as interior damages. Also notice the bead of caulking which was installed to the edge of the drain.

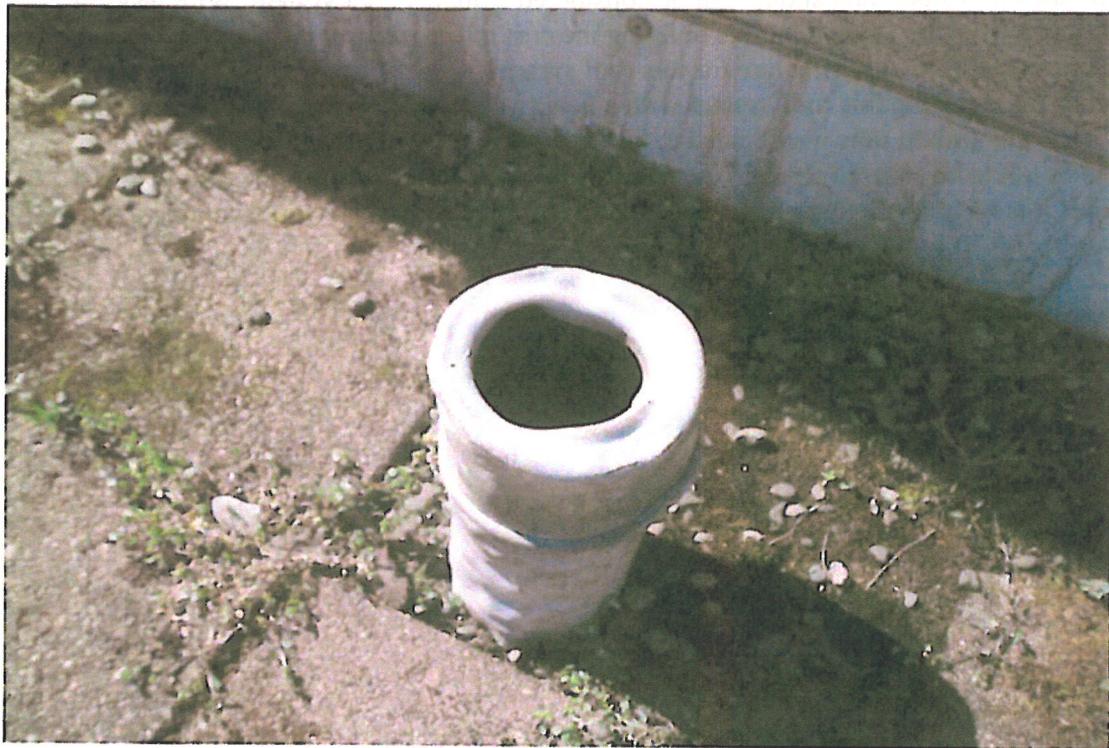
18 – Several of the settlement caps do fit correctly which could result in water ingress between the pipe and the flashing.
