MINUTES OF COUNCIL MEETING
STRATA CORPORATION LMS 280 CHATEAU COMOX
HELD ON MONDAY MARCH 11TH, 2024 AT 7:00 P.M.
MEETING ROOM 1272 COMOX STREET, VANCOUVER BC

Engineering Investigation

Parkade Condition Assessment

Chateau Comox

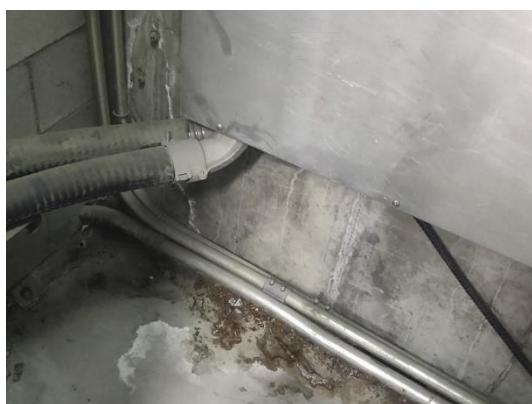
Figure 7

<p><u>Location:</u> Between first and second floor of the parkade.</p> <p><u>Defect:</u> Efflorescence deposits.</p> <p><u>Remarks:</u> Efflorescence deposits indicate moisture is penetrating the foundation wall.</p>
--	--

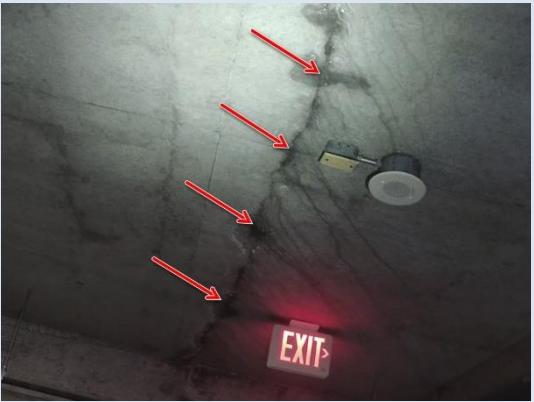
Figure 14

<p><u>Location:</u> Ceiling within the level 3 of the parking garage.</p> <p><u>Defect:</u> Active water ingress.</p> <p><u>Remarks:</u> The water ingress is originating from Level 1 above, which does not currently have a traffic coating.</p>

A traffic coating should be installed on the first floor level of the parking garage to protect the suspended slab from water ingress. Traffic coating should also be applied over various stairs leading to the parking garage as necessary. As part of a comprehensive parking garage waterproofing project.

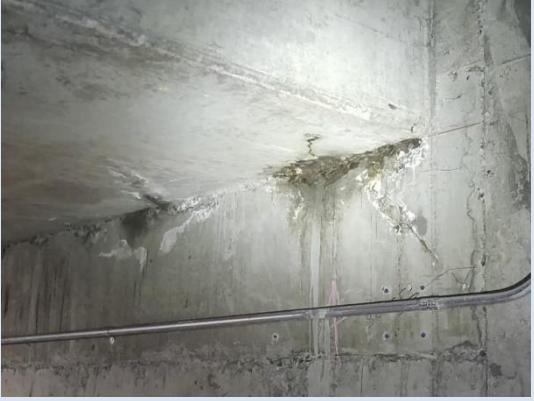
Figure 16

<p><u>Location:</u> Wall to ceiling transition of the second to third floor ramp.</p> <p><u>Defect:</u> Efflorescence and active water ingress.</p> <p><u>Remarks:</u> Active water ingress observed at the underside of suspended slab to foundation wall interface.</p>
---	---

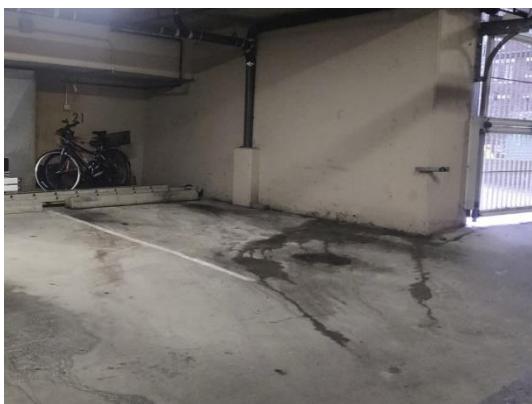
Figure 21

Photo	Observations
	<p><u>Location:</u> First floor-to-second floor ramp of the parking garage.</p> <p><u>Defect:</u> Active water ingress through the ceiling of the first floor trickles down the ramp towards the second floor.</p> <p><u>Remarks:</u> Water is infiltrating through the planters above, the water is then penetrating the slab and entering the third level below due to lack of a traffic coating.</p>

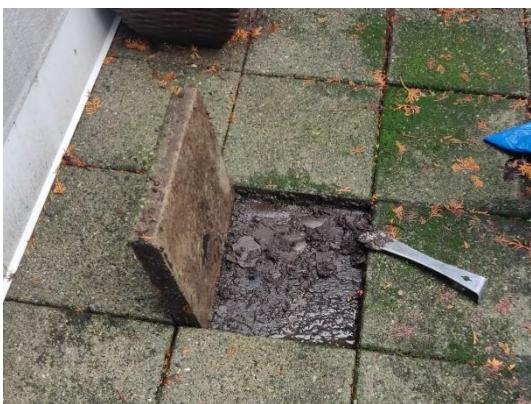
Figure 27

Photo	Observations
	<p><u>Location:</u> Unit 204 planters.</p> <p><u>Defect:</u> The waterproofing below the planters have failed, based on our observations of the membrane under the pavers.</p> <p><u>Remarks:</u> The membrane has failed systemically.</p>

While the concrete structure of the parking garage can sustain water ingress for a period before significant deterioration occurs, the waterproofing membrane has failed and should be budgeted for replacement within the next 2-5 years. This would require removal of all landscaping, pavements atop the footprint of the parkade including planter areas, and patios to access to the membrane.
