**OBSERVATION REPORT**

**Project:** **Strata Plan LMS 280 – Chateau Comox** File No. S18-558  
**1272 Comox Street** Report No. 3  
**Vancouver, B.C.** Date: May 23, 2019

**ITEM: Building Envelope Field Review**

**STRATA PLAN LMS 280 - CHATEAU COMOX**  
**1272 COMOX STREET, VANCOUVER, B.C.**  
**PHOTOGRAPHS TAKEN BY JOHN DRINKWATER, P.ENG.**  
**ON MAY 23, 2019**

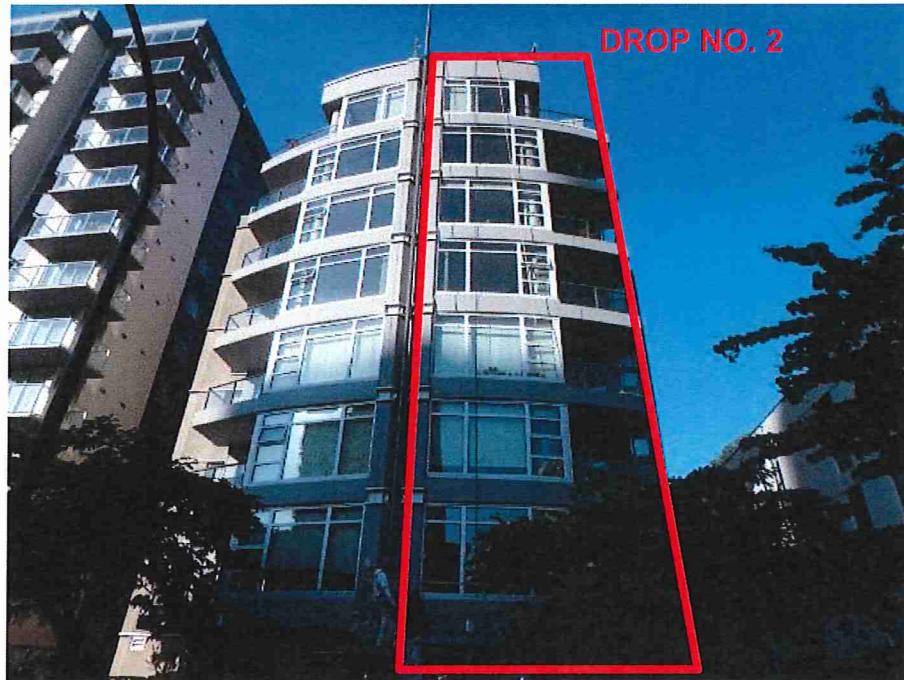
**Photos No. 3.1 and 3.2**

Item	Comment	Action By	Date Cleared	Cleared By
3.1	John Drinkwater, P.Eng. of Spratt Emanuel Engineering Ltd. (SEE) attended the above noted development on May 23, 2019 to review completed work on Drop No. 2, located on the north elevation. The following are the observations of the writer while on site (Photo No. 3.1).

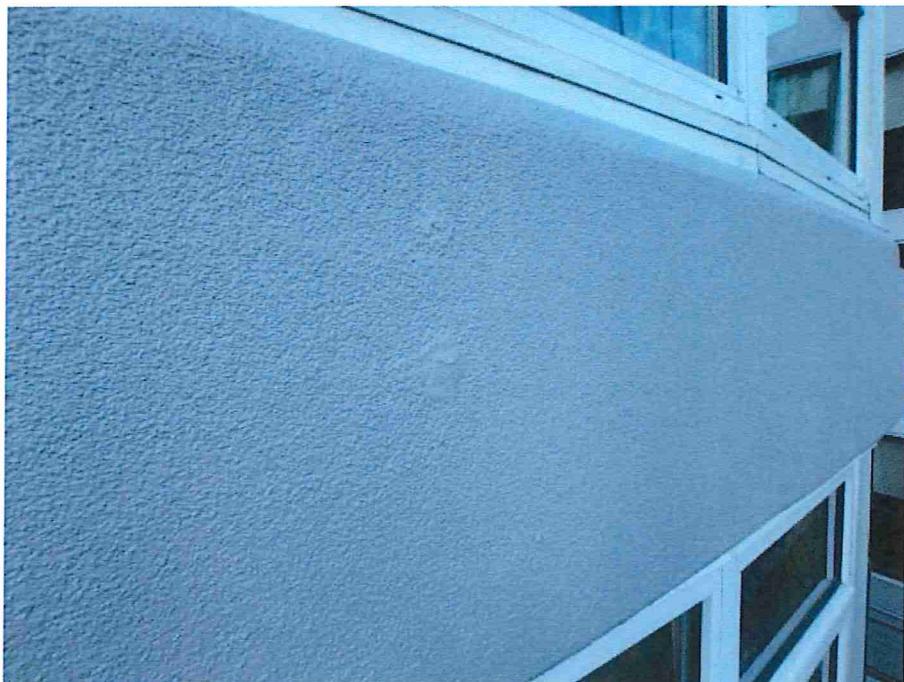
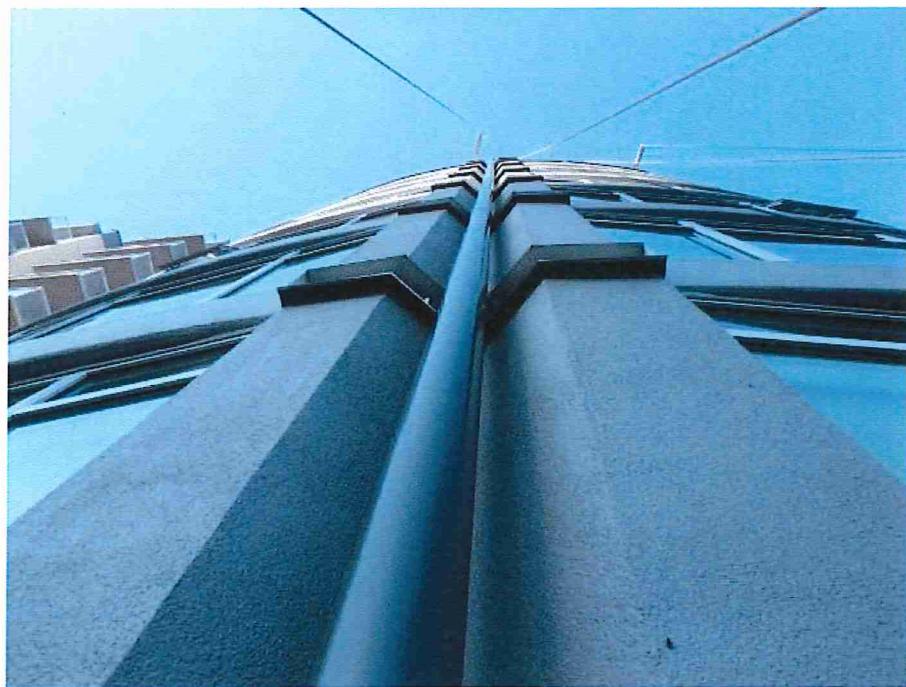
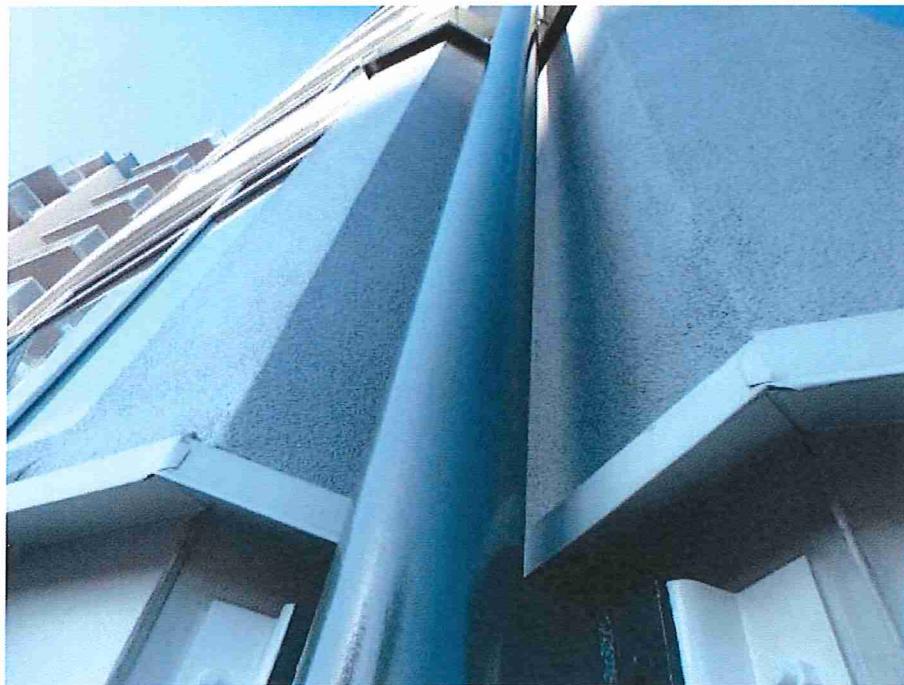
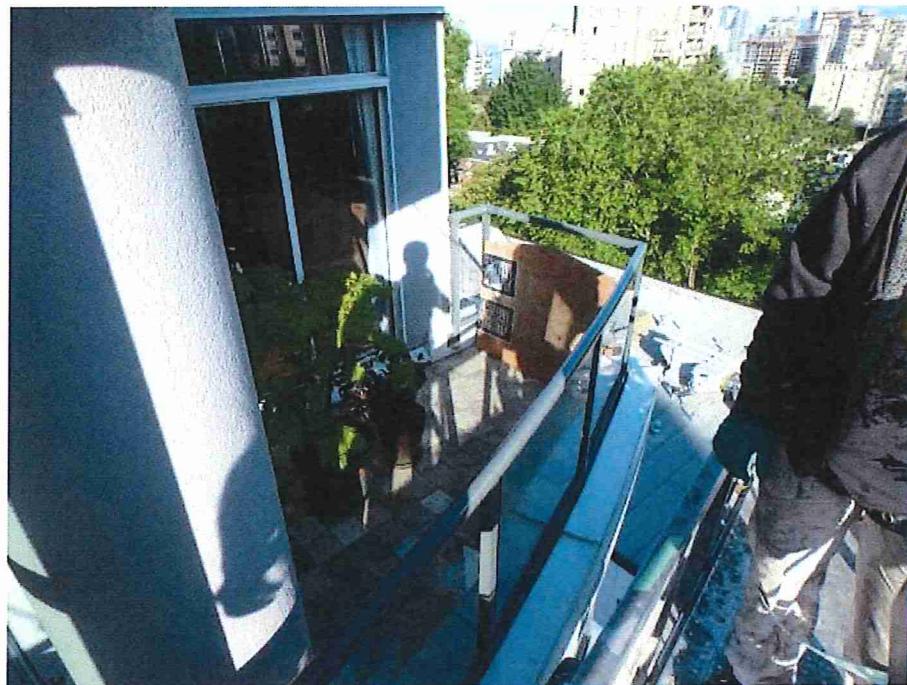
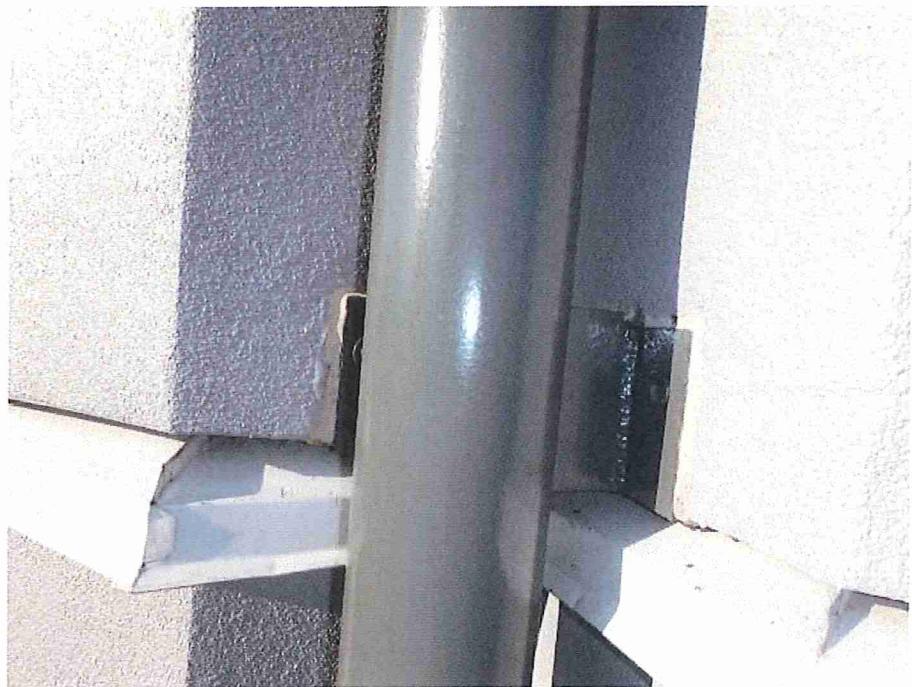
3.2	Drop No. 2: The Contractor has applied new Dulux diamond exterior acrylic latex coating to the stucco finished walls with very good workmanship observed. Work on this drop also included painting of the metal flagpole and base supporting plates and northwest corner balconies and guardrails. Good workmanship and high level of finish is observed throughout (Photos No. 3.2 to 3.6).

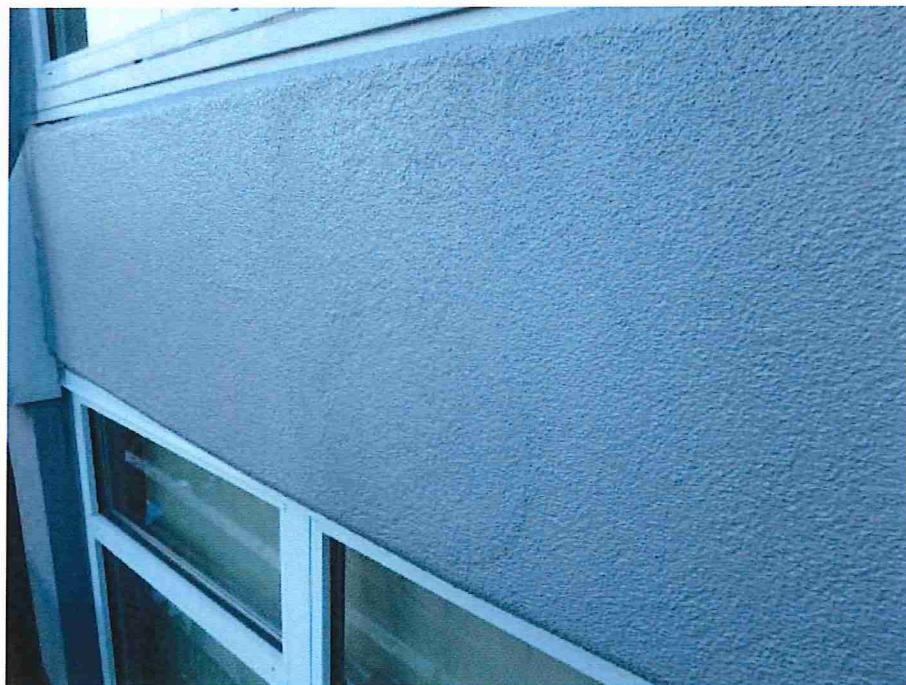
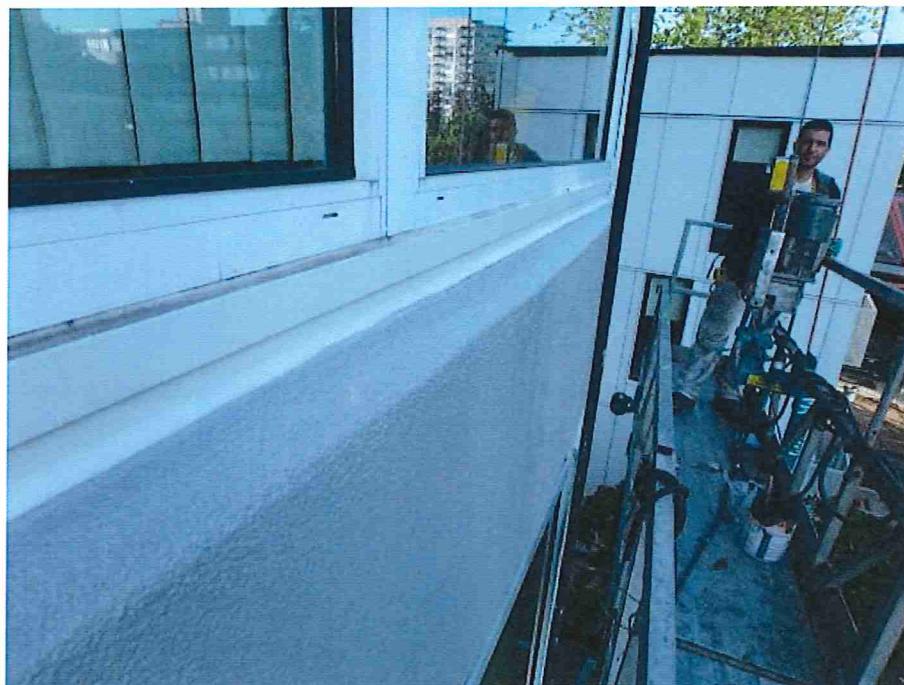
**Photos No. 3.7 and 3.8**

3.4	Drop No. 2: Two acrylic stucco finish patch repairs were done at Levels 3 and 4. The repair patches are an almost identical match for the original finish and are virtually indistinguishable from the surrounding sound material. Workmanship is excellent (Photos No. 3.7 and 3.8).

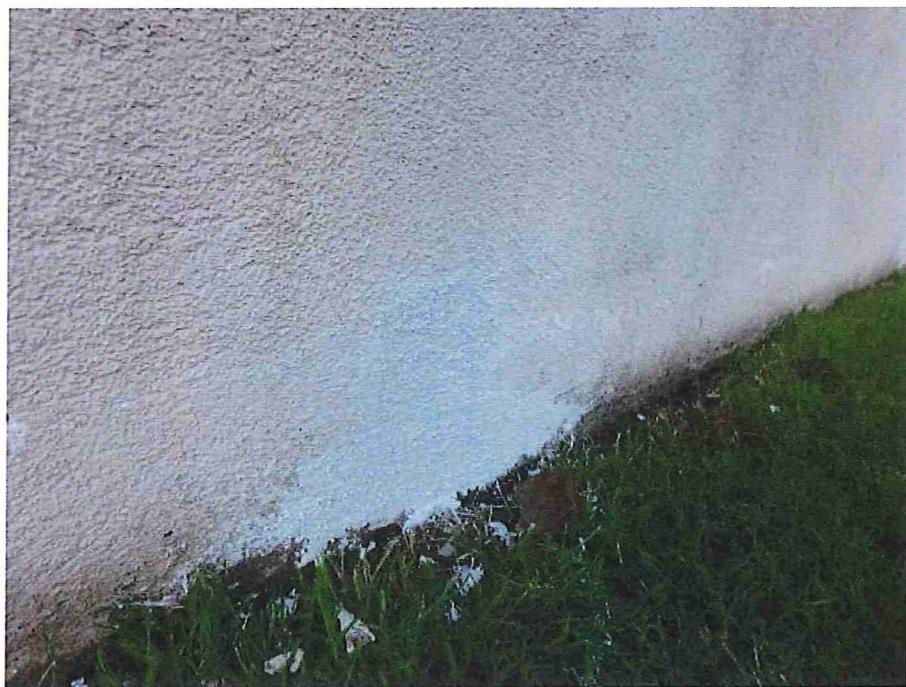
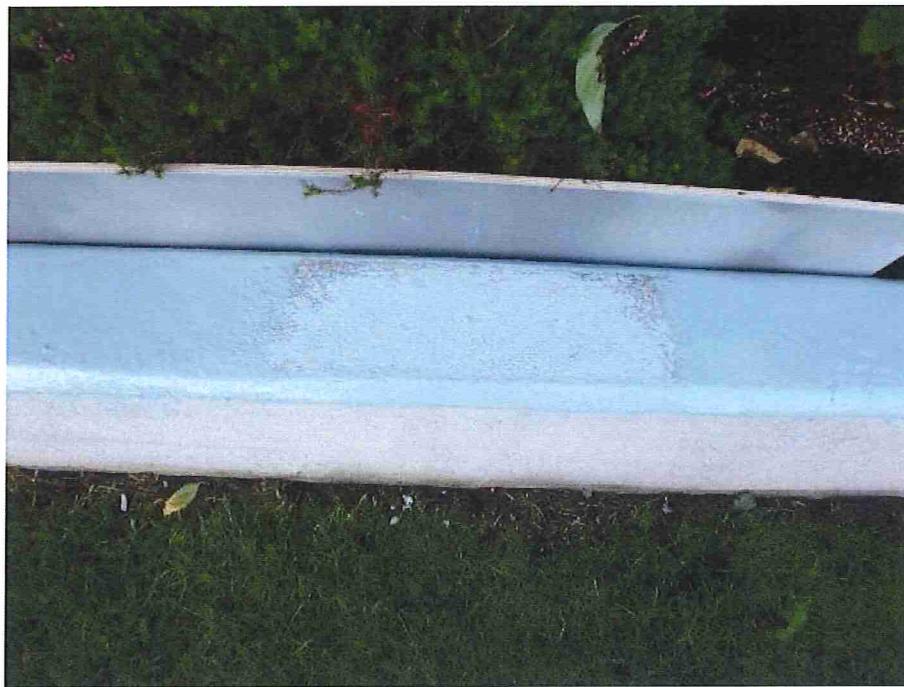
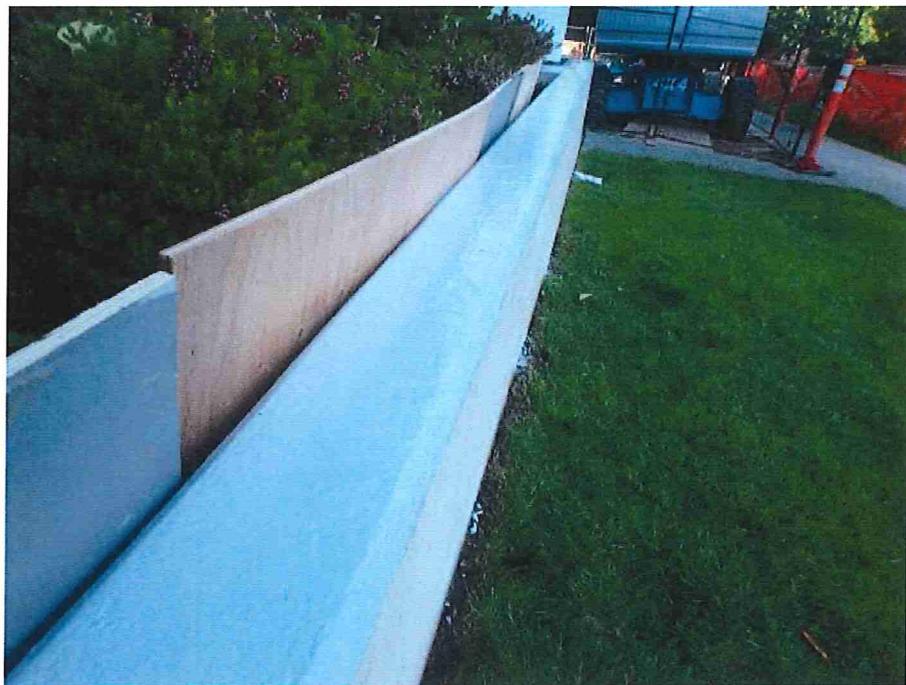
**Photos No. 3.9 and 3.10**

3.5 Work is in progress on the ground floor planter and building walls at the north side main entry. Minor damage and delaminations in the acrylic finish are being repaired with a close match to the original. Tremco polyurethane traffic membrane has been applied as requested to the top horizontal surfaces of the parapets with good workmanship observed. This membrane has been chosen for the parapets as it is suitable for use in a horizontal application, where standard painting products would quickly fail and peel. This project does not have sufficient quantity usage to economically obtain a colour match formula. The closest factory colour to the exterior walls has been selected (Photos No. 3.9 to 3.11).

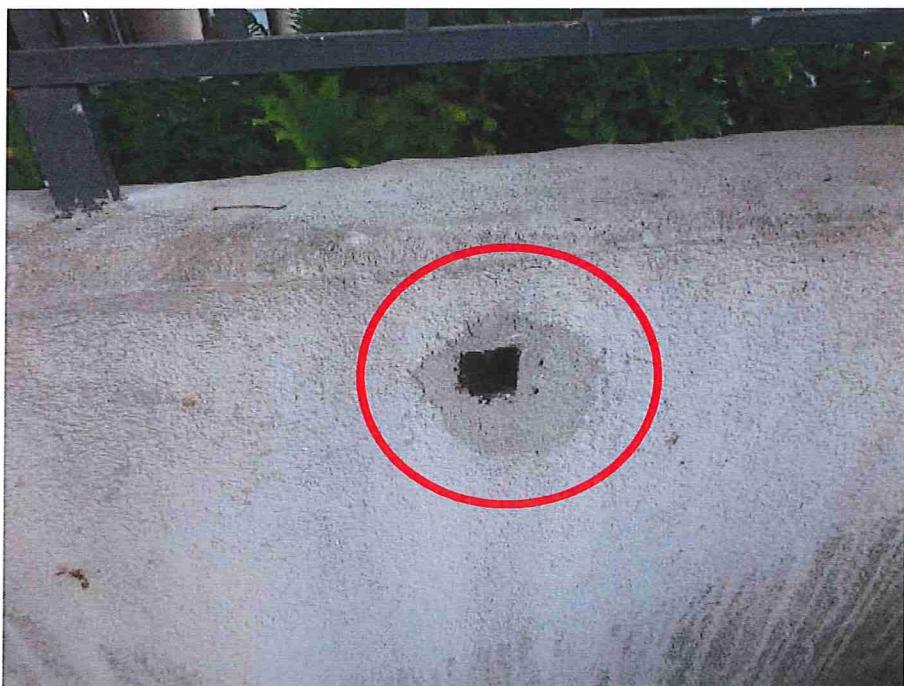
3.6 Near the top of the fire exit stairwells there is a void in the concrete wall, suspected forming material dating to original construction. This wood is now rotten resulting in a void space. SEE instructed Spectrum Painting to remove the remaining wood, patch with a repair mortar, then recoat the wall as normal (Photo No. 3.12).
