OBSERVATION REPORT

Project: **Strata Plan LMS 280 - Chateau Comox**
1272 Comox Street
Vancouver, B.C. **File No:** S18-558
Report No: 12

ITEM: Building Envelope Field Review

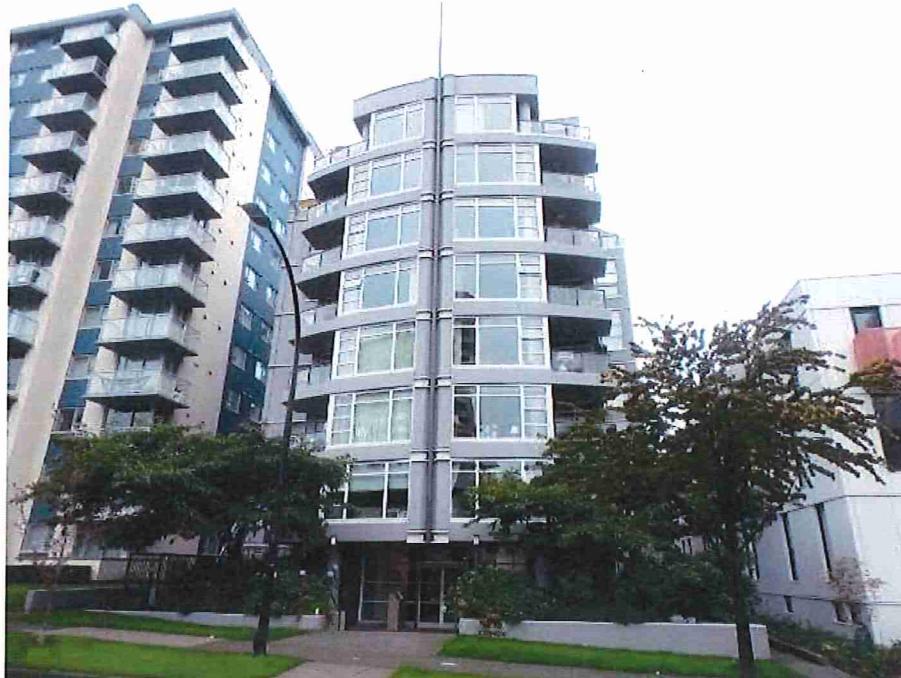
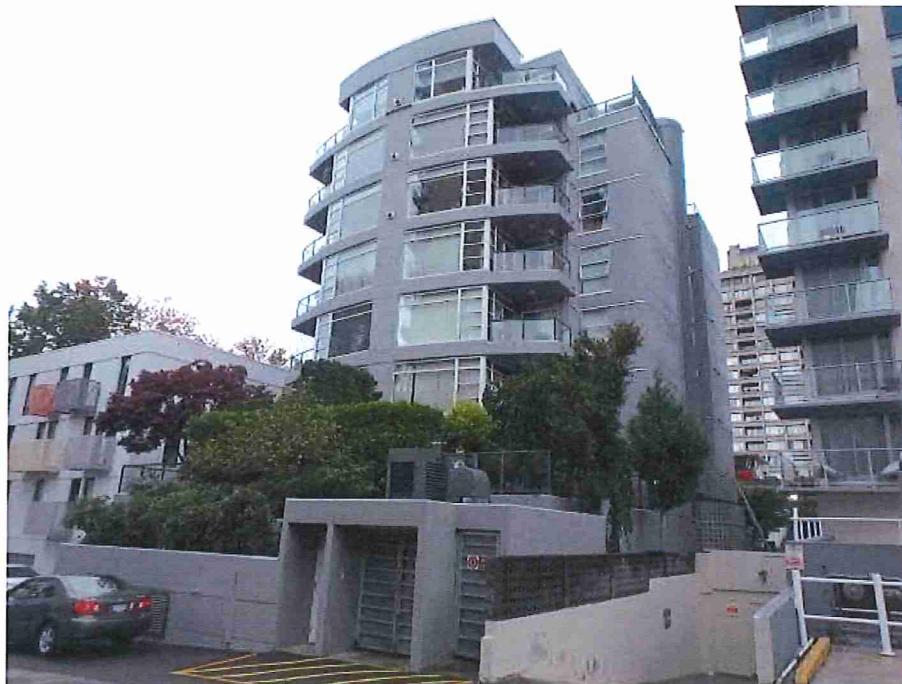
Photos No. 12.1 and 12.2

Item	Comment	Action By	Date Cleared	Cleared By
12.1	John Drinkwater, P.Eng. of Spratt Emanuel Engineering Ltd. (SEE) attended the above noted development on September 26, 2019 to conduct a building envelope field review. The following are the observations of the writer while on site (Photos No. 12.1 and 12.2).			
12.2	Work on the remaining section of the east elevation wall is complete and a review was conducted on the final drop of this project on the north elevation at the east corner. Excellent workmanship was observed with no deficiencies noted (Photos No. 12.3 to 12.6).			
12.3	At the main roof level the final remaining painting and caulking tasks are complete or near complete. Perimeter cap flashings, skylights, and the steel elevator maintenance room stair have all been repainted with excellent finish observed (Photos No. 12.7 to 12.9).

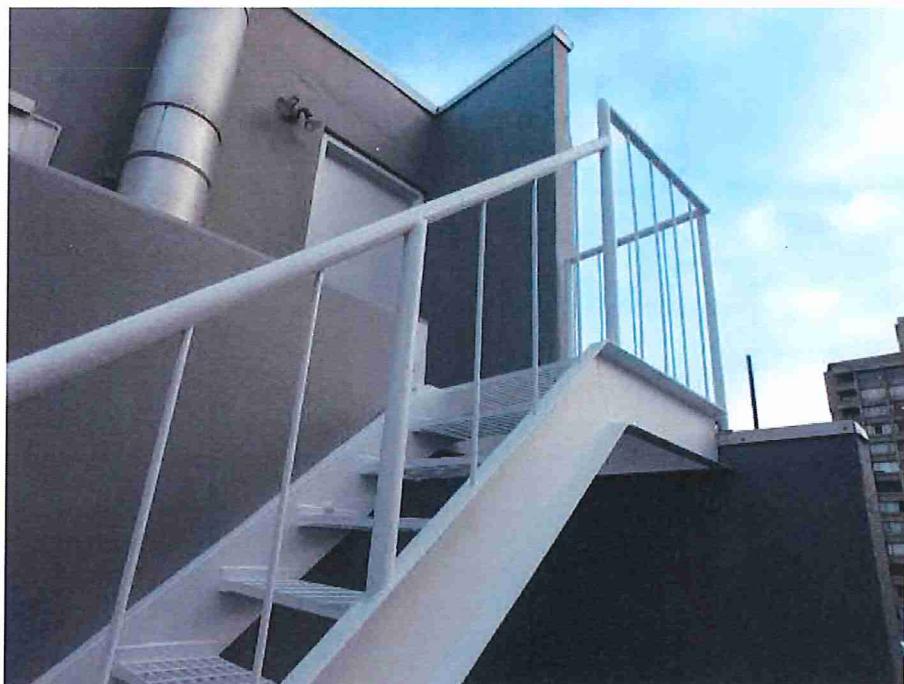
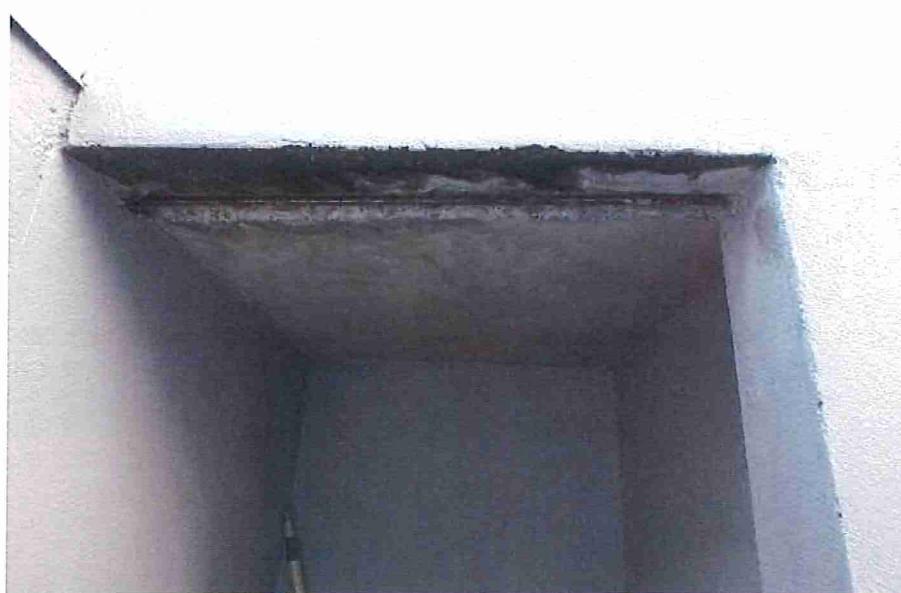
Photos No. 12.9 and 12.10

At the rooftop, the small alcove below the elevator room had concrete spalling due to a reinforcing bar with insufficient cover. The rusting steel is due to a defect in original construction, a drip edge groove was not cast into the concrete, allowing water to run across the soffit ultimately resulting in rusting of the steel. SEE instructed Spectrum Painting to cut a $\frac{1}{2}'' \times \frac{1}{2}''$ triangular groove 1" back from the wall to serve as a drip edge. The reinforcing steel will be cleaned and primed, and the concrete patched. SEE advised Spectrum that full 1" concrete cover will not be required as the location will be protected from water and due to the steel orientation it is virtually impossible to achieve (Photos No. 12.10 and 12.11).
