Chateau Comox

Our File No.: S07-262
8 November 2007

Re: Strata Plan LMS 280 - "Chateau Comox" 1272 Comox Street, Vancouver, B.C.
– Building Envelope Leak Investigation

STRATA PLAN LMS 280 – CHATEAU COMOX, 1272 COMOX STREET, VANCOUVER, BC
PHOTOGRAPHS TAKEN BY CLIFFORD SUTTON, M.ENG. ON NOVEMBER 5 - 7, 2007

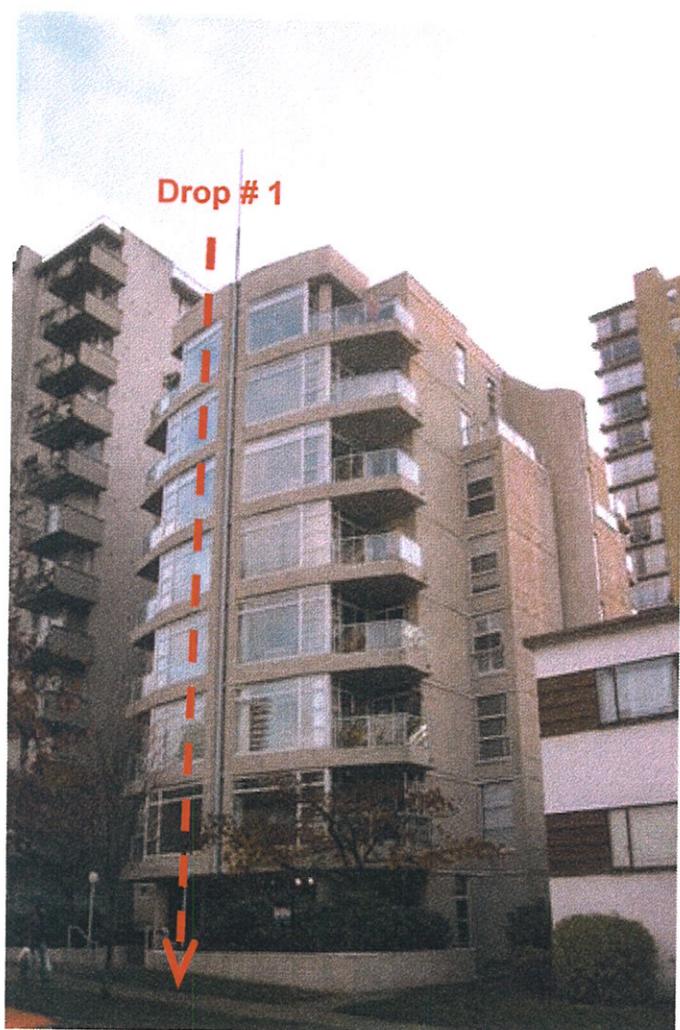
Photos No. 1 and 2

- 3.5.1 Drop #1 was performed on the centre of the north elevation, directly east of the flagpole (**Photo No. 1**).
- 3.5.2 Sections of parging have delaminated from the concrete parapet walls at the roof level (**Photos No. 19 & 20**).

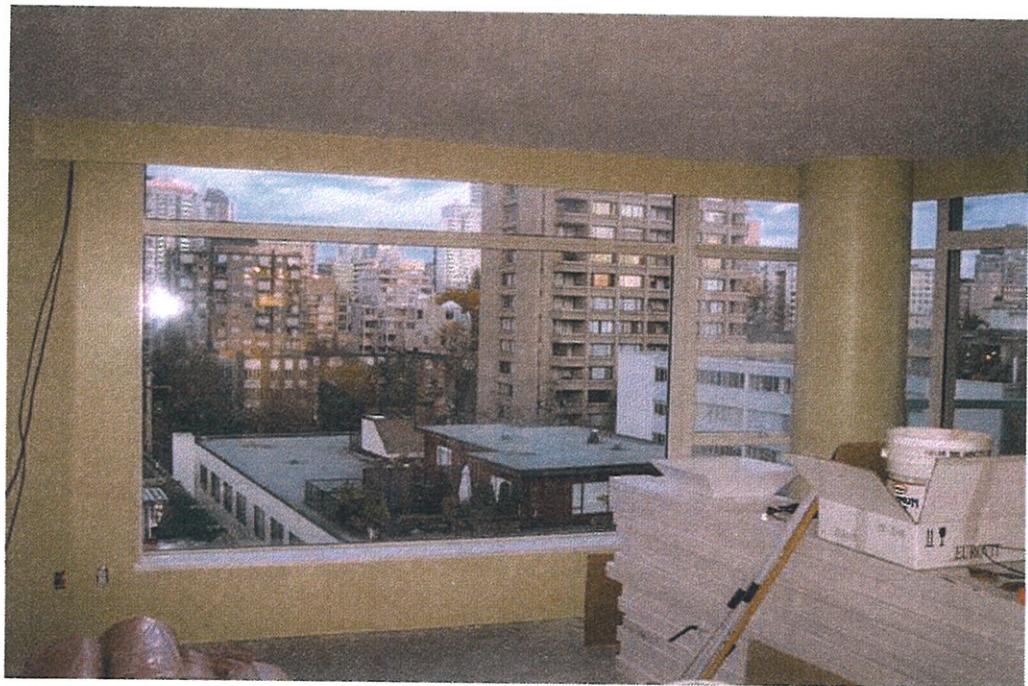
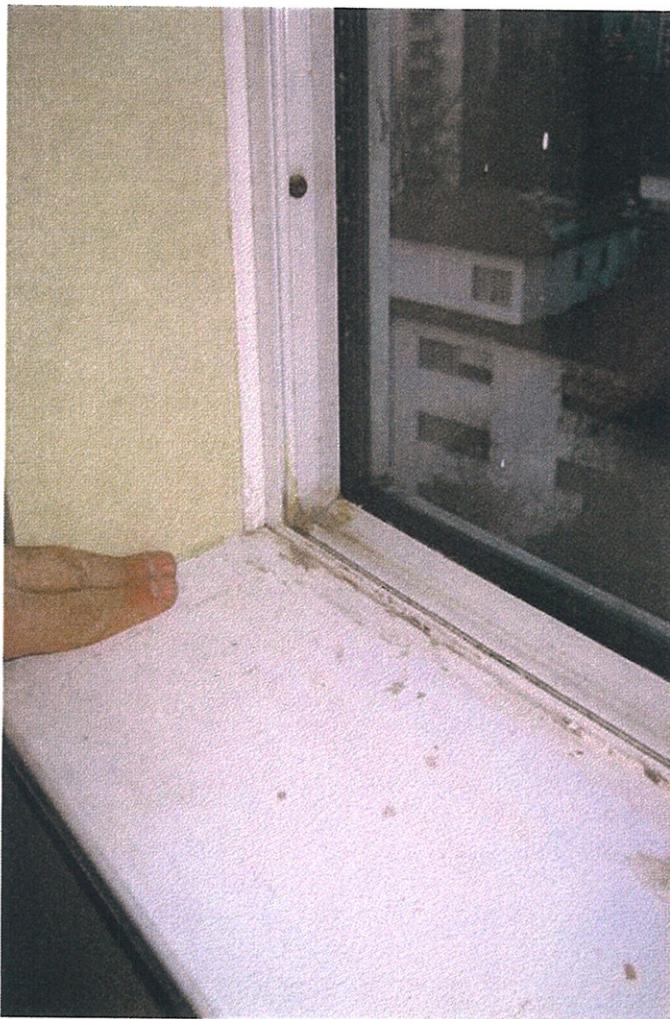
Photos No. 5 and 6

- 3.1.1 The leak investigation began in this unit where water accumulation was visible in the sill collection track of the window directly east of centre on the north elevation. Long-term moisture damage was visible on the wooden window sill which appeared swollen with delaminating paint (**Photos No. 5 - 7**). The owner reported that previously the exterior caulking has been renewed around the window frame, caulking was applied to the joint between the glazing and the

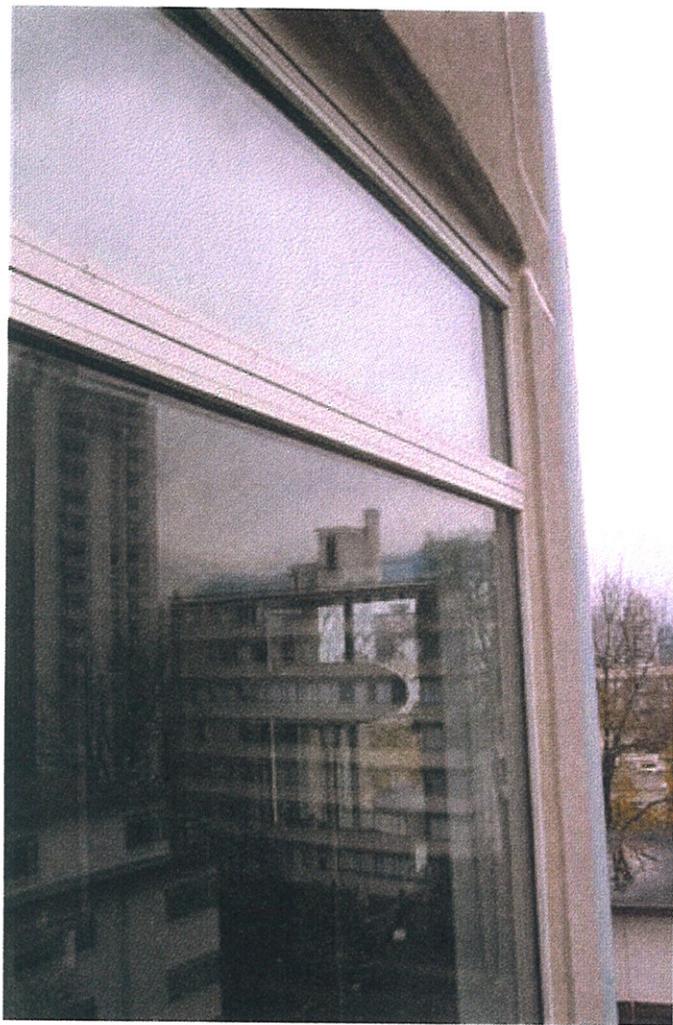
Photos No. 29 and 30

- 3.5.5 The sixth storey window unit has also been re-sealed around the perimeter joint with the cladding, and the weep holes have been blocked with tape (**Photo No. 29**).

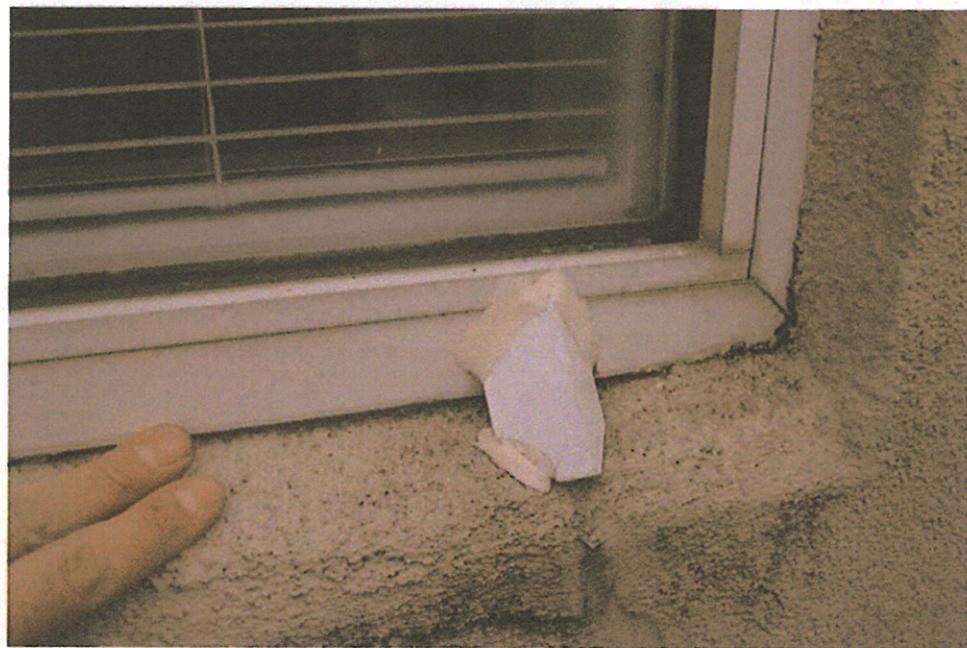
Photos No. 35 and 36

- 3.5.6 On the windows below the sixth storey to the west of the flagpole, and all the windows to the east of the flag pole, there has been no remedial sealant application at the perimeter of the windows. There are large, open joints on the window sills between the aluminium frame and the concrete upstand where staining and organic growth is accumulating (**Photos No. 30 - 34**). The window weep holes have not been taped on the windows west of the flagpole, nor on the windows below the fifth floor. The one exception is the second floor where a small aluminium channel has been caulked to the window frame to cover the weep hole (**Photo No. 35**).

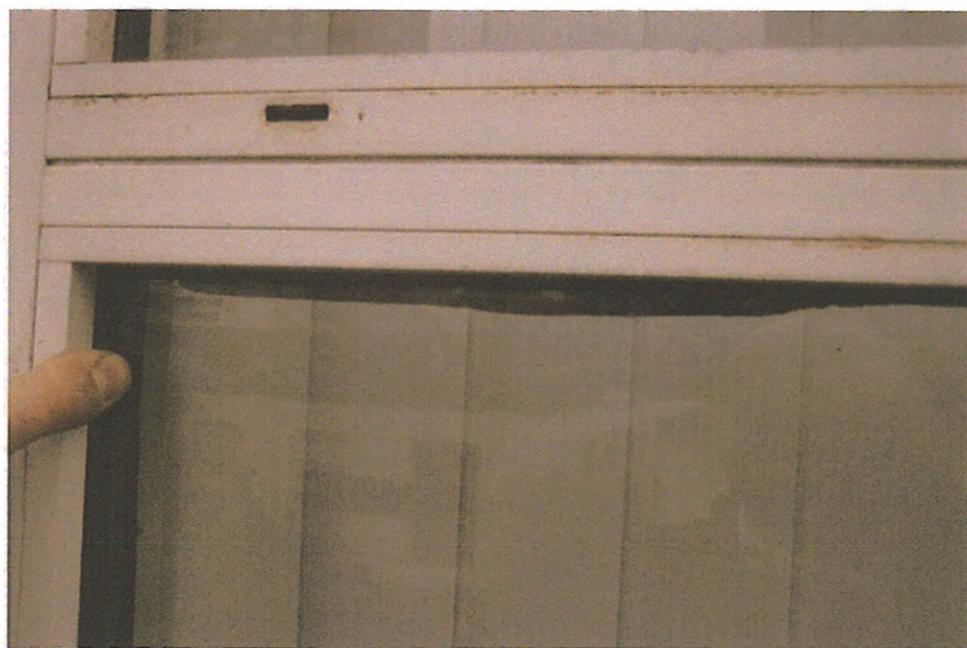
Photos No. 41 and 42

- 3.5.8 On the fourth storey window, movement of the glazing is evident by displacement of the glazing tape on the interior of the window (**Photo No. 41**).

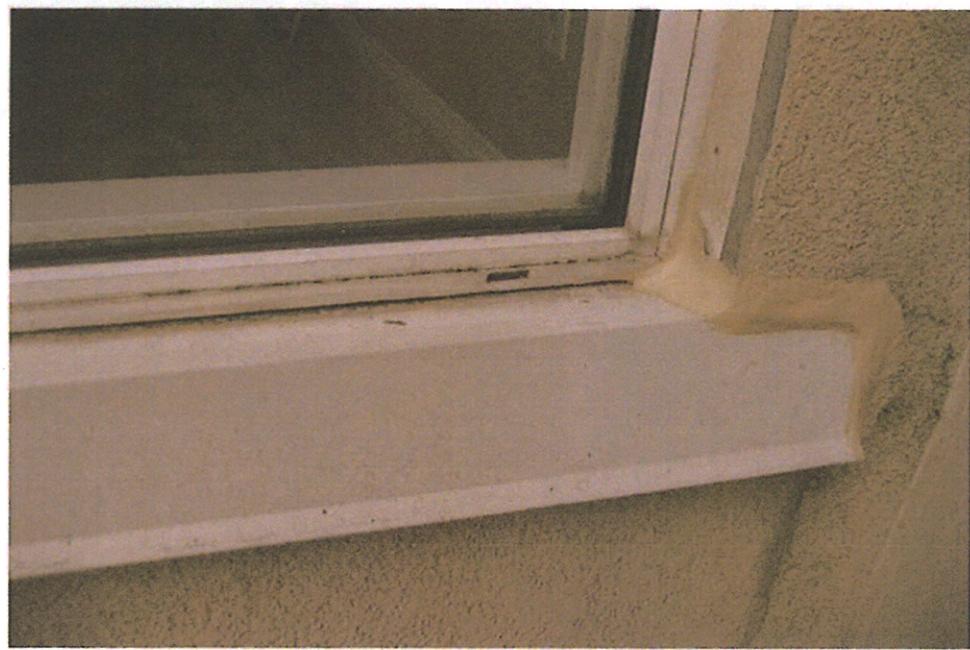
Photos No. 47 and 48

- 3.6.3 Metal window sill flashing is demonstrating a visible back-slope toward the building on the punch windows of this elevation. Remedial sealant application has been attempted on several window sills, likely in an attempt to prevent ponded water from infiltrating the window assembly (**Photos No. 47 - 52**). On most of the windows of this elevation, the weep holes have been closed with tape.

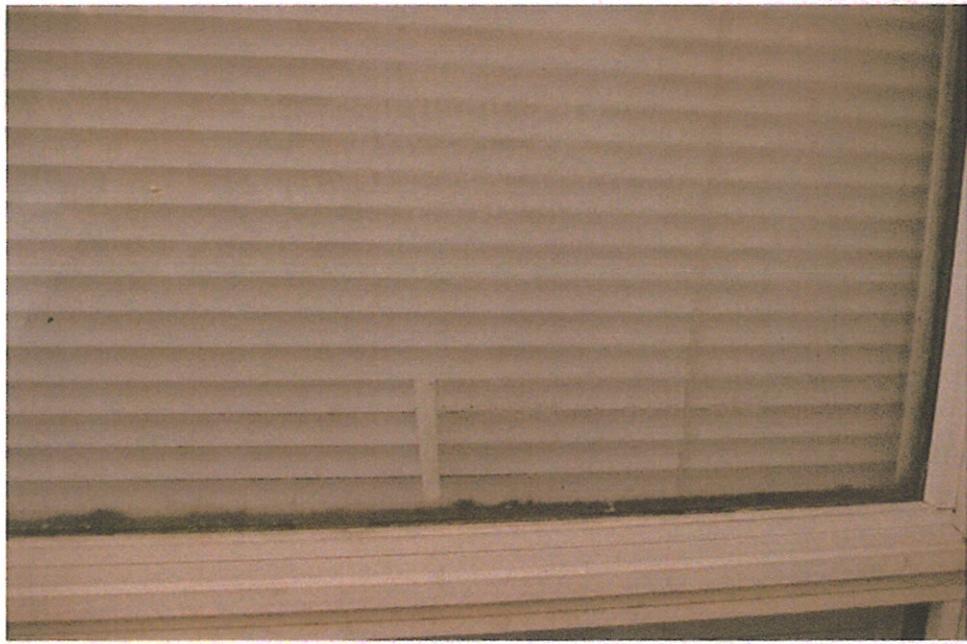
Photos No. 53 and 54

- 3.6.4 At least two failed sealed units were noted on the punch windows of this elevation (**Photos No. 53 & 54**).

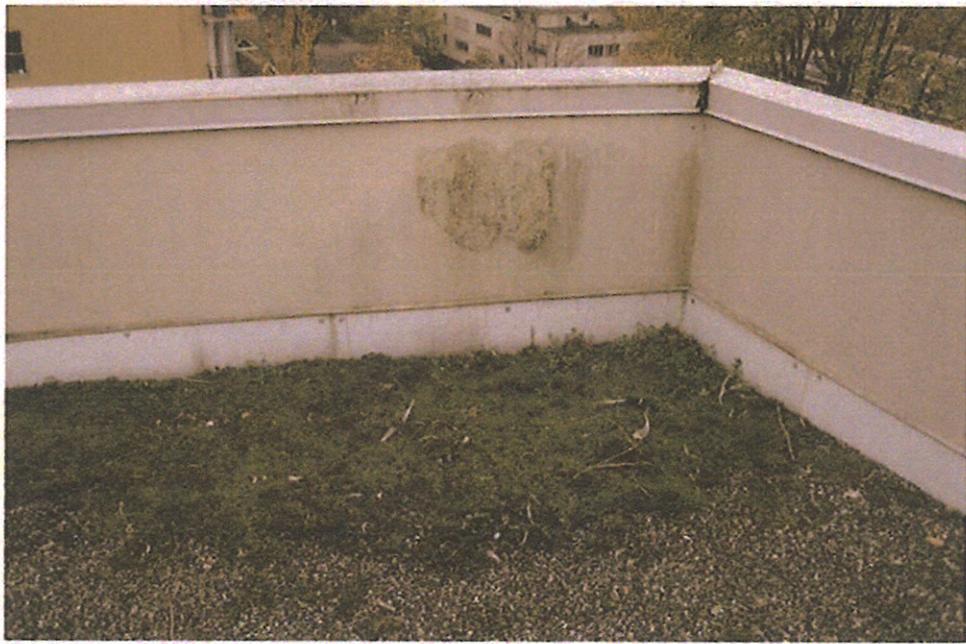
Photos No. 55 and 56

- 3.7.1 The roof assembly on this building consists of a waterproof membrane applied to the concrete slab, approximately 1.5" of XPS insulation, filter cloth, and gravel ballast. Digging through the gravel to inspect the membrane was futile in the wet conditions on the day of review (**Photo No. 55**).

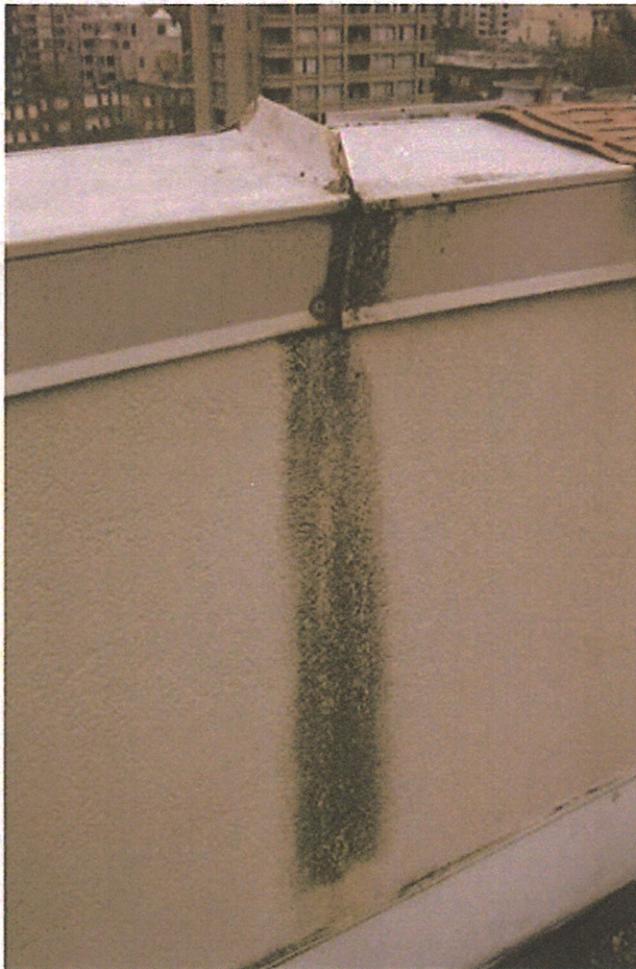
Photos No. 67 and 68

- 3.7.7 Heavy staining is noted on the parapet walls at the roof level, and also on the walls of the elevator machine room, directly below the standing seam connections for the cap flashing pieces (**Photos No. 67 & 68**).

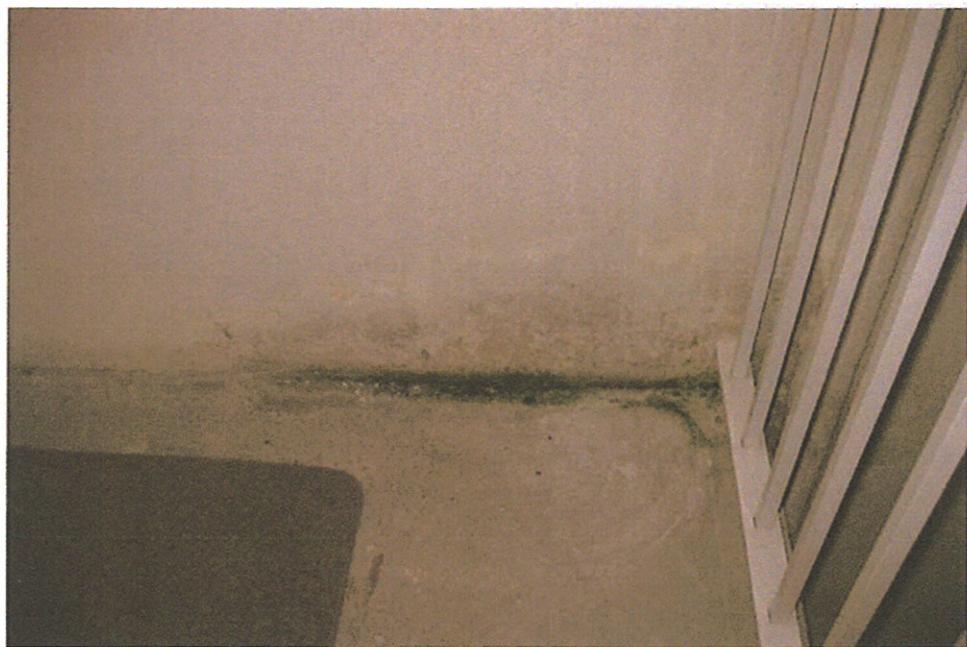
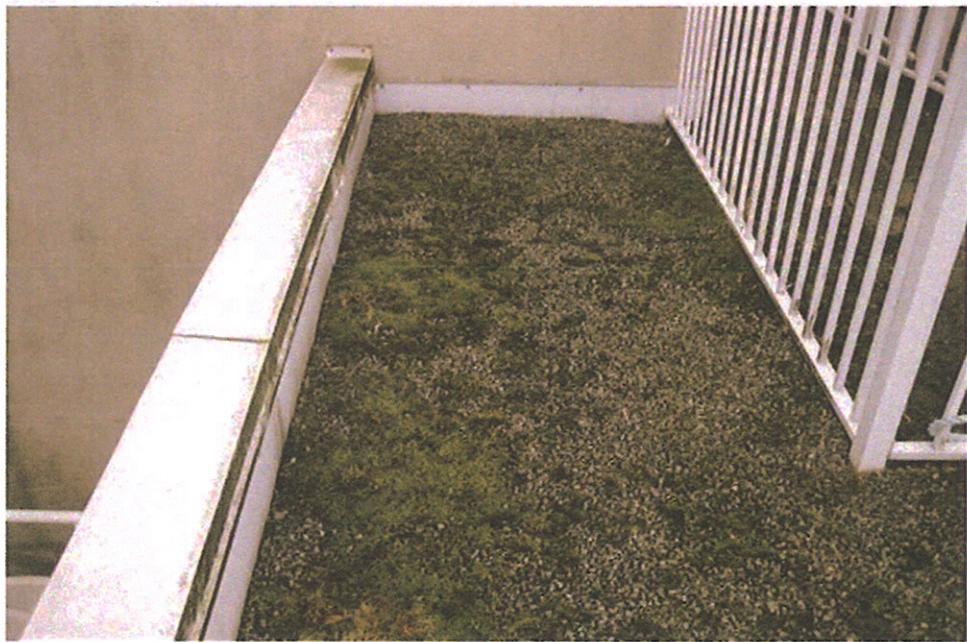
Photos No. 69 and 70

- 3.7.8 Evidence of moisture infiltration was noted at the stairwell landing on the roof level. On the exterior side there is a saddle connection between the parapet wall and the stairwell wall where the cap flashing is poorly sealed to the concrete wall (**Photos No. 69 - 72**).
- 3.7.9 In the same stairwell, there is evidence of moisture infiltration at the glass block windows on the east wall at the roof level (**Photo No. 73**).
- 3.7.10 On the roof of the elevator machine room there is thick organic growth that nearly obscures the stone ballast (**Photos No. 74 & 75**).
- 3.7.11 The walls of the elevator machine room appear to have been coated with an elastomeric paint and sealing tape along the concrete joints (**Photo No. 76**).
