VISUAL BUILDING ENVELOPE CONDITION ASSESSMENT

STRATA PLAN LMS 280 – CHATEAU COMOX
1272 COMOX STREET, VANCOUVER, B.C.

Our File No.: S18-551

September 30, 2018

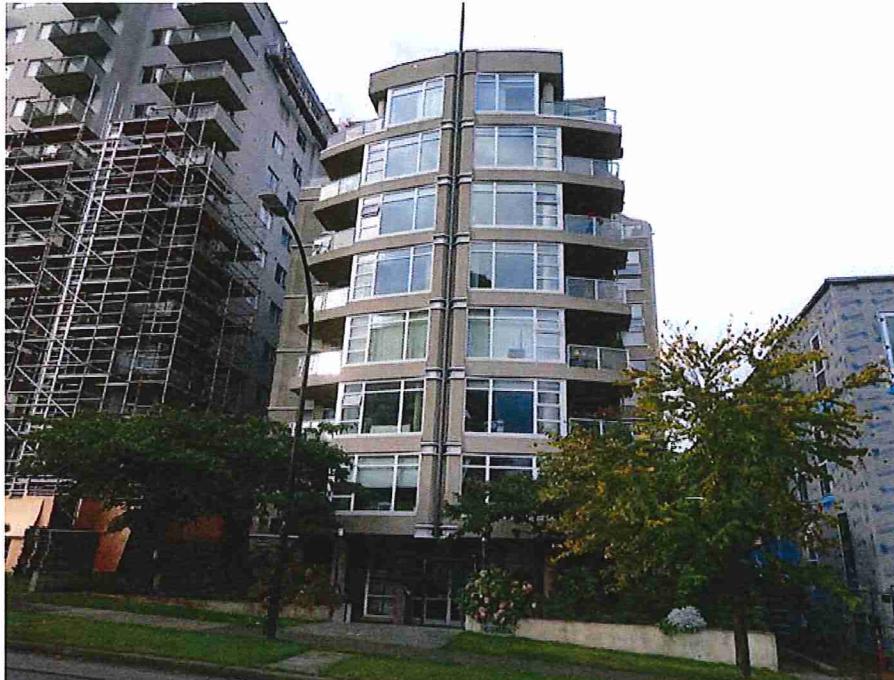
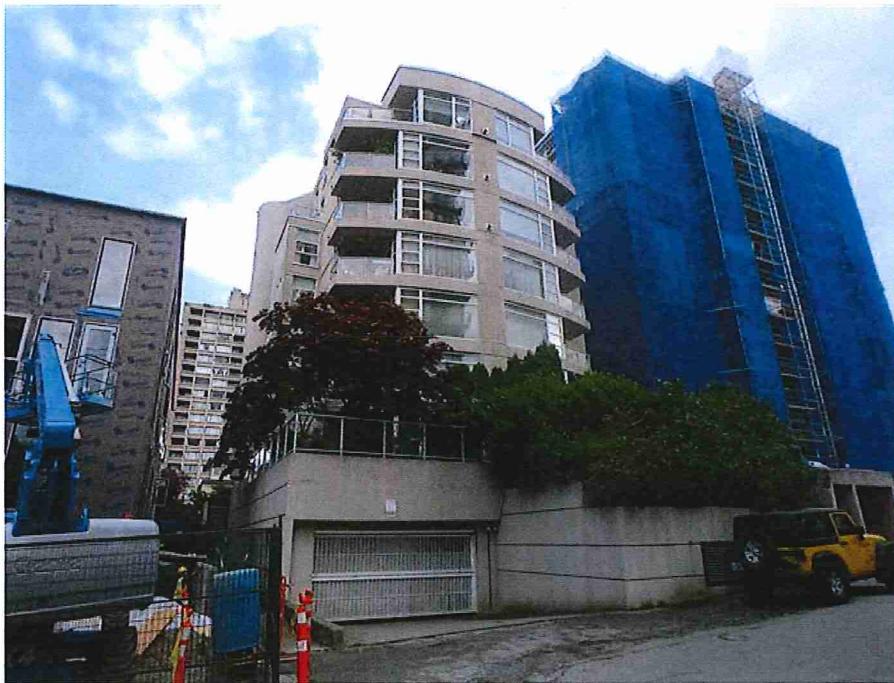
Photos No. 1 and 2

- 2.1 Chateau Comox is an 8-storey, non-combustible, cast-in-place concrete mid-rise building located at 1272 Comox Street, Vancouver, B.C.
- 2.2 The tower main roof consists of a ballasted inverted roof membrane assembly. Conventional low-slope roof assemblies protected by torch-applied SBS membrane are present in limited areas. The building exterior is primarily finished with an aluminum window wall system with stucco and mass concrete wall areas. The original face-sealed stucco walls, generally on the east, north and west elevations have been replaced with rainscreen stucco in phases (**Photos No. 1 to 3**).

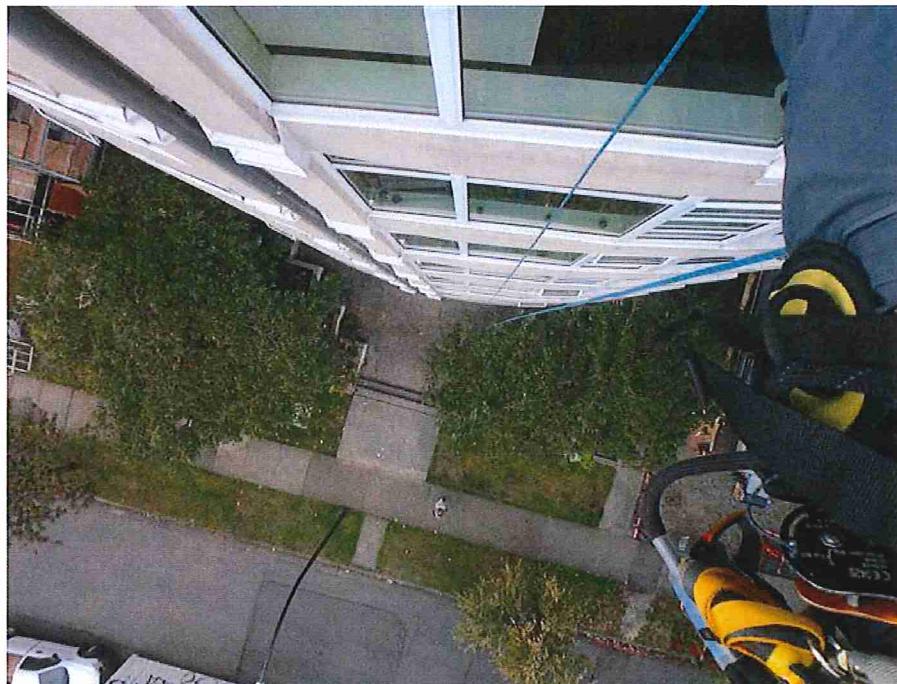
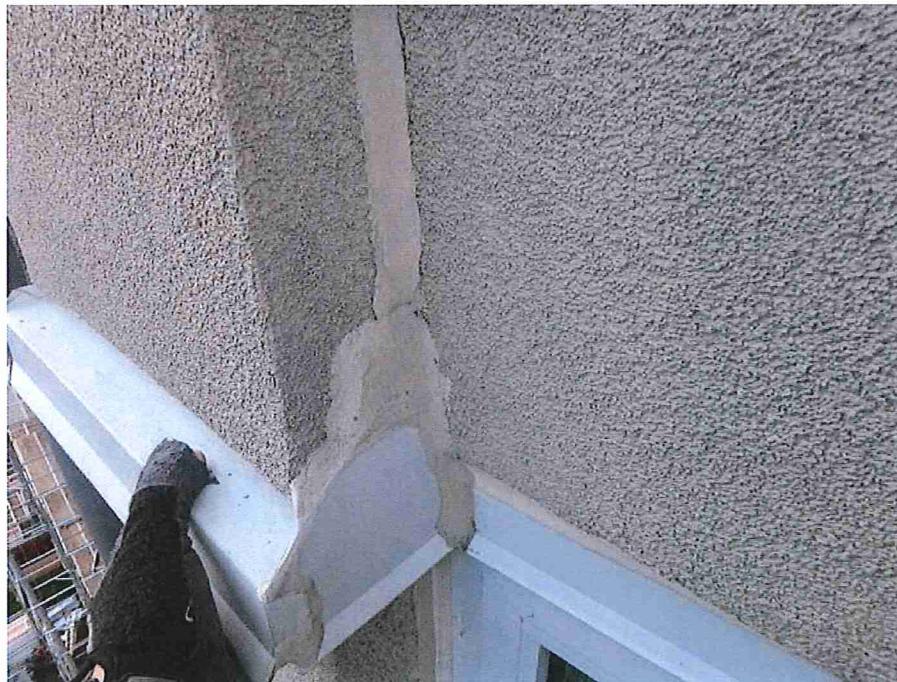
Photos No. 5 and 6

Description	Photo	Type
3.1.1 Drop No. 1 is located near the centre of the north elevation, on the west side of the flag pole.	4 and 5	O
3.1.2 Sealants between rainscreen stucco and acrylic finished concrete are in fair condition. There are defects including delaminations and alligatoring indicative of age.	6 and 7	O

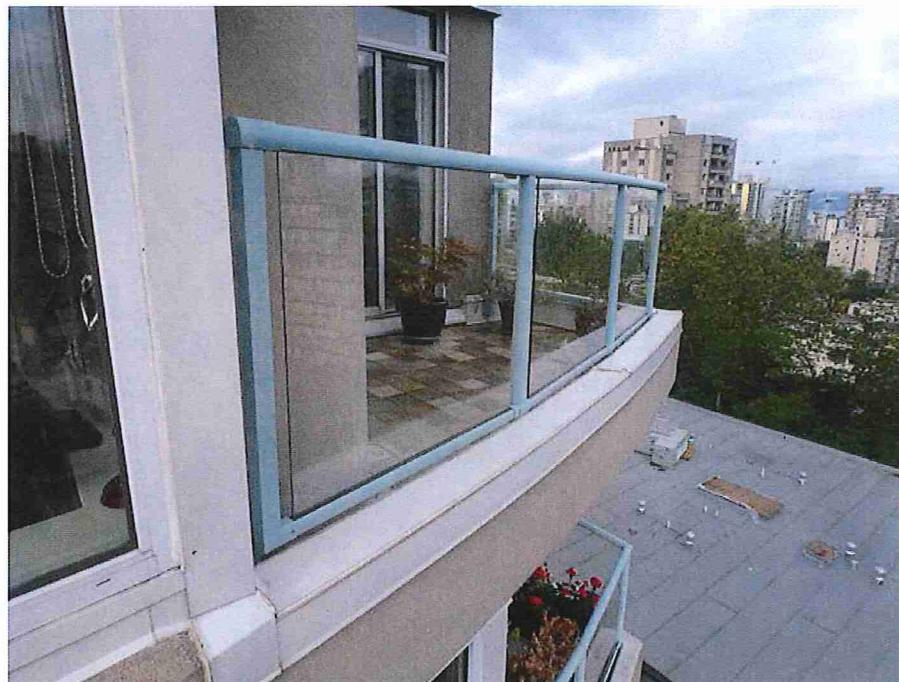
Photos No. 9 and 10

3.1.4 Guardrails are side mounted and cap flashings slope to the interior as required.	9	O
3.1.5 Level 8: Some minor caulking failures were observed in the bottom window caulking bead. SEE recommends caulking maintenance	10 to 12	M

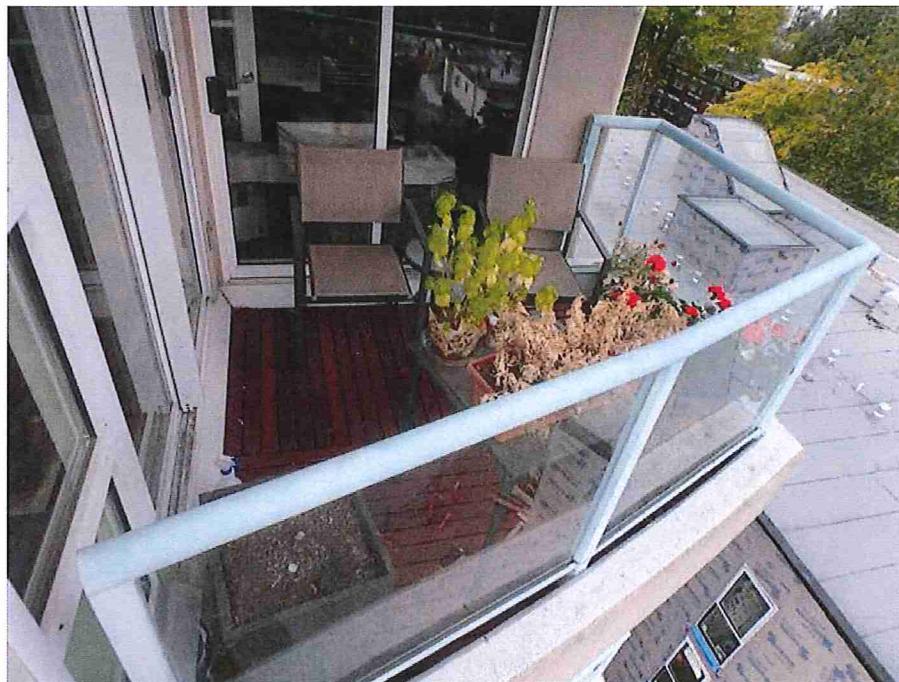
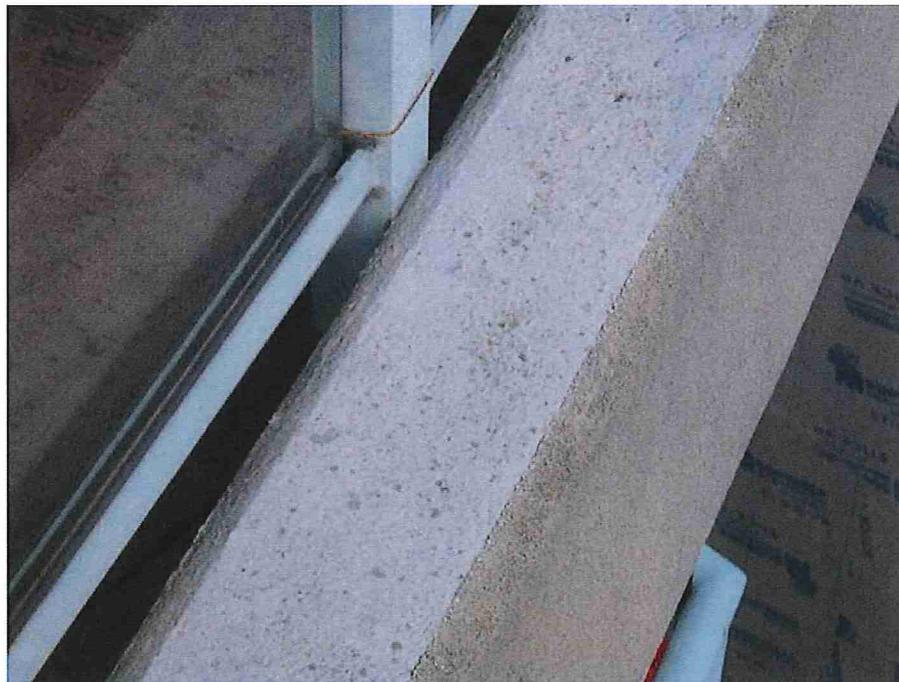
Photos No. 13 and 14

3.1.6 Level 7: The balcony is protected with a liquid-applied membrane which has been terminated on the top horizontal surface of the balcony parapet. Condition appears good.	13 and 14	O

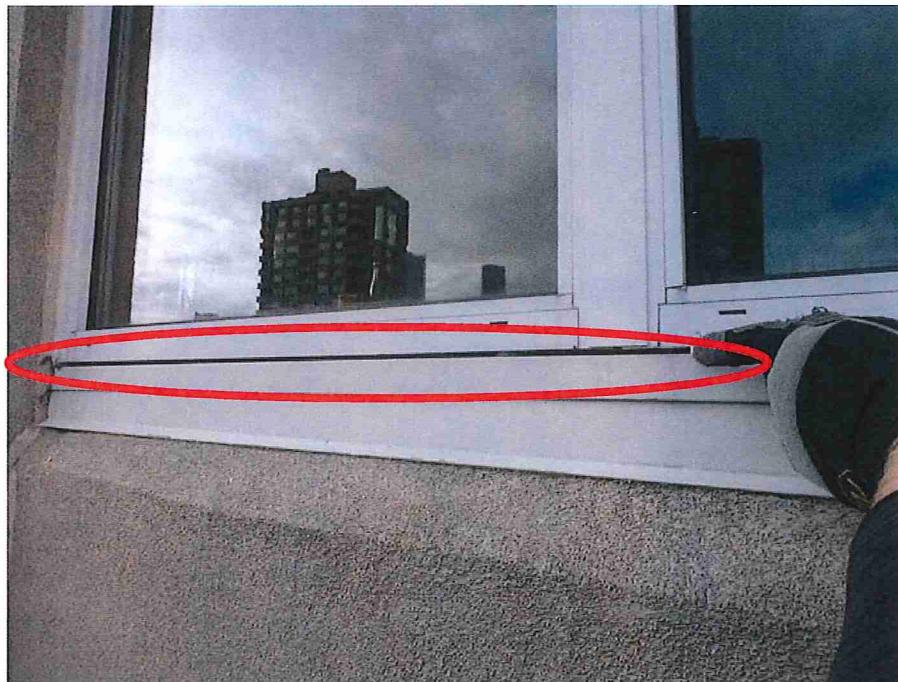
Photos No. 15 and 16

3.1.7 Level 7: The horizontal caulking joint at the sill requires re-application	15 and 16	M
3.1.8 The flagpole attachment has been done with stainless steel hardware which appears to be in excellent condition. The double flashing arrangement is providing good protection of the connection point.	17 and 18	O

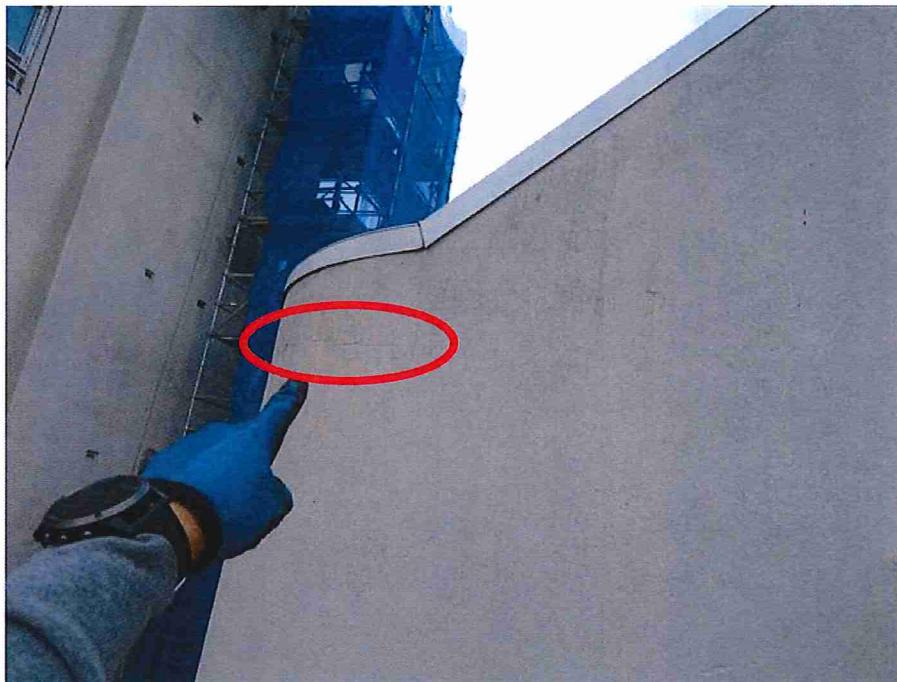
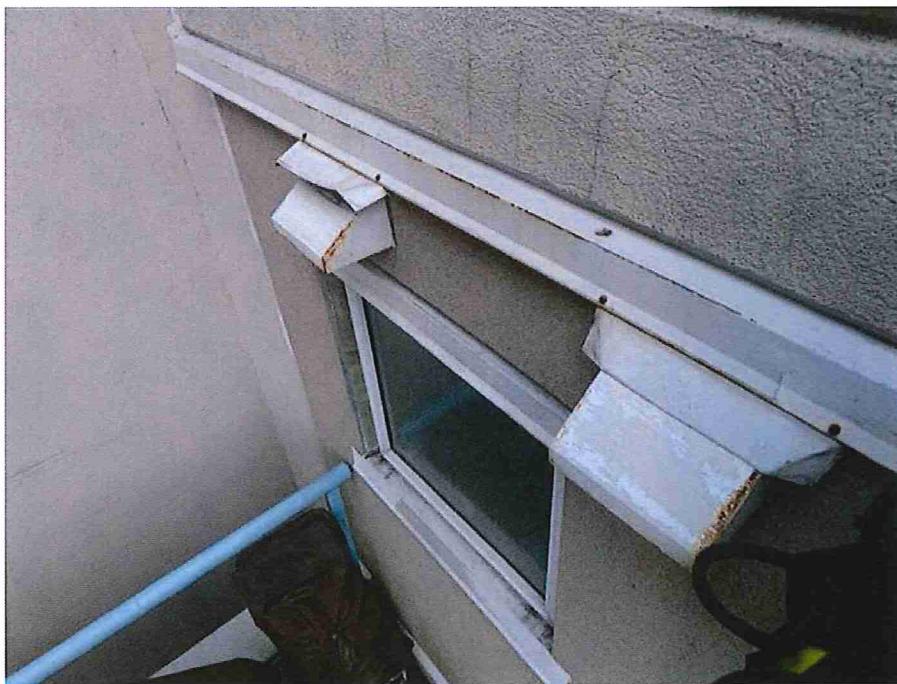
Photos No. 29 and 30

3.2.3 Level 8: There is an unsealed horizontal crack above on the exterior wall of the east stairwell. The crack should be routed and sealed with polyurethane sealant.	29	M

3.2.4 Prefinished metal surfaces along this drop are in fair to poor condition, with peeled paint and surface rust. A global recoating of metal surfaces with exterior-grade enamel paint is recommended.	30 and 31	M

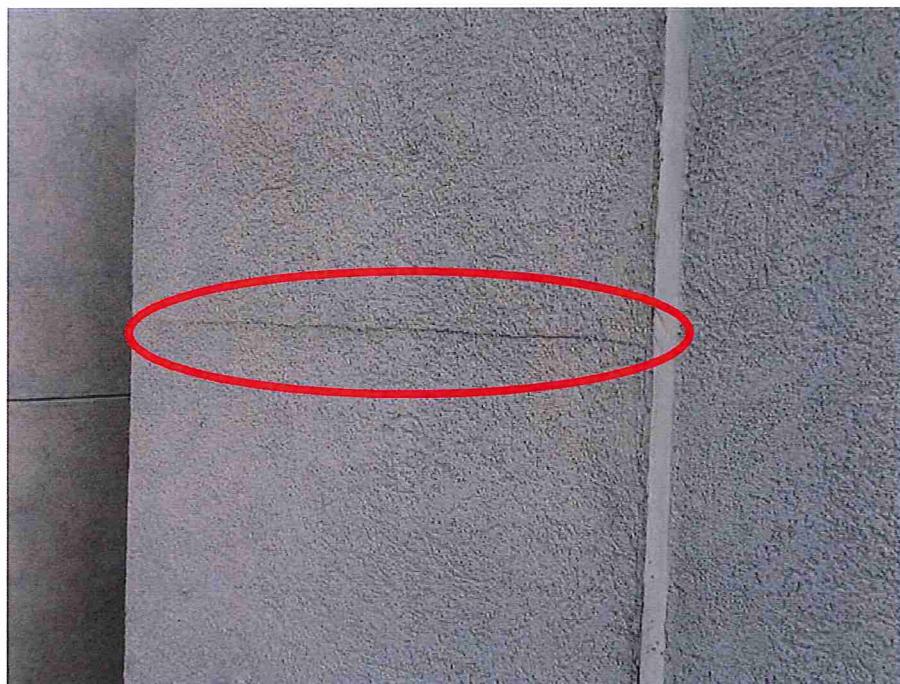
Photos No. 33 and 34

3.2.6 The vertical sealant joint to the south of the descent is in good condition. There are hairline cracks directly beside the sealant joint which should be addressed at the time of wall re-coating.	33 and 34	M

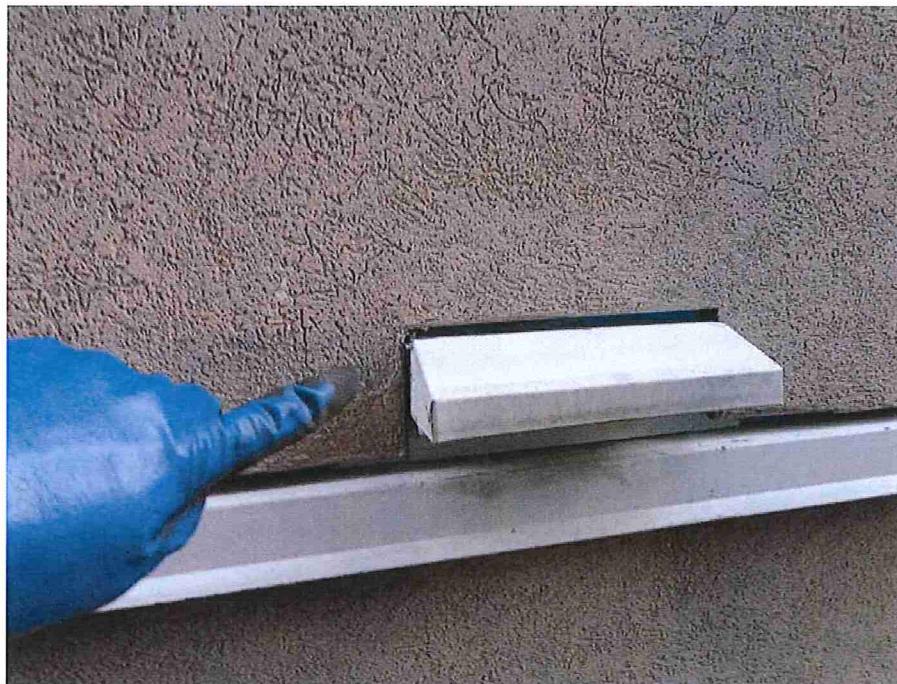
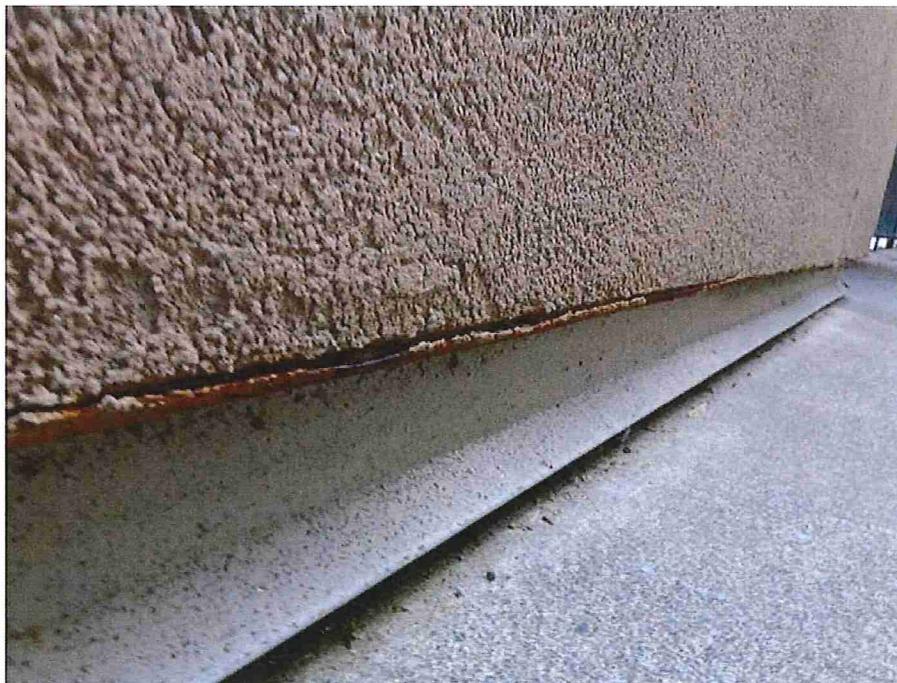
Photos No. 35 and 36

3.2.7 Level 2: Sealant is missing around an exhaust vent and should be installed with backer rod.	35	M

Description		Photo	Type
3.2.8	Rusted J-trim and flashing at the base of the ground level requires grinding and coating with zinc-rich primer.	36	M
3.2.9	The rainscreen stucco walls appear to be in good condition. Through wall flashings at each level are positively sloped and well joined with 'S'-locks. The majority of exhaust vents are located directly under the through wall flashings for head protection.	37	O

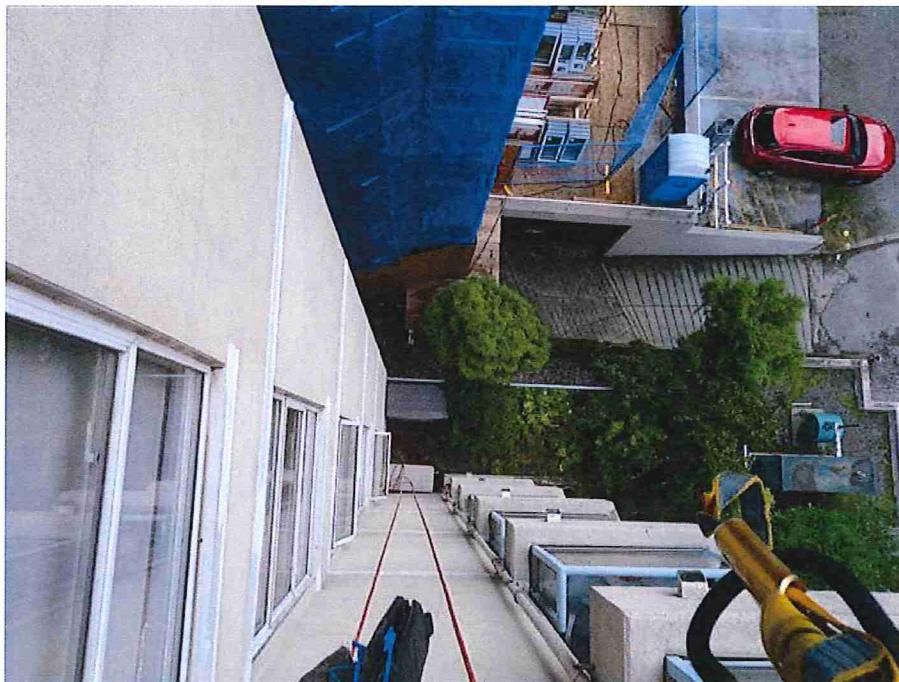
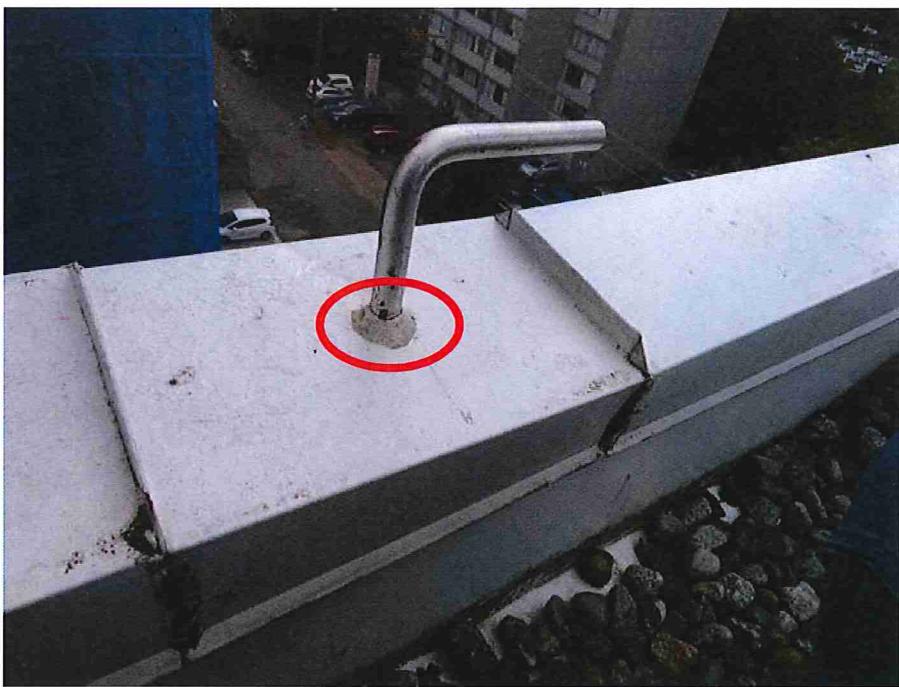
Photos No. 39 and 40

Description		Photo	Type
3.3.1	Drop No. 3 is located on the south half of the east elevation, at the southeast corner balconies.	38 and 39	O
3.3.2	The rope re-direct located at the roof level has sealant applied to its perimeter which is debonded and alligatorized. The sealant should be replaced with new polyurethane sealant.	40	M

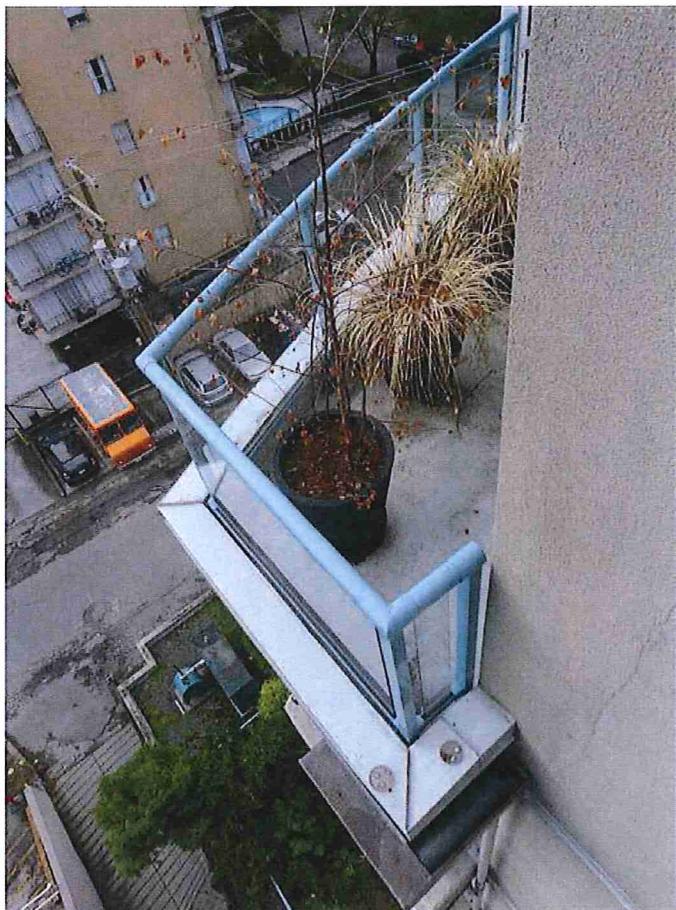
Photos No. 41 and 42

3.3.3	The bank of balconies at the very southeast corner of the building include a cold liquid-applied polyurethane waterproofing membrane over the cantilevered concrete structure. Most balconies are covered with either tiles installed over thinset mortars or removable deck tiles. Where uncovered, the membrane appears to be in fair condition.	41 and 42	O
