# CAPITAL PLAN

Chateau Comox  
1272 Comox Street  
Vancouver, BC

**TK Elevator (Canada) Limited**  
2303 Douglas Road  
Burnaby, BC, V5B 5A9

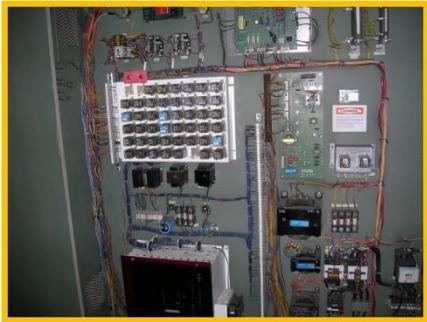
**Controller** - The controller at **Chateau Comox (1272 Comox Street)** is a TKE Northern Elevator M100 Relay Microprocessor. Original relay based 1990 Northern Controller, mechanical relay, microprocessor consisting of moving parts and contacts subject to wear and failure. The controller is responsible for processing all the car and hall calls as well as levelling and dispatching.

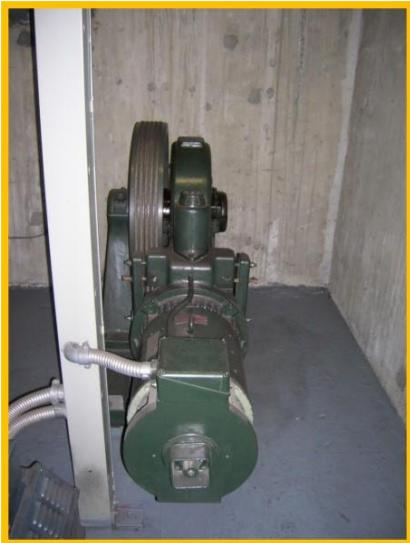
**Machine/Motor** - The hoist machine including the motor will be replaced during the modernization. The original DC motor would be replaced with a new AC VVVF drive and motor, and together with the control upgrade provide better performance and energy efficiency. The elevator will gradually speed-up at takeoff, and slowdown before it comes to a complete stop. The ride will be smooth and steady.

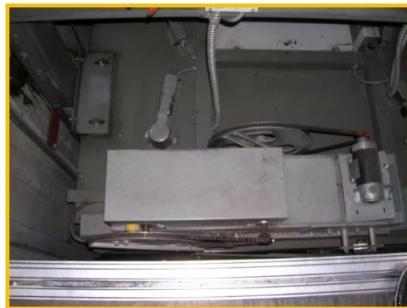
**Door Operation** – The most utilized elevator component, the door operator cycles 400% more often than the elevator does – (consider that the doors open, doors close, car moves, doors open, doors close with each destination). The existing door operator installed at **Chateau Comox** is an ECI895. This operator is a “light” duty component and is obsolete, it is classified as a “open loop” design that does not communicate with the controller. It is currently operating in fair condition. As the equipment ages, it will be important to monitor the door operation and budget to upgrade in next few years.

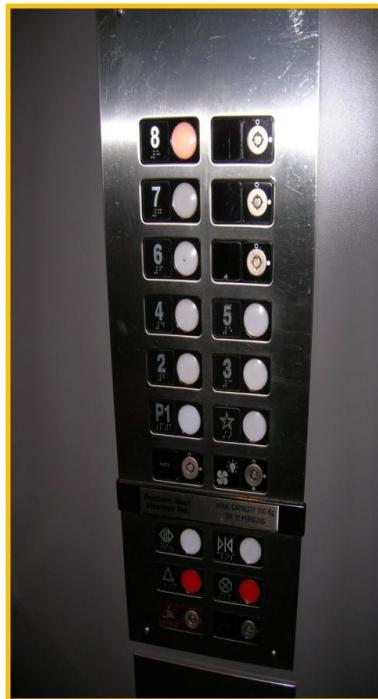
**Pushbutton Fixtures** – New pushbutton fixtures will conform to current Safety Code for Elevators (CAN/CSA-B44) and the requirements for the disabled [barrier free access] to be installed at lower height in both the cab and the hallway. New designs provide illuminated push buttons that are more energy efficient, and will comply with current handicap requirements. The recommended new “in car” fixtures (car operating panel) would include a digital floor position indicator, emergency light and hands free emergency phone.
