Depreciation Report | Project 7671.00
Chateau Comox, 1272 Comox Street, Vancouver, BC

Site Visit April 10, 2014
Submitted January 23, 2015 by
RDH Building Engineering Ltd.
224 W 8th Avenue
Vancouver BC V5Y 1N5

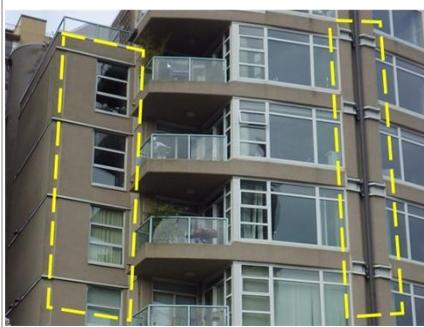
Encl 10 - Stucco Clad Wall - Drained - 2009

Targeted wall areas on all elevations, including levels 2-8 on north elevation, level 8 on south elevation between windows and sheathing membrane.

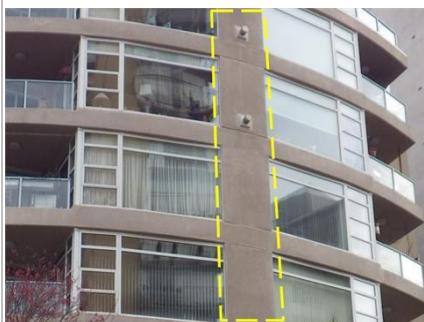
Encl 13 - Stucco Clad Wall - Undrained - Original

Between windows on south elevation at levels 2 to 7, and east elevation at levels 2 to 8.

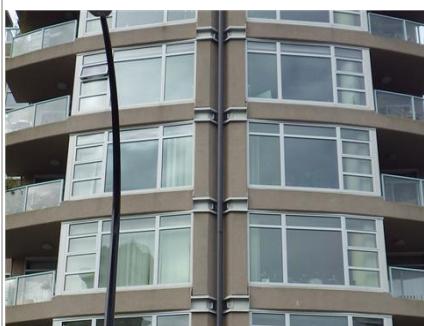
Encl 14 - Aluminum Framed Window - 2009

Centre stack windows on north elevation at levels 2 to 8, south elevation at level 8, and east & west facing windows on north balconies at levels 2 to 8.

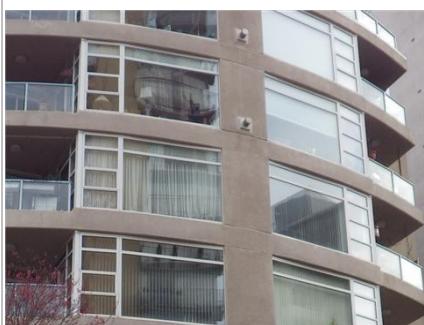
Encl 15 - Aluminum Framed Window - Original

Exterior walls on all elevations, except for windows replaced 2009.

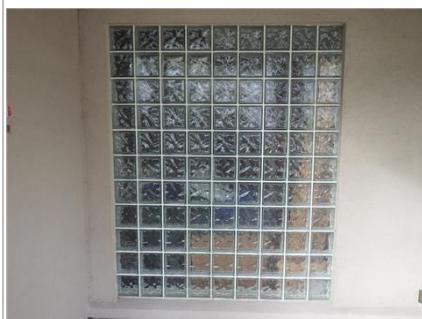
Encl 17 - Glass Block Window

Location	Description		
Exterior walls of amenity room and stairwells.	Glass block window.		
Information	Service Life:	30	Install Year:
Chronological Age:	23		1992
Effective Age:	17		Next Event Year: 2028

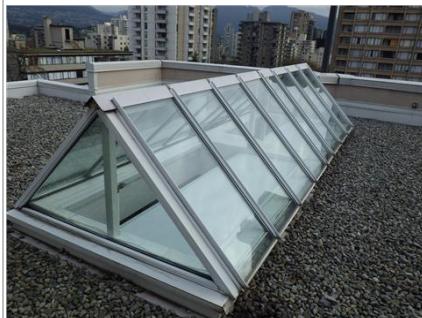
Encl 18 - T-Bar Skylight

Location	Description		
Main rooftop level.	Aluminum T-bar supported skylight system with glazed units.		
Information	Service Life:	20	Install Year:
Chronological Age:	23		1992
Effective Age:	13		Next Event Year: 2022

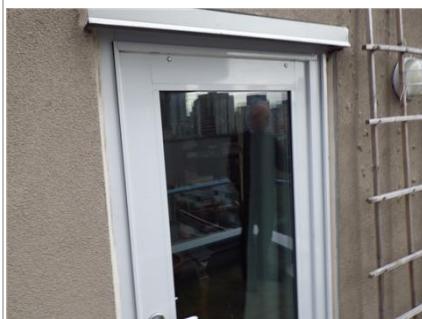
Encl 19 - Aluminum Frame Glazed Swing Door - 1999

Location	Description		
Access to decks on levels 7 and 8.	Aluminum frame swing door with insulating glazing units.		
Information	Service Life:	25	Install Year:
Chronological Age:	16		1999
Effective Age:	16		Next Event Year: 2024

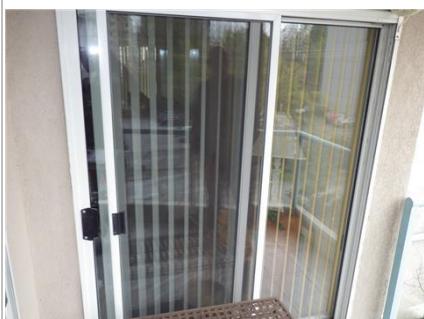
Encl 23 - Aluminum Framed Sliding Glass Door - Original

North elevation balconies (bedroom access) at all levels, and south elevation balconies (ground floor to 7th floor).

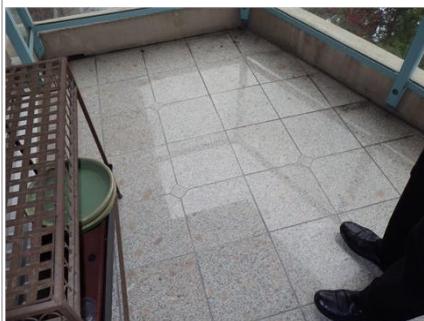
Encl 26 - Exposed Urethane Balcony Membrane - Concrete Substrate (Original)

South elevation, floors 2 to 7.

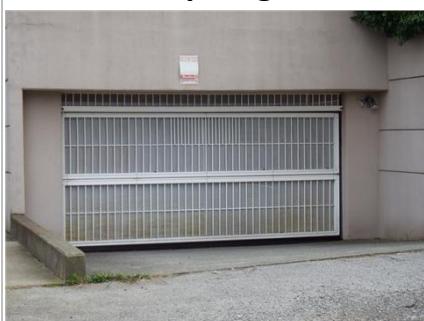
Encl 27 - Open-grid Overhead Parkade Gate

Parkade access on south side of the building.

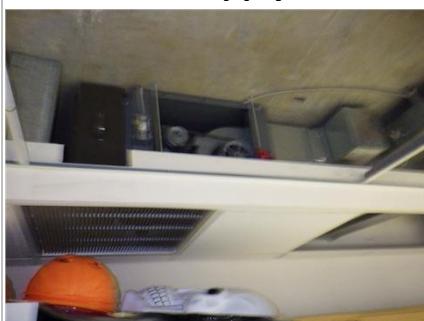
Mech 21 - Supply Fan - Inline Duct Blower

Ceiling of meeting room and exercise room. Delhi 207 3/4 HP centrifugal fan suspended from structure. Supply fan in exercise room (pictured) is not operational.

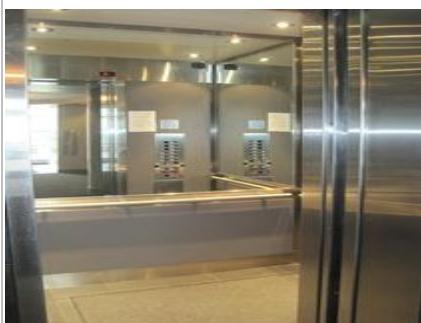
Elev 02 - Elevator Cabs & Hoistway

Single speed side opening door, plastic car and hall pushbuttons, one (1) car operating panel with plastic pushbuttons, mechanical safety edge with dual lights (dual lights are not functional) door protection, ECI-895 door operator, stainless steel car door and front return, mirrors with stainless steel reveals on walls, plastic laminate ceiling, tile flooring, tubular stainless steel handrails on all non-access walls, firefighter's emergency operation, standby power provisions, hand-held voice communication device (in cabinet), no seismic provisions.

- Modernization of elevator controls (Elev 01 & 02), and possible replacement of fire alarm panel (Fire 01) in conjunction.
 - Possible rebuilding or replacement of the make-up air unit (Mech 20).

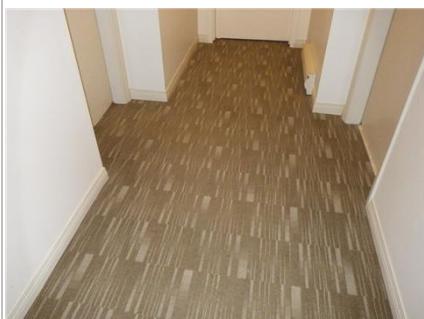
Finish 04 - Sheet Carpet - Levels 3-5

Floor of hallways at levels 3, 4, and 5.

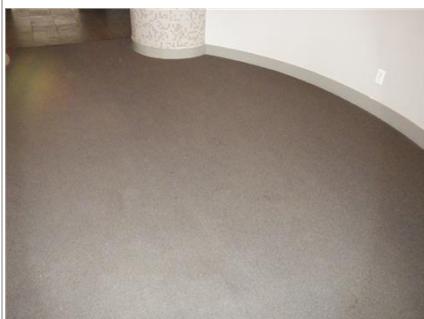
Finish 05 - Sheet Carpet - Lobby

Floor of entry lobby.

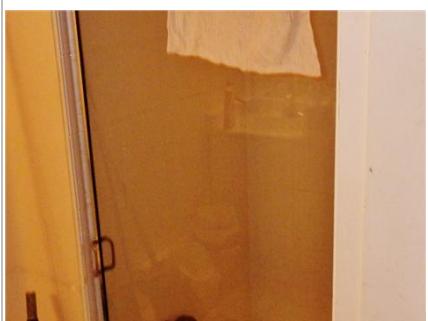
Finish 08 - Ceramic Tile - Washrooms

Walls of showers in exercise (storage) room. Ceramic tile on mortar bed and substrate with grout and sealant at interfaces.

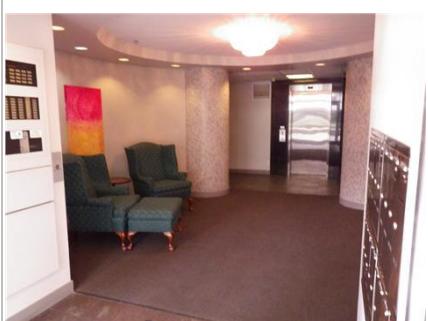
Finish 09 - Paint

Walls of entry lobby, hallways, washrooms, and meeting room.

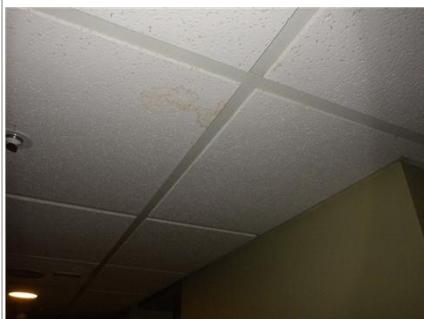
Finish 10 - Acoustic Ceiling Tile

Ceiling of hallways, amenity rooms, and washrooms.

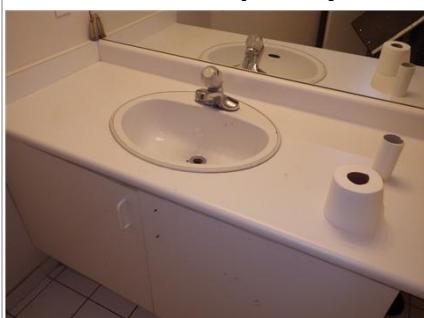
Finish 11 - Carpentry and Millwork

Washrooms in exercise room and kitchenette in meeting room.

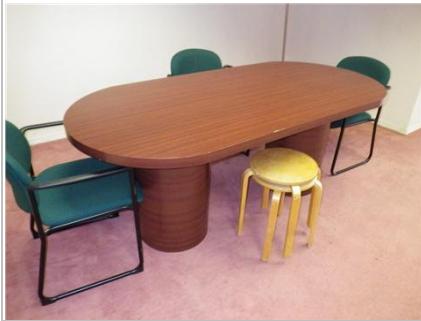
Amen 02 - Furniture & Accessories

Entry lobby and meeting room.

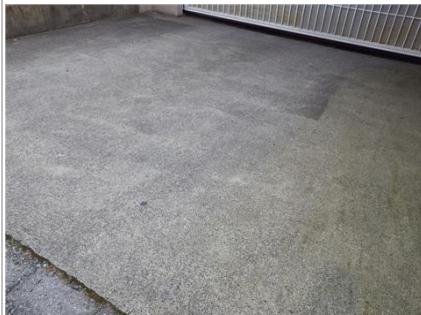
Site 02 - Concrete Paving

Parkade entry ramp, lobby plaza, and walkways on east and west sides of the building.

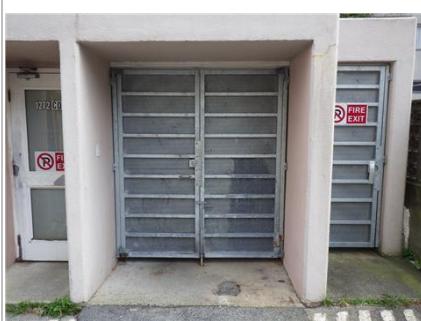
Site 03 - Metal Gate - Garbage Room

Access to garbage room and parkade P3 stairwell on south elevation.

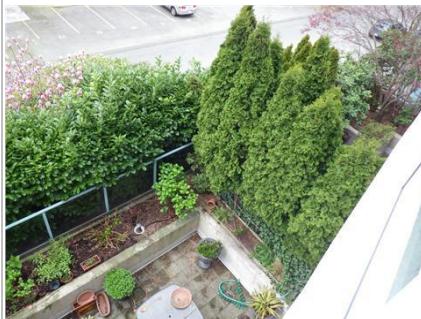
Site 05 - Soft Landscaping

Planters on north and south sides of the site.
